Agreement for the Menomonee River Levee System Accreditation

Design Report – Replacement of the Storm Sewer/Outfall on Honey Creek Parkway between 70th and 72nd Streets and Rehabilitation of the Schoonmaker Creek Culvert

- Inspected from North to South, heading downstream
- Objective: to capture defects, describe their location and size

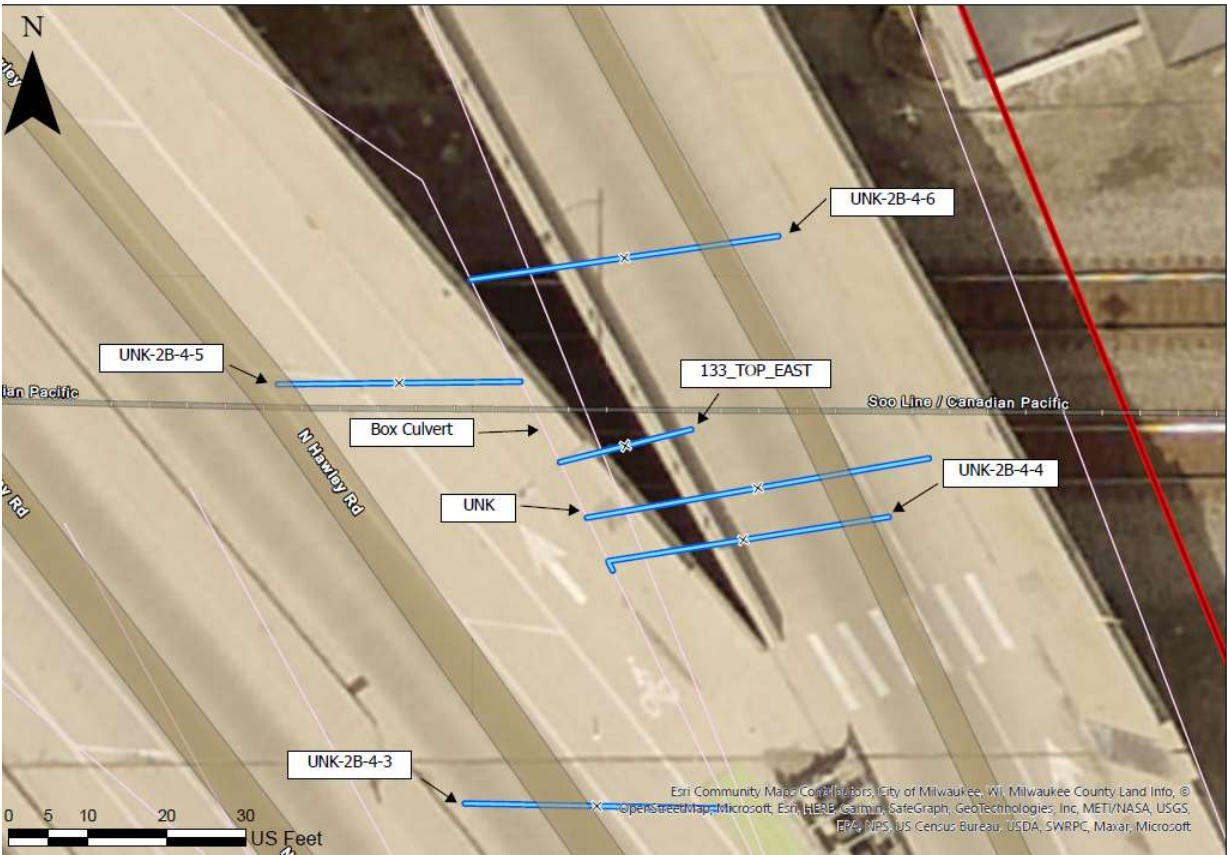
Figure 2-1 Box Culvert Tap Locations

Michels Investigation: On September 2, 2022, Michels attempted to flush with water a pipe connected to a drain from the overhead bridge of North Hawley Road to determine where it connects to the box culvert. The actual inlet on the bridge was clogged, so Michels flushed water around the pipe as it went below ground (See Figure 2-2 and Figure 2-3), but the volume of water entering the drain pipe was limited. No infiltration was observed in the box culvert; therefore, the point of connection from the bridge drain into the box culvert was not determined. Because this bridge deck drain is likely connected to an underground pipe that is clogged or collapsed (based on the 2020 TREKK CCTV inspections of the box culvert connections in this area) and based on discussions with the District, Arcadis recommends managing the drainage from the bridge deck at this location by reconfiguring the bridge deck drains to discharge to an appropriate location at grade and abandoning the below grade pipe.

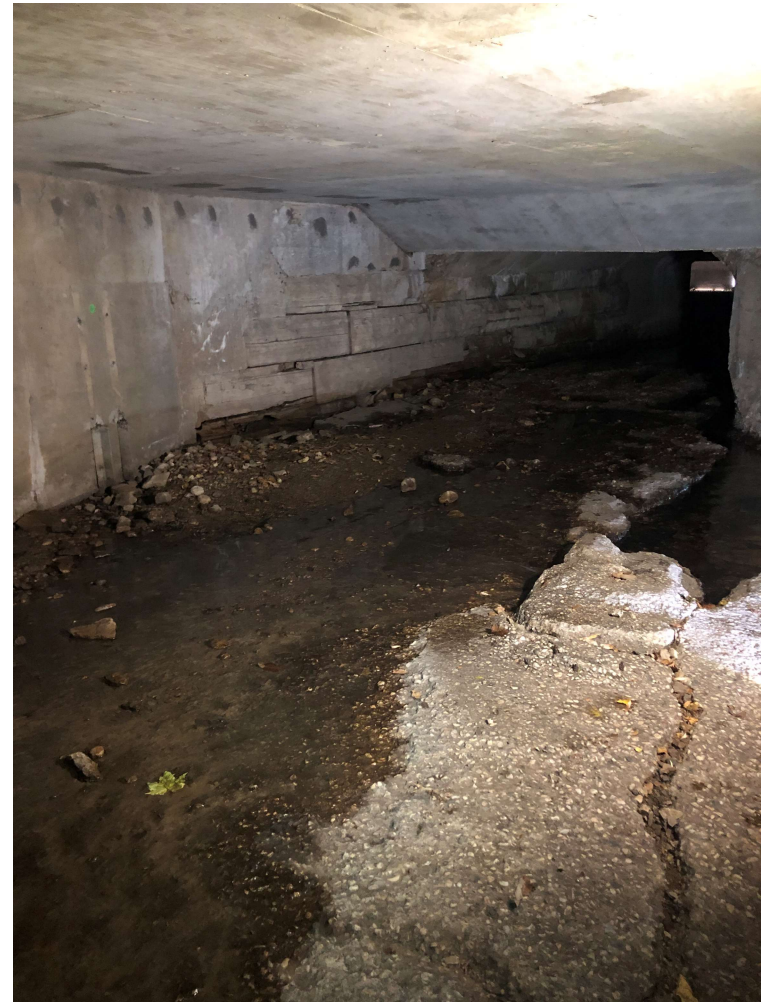
Joint 1 to Joint 2: 11'

- Patch work on east wall of chamber: 4'11" top length, 3' height on left side, approximate right triangle shape (see figure on next slide)
- At 3" from joint 1 on bottom: stone wall, pieces missing
- Calcium deposits begin from joint 1 continuous to joint 3
- At 8'10": Wire mesh visible on floor. length 10'6", width 2'1"

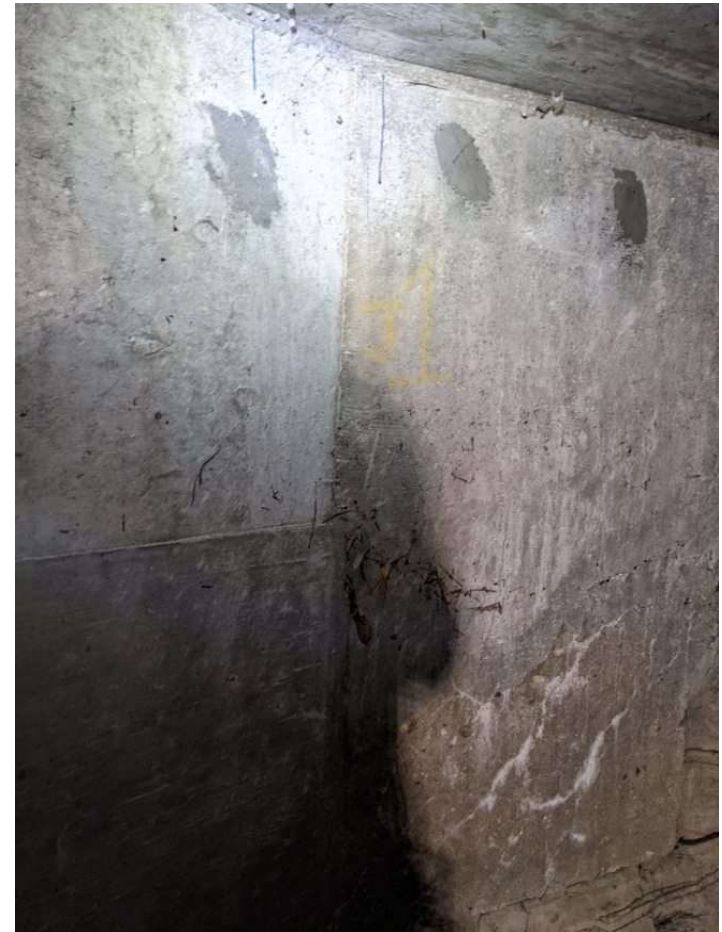
East Channel

- At 0 ft from Joint 1:
- Patch work on top of East side of channel, 4'11" top length, 3' height on left side, right triangle shape
- (Missing stone wall visible on bottom)

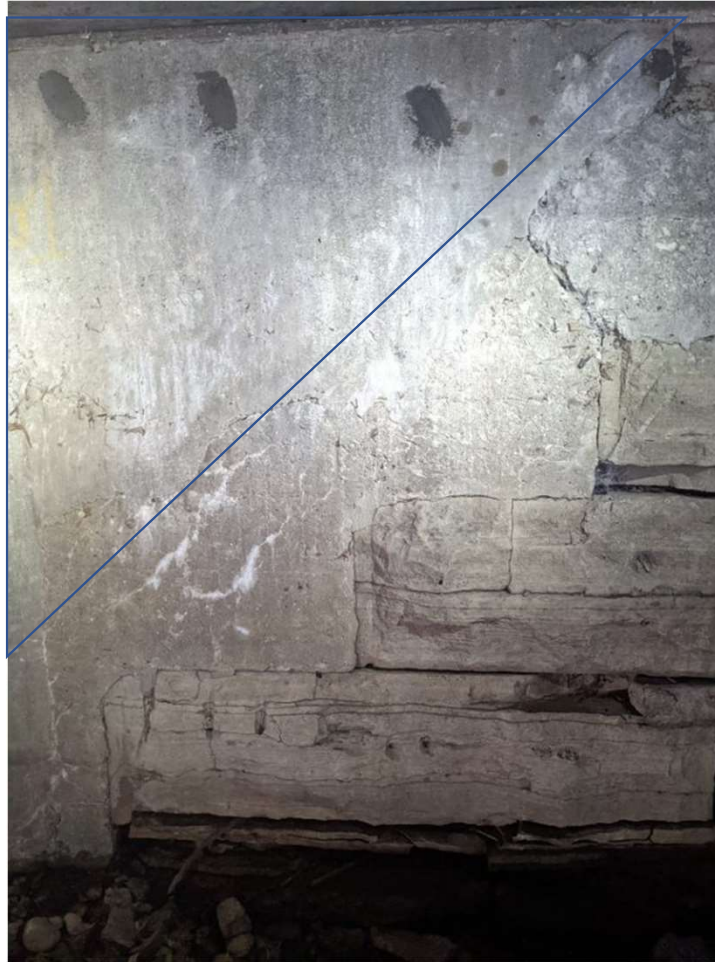
Joint 1 to Joint 2

At 0 ft from Joint 1:
Missing stone wall
visible on bottom.
Details on following 2
slides

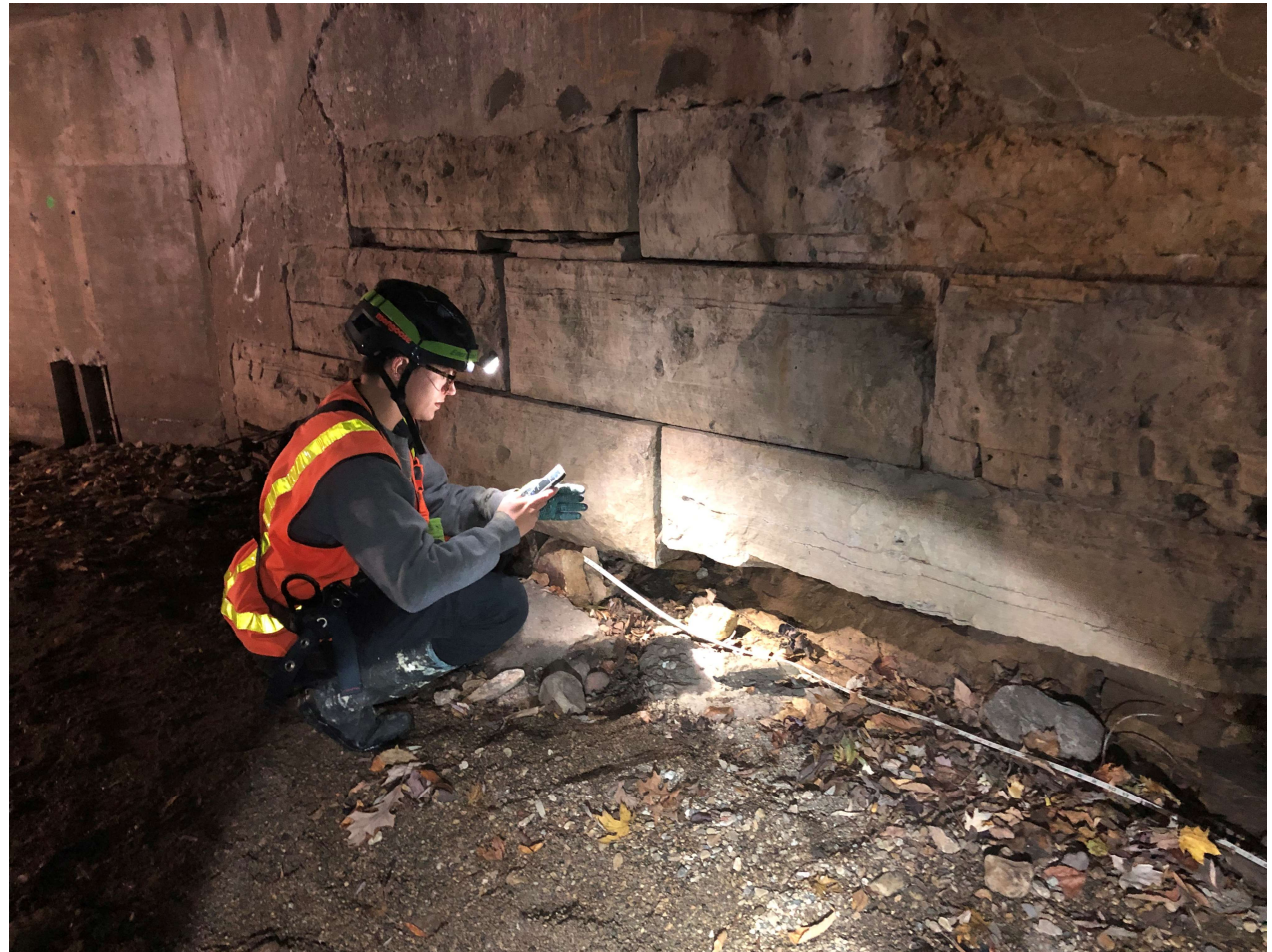
Joint 1 to Joint 2

- Starting 4" from joint 1, the first large piece of missing wall is 46" in length, 10" tall, and varies from 1" to 11" in depth (6" average depth)

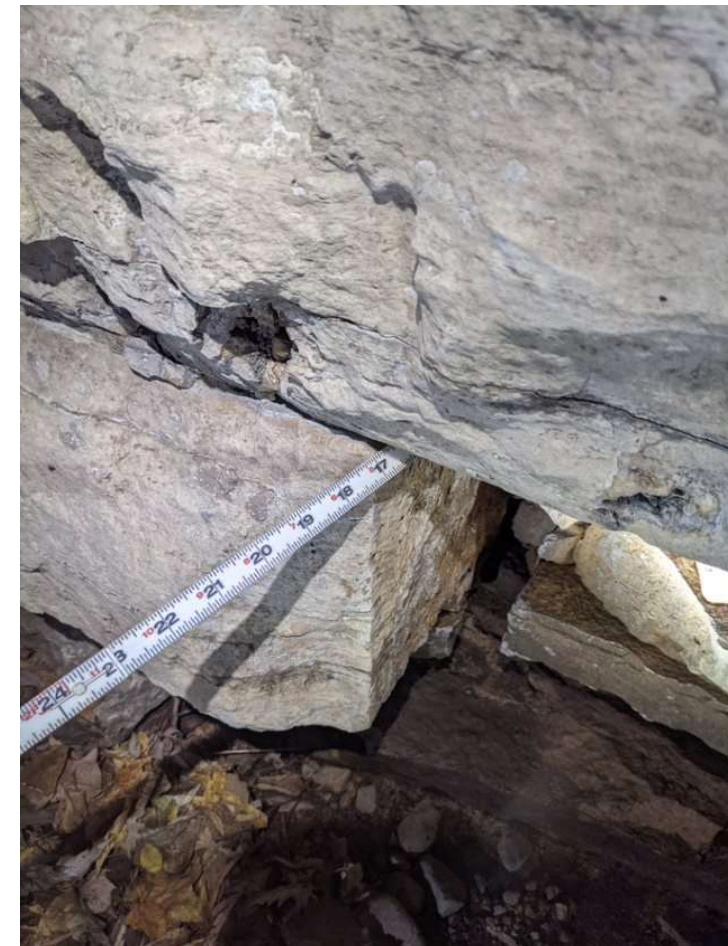
Joint 2 to Joint 3

- 11' from joint 2: missing section of stone wall
- Irregular shape
- Height: 37" at highest
- Width: 60" at widest
- Depth: 8" average

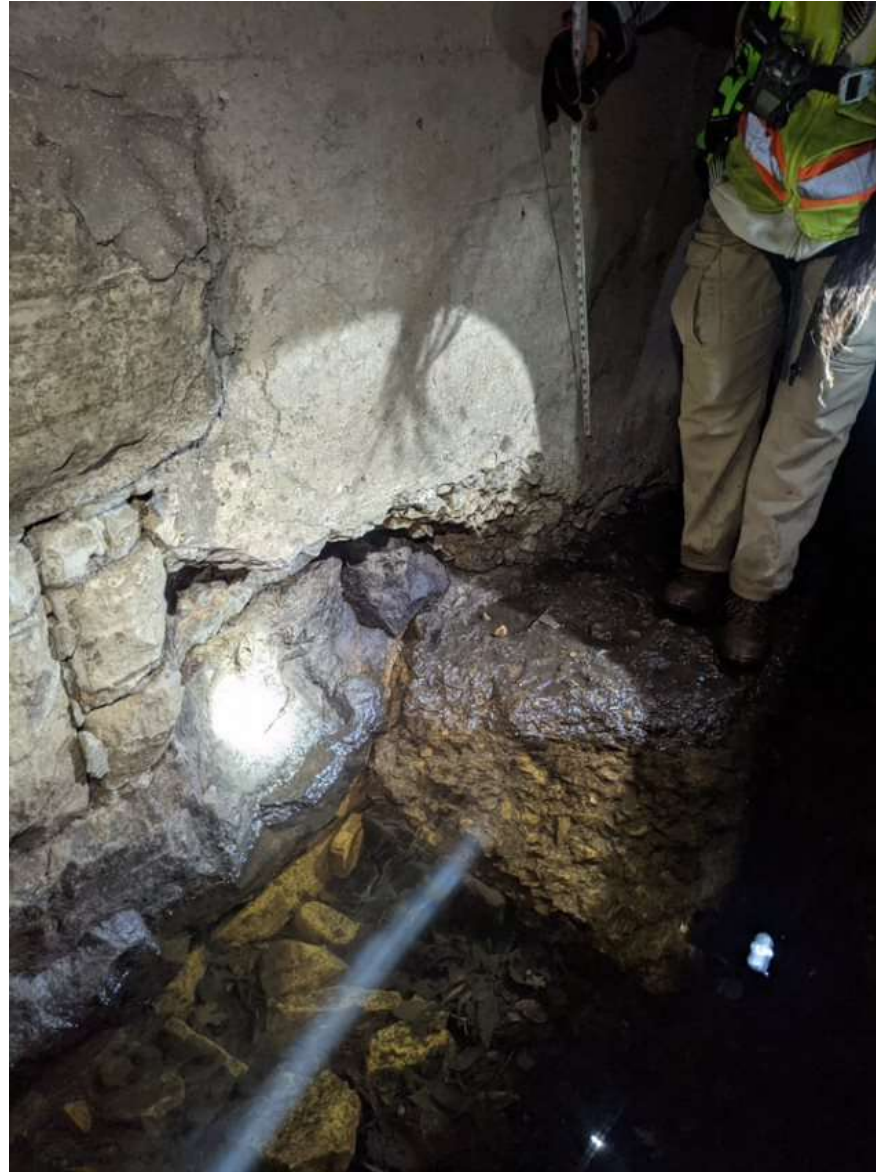
Joint 2 to Joint 3

- Length: 40"
- Height: 2' tall
- Depth: 8" average (2" to 14")

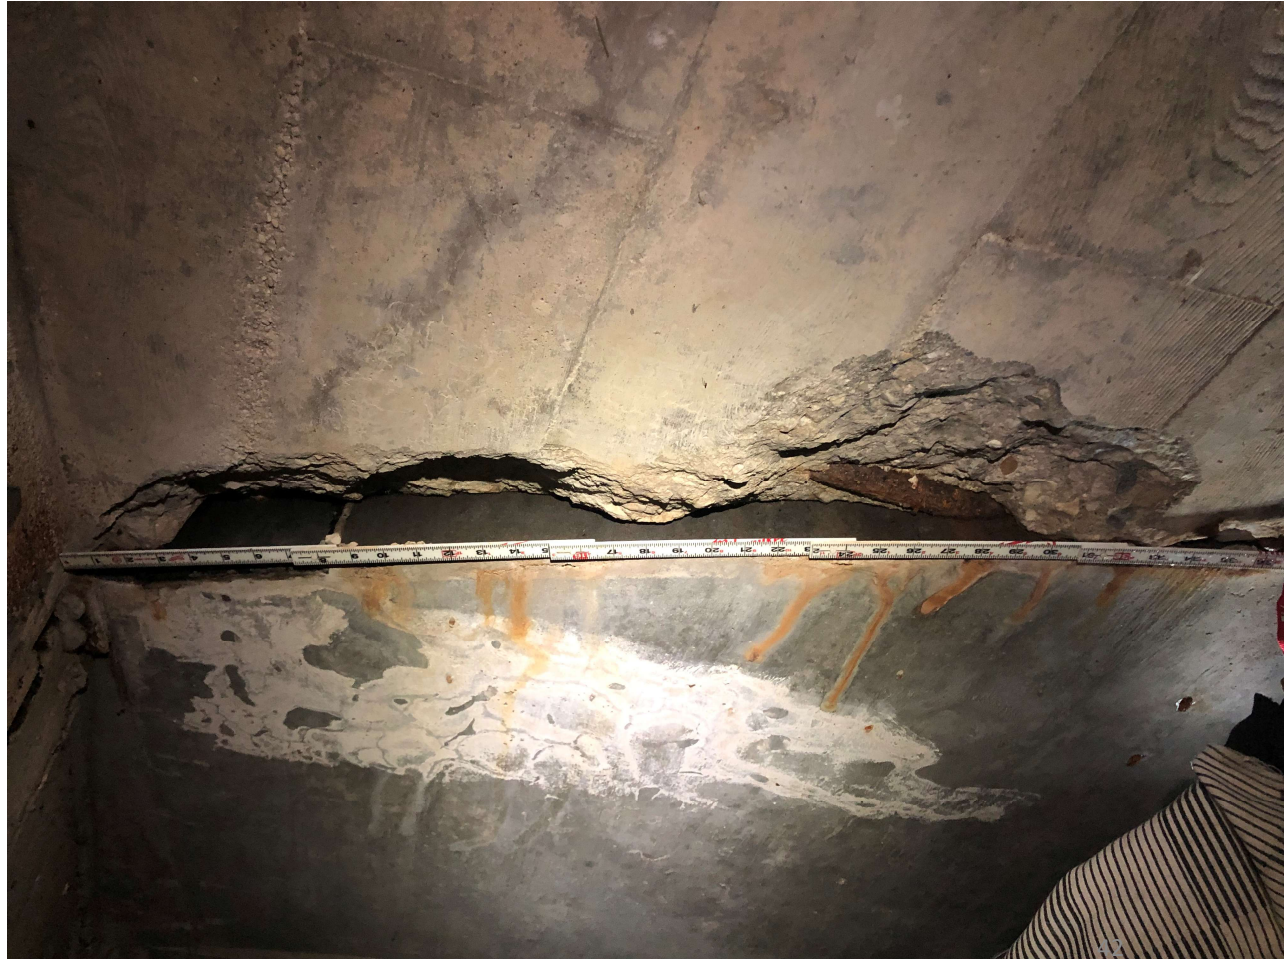
Joint 4 to Joint 5

- 1' width, 2 ft length, 2" depth, center of ceiling

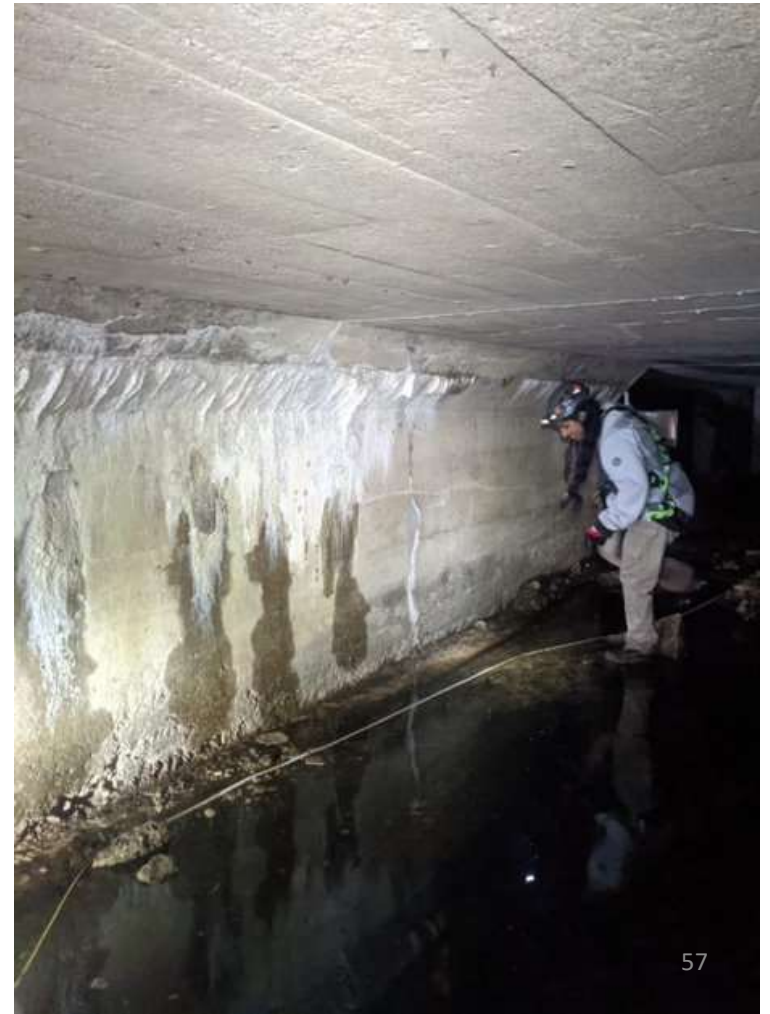
Joint 2 to Joint 3

- Continuous spall along bottom of east and west walls from joint 2 to joint 3,
- Image and defect dimension of the east wall:
- Height: 6"-12", average 8"
- Depth: 1"

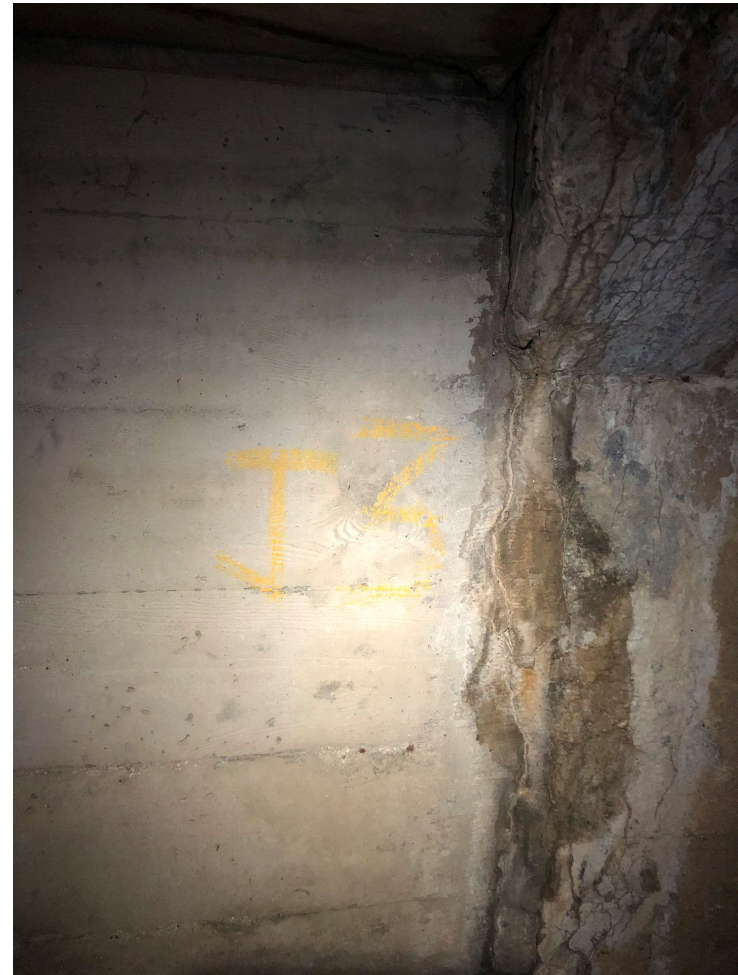
Joint 3 to Joint 4

- From Joint 3 to Joint 5:
- Floor defect/ Pool 22', average 1" depth standing water

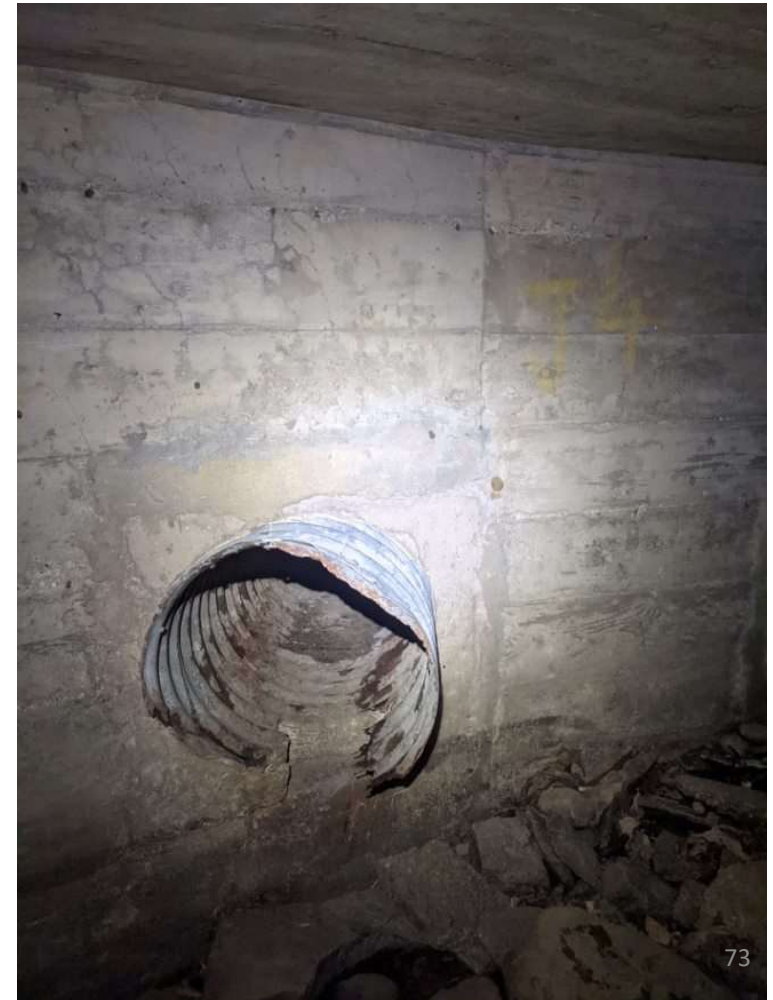
Joint 4 to Joint 5

- Infiltration stains on West side, continuous defect

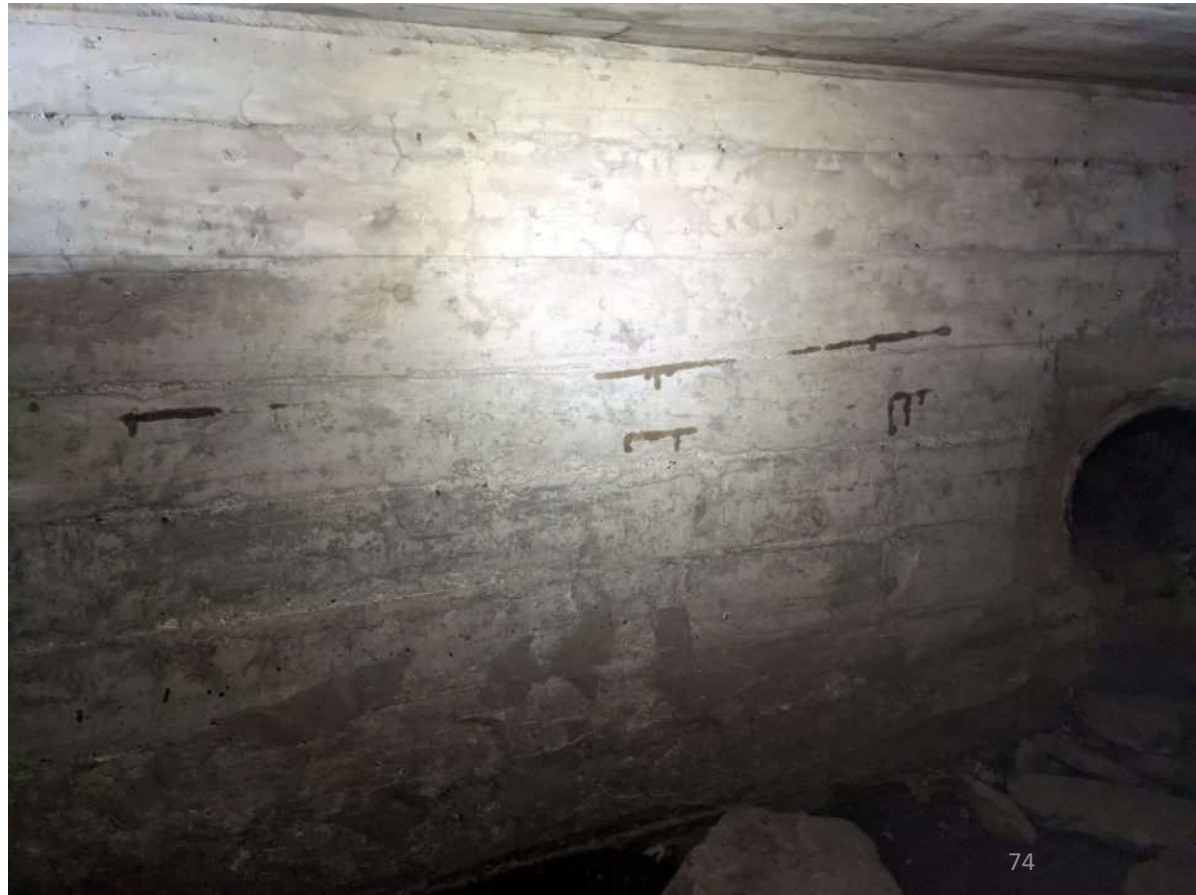
Joint 4 to Joint 5

- Bumps on floor, continuous from Joint 4 to Flood Gates, minor defects in floor

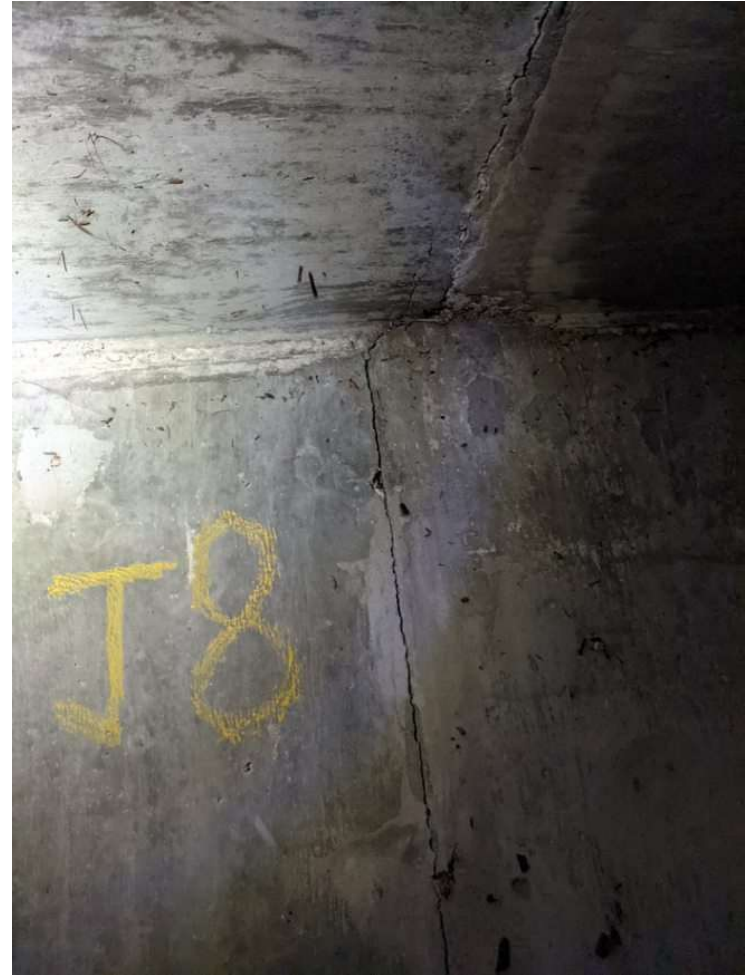
Joint 8 to Floodgate

- Circumferential crack at Joint 8
