FEASIBILITY STUDY

# WAUWATOSA CITY HALL AND LIBRARY

JANUARY 11, 2023

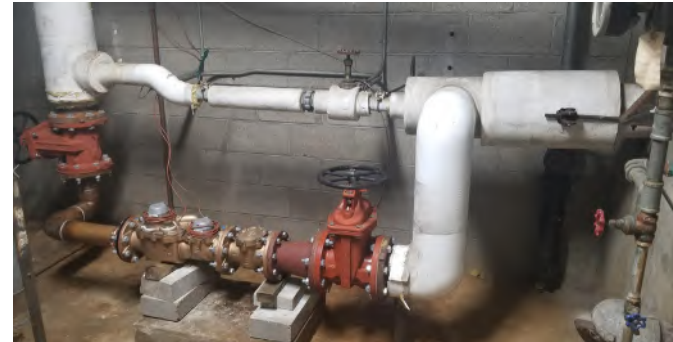
*Domestic Water Service and Meter*

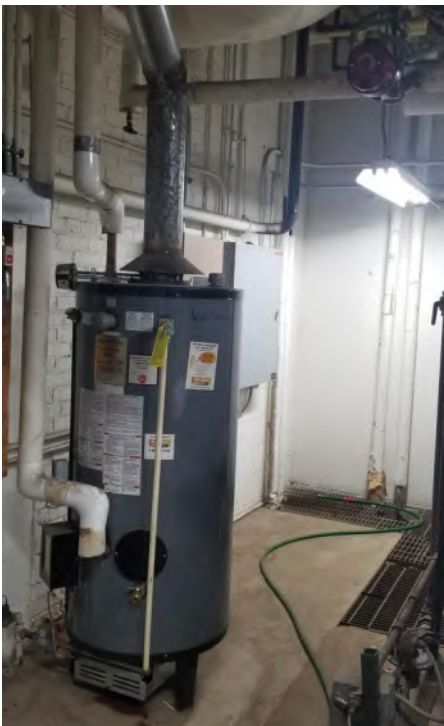
*Building Water Heater and Circulating Pump*

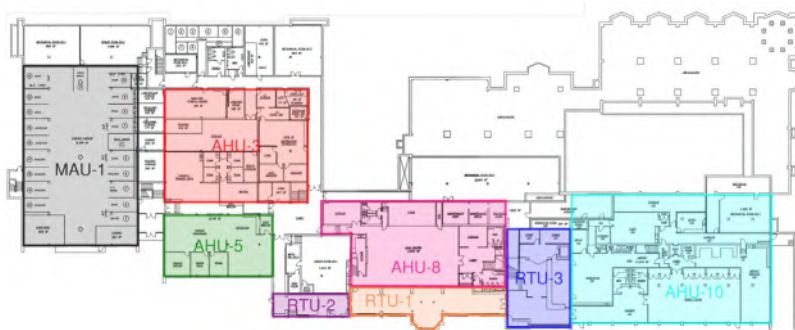
Areas of Building Served by Air Handling Equipment – Lower Level

The majority of the building is heated and cooled by ten indoor air handling units (AHUs) and three rooftop units (RTUs). The approximate areas served by each of the AHUs and RTUs is as shown in the following figures.

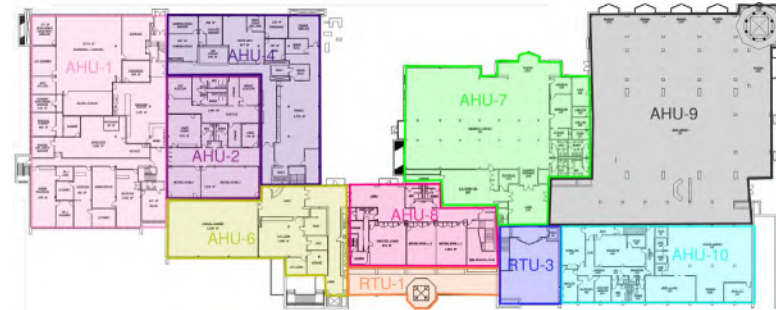
Areas of Building Served by Air Handling Equipment – Upper Level

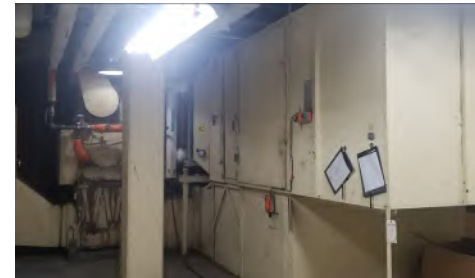
AHU-1 is located in Mechanical Room #1 and is original to the 1969 addition and includes a supply fan and chilled water coil. A duct-mounted return fan brings air back to the unit. The unit is variable volume and supplies air to a series of variable air volume (VAV) boxes with hot water reheat coils for conditioning of individual zones and spaces also include perimeter hot water fin tube.

AHU-1 and associated return fan

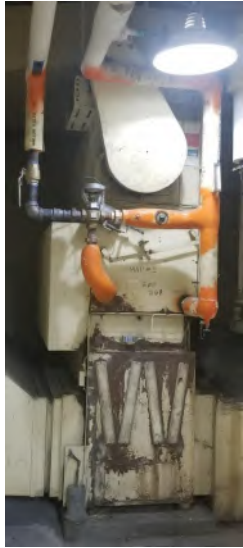
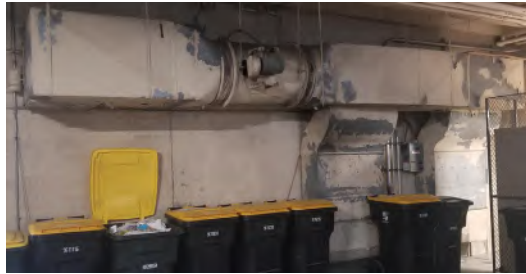
MAU-1 and EF-2 serving parking garage.

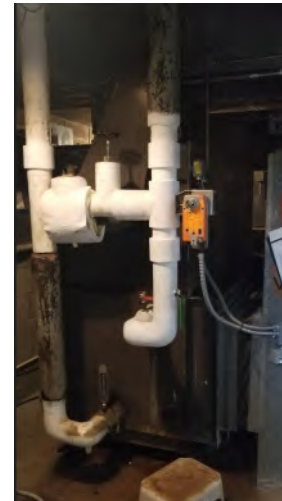
AHU-5 is a small, vertical unit located in Mechanical Room #4 and is original to the 1955 building. The unit includes a chilled water coil and supplies air to a series of variable air volume (VAV) boxes with hot water reheat coils and spaces also include perimeter hot water fin tube. It was noted that this unit is short on airflow which results in an inability to adequately condition the spaces it serves.

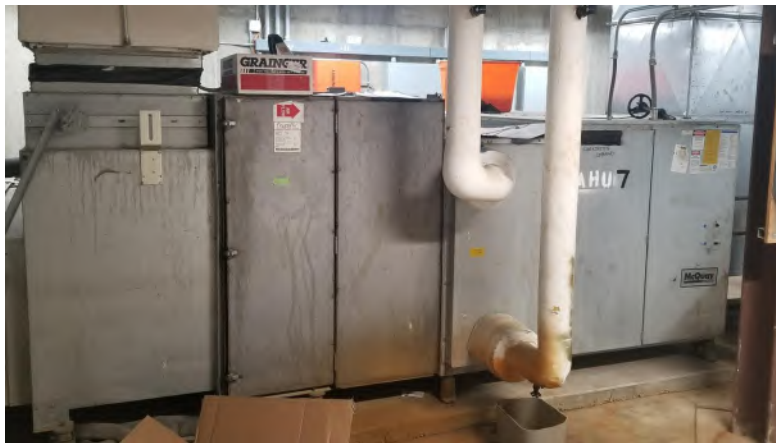
AHU-7 (AHU-8 and AHU-9 similar)

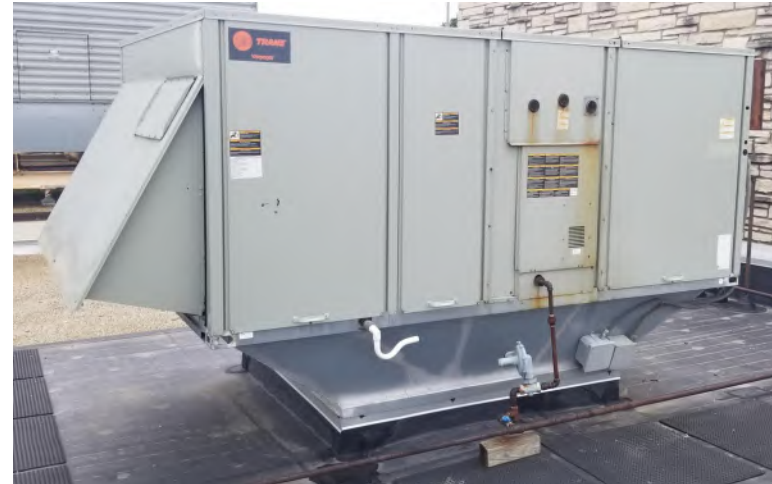
RTU-1, RTU-2, and RTU-3 are located on the roof above the main entry areas and are single zone units. RTU-1 and RTU-2 were replaced about 10 years ago, but RTU-3 appears to be older. Each RTU include a DX cooling coil and gas burner.

RTU-1 (RTU-2 and RTU-3 similar)

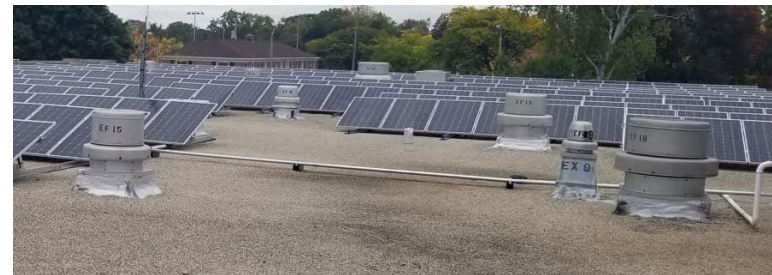
Roof-mounted exhaust fans amongst photovoltaic panels

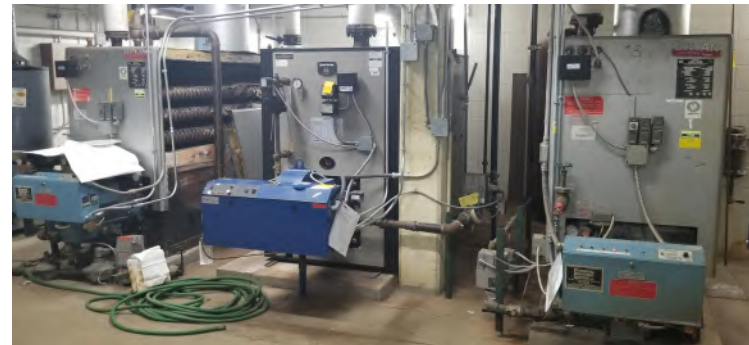
Boiler B-1 is no longer operational and has been abandoned. Boiler B-2 is the largest boiler and is a newer cast iron boiler. Boiler B-3 appears to be original and is about half of the size of B-2. Each boiler has an associated primary inline pump (P-6 for B-1, P-7 for B-2, and P-8 for B-3). One of the boilers and pumps was noted to be on backup power so some heating is to the building available on loss of primary power. This allows the building to operate as an emergency operation center, if needed. No cooling is on backup power.

Boilers (left-to-right: B-1, B-2, & B-3)

Some additional efficiencies could be realized by changing the heating water system setup. When boiler B-3 needs to be replaced, it could be replaced with a condensing boiler and the controls could be set up to provide lower temperature water at low load conditions.

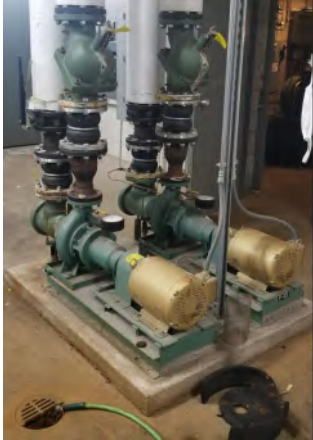
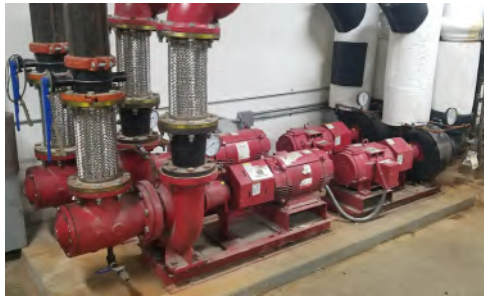
*Pumps (Left: P-9 & P-10; Right: P-16, P-17, P-18, & P-19)*

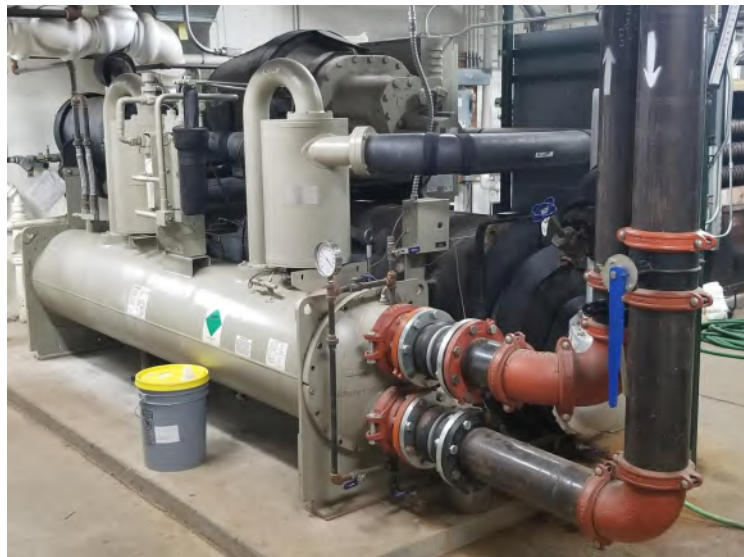
*Chiller*

The chilled water system consists of a chiller and cooling tower as the source for chilled water. The chiller is located in Boiler Room #1. The chiller includes a refrigerant leak detection sensor and alarm as required by code at the time, but current code would require additional safeties that would need to be included with any chiller replacement. The chilled water supply temperature resets between 43 and 52 deg F, based on outside air relative humidity.

The chiller will need to be replaced within the next few years and consideration should be given to adding some redundancy when replacing chiller. For example, installing chillers sized at 50% of the load would allow for chilled water to be available if there was an issue with one of the chillers. Additional energy savings could be realized by converting the chilled water system from constant volume to variable volume.

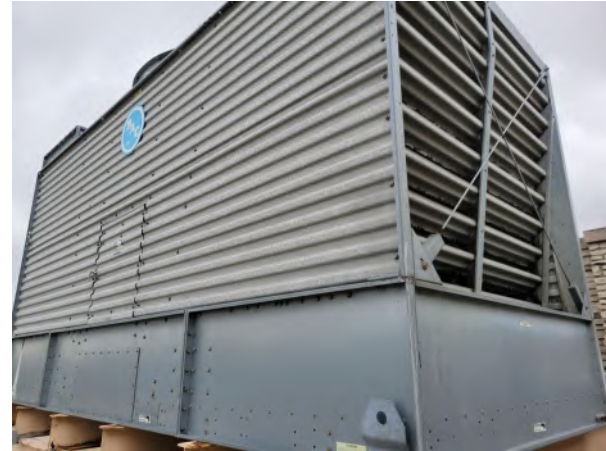
*Cooling Tower*

The cooling tower is located on the roof. The cooling tower had a new VFD installed in 2021 and some piping on the roof has been replaced in the past. Redundant condenser water pumps (P-18 and P-19) are located in Boiler Room #1. A chemical treatment system is also located in this room.

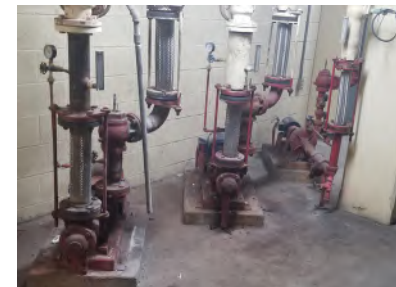
*Three pumps in Boiler Room #2 that appear to still be in use.*

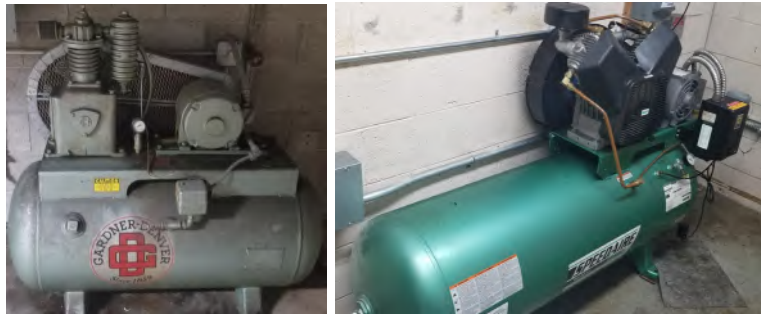
replacement) and the Equipment Room off of Mechanical Room #4 (recently replaced and in good condition). An older air compressor is located near the new air compressor and is not operational and appears to have been abandoned in place.

Air compressors for pneumatic controls

It is recommended that the conversion from pneumatic to DDC continues, especially as renovations occur in the building, with a goal of eventually phasing out all pneumatics in the building. The operational efficiency of DDC control over pneumatics will save energy and help offset the cost of the conversion over time.

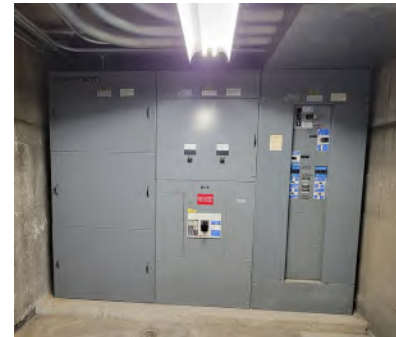
The main east service switchboard includes breakers to serve its' loads. There is space for additional breakers to serve new loads. However, due to the location of existing main service and how existing equipment is installed, utilizing switchboard space for new loads may not be feasible. There is little to no room for future loads to leave the existing equipment due to height of equipment and the low structure height.

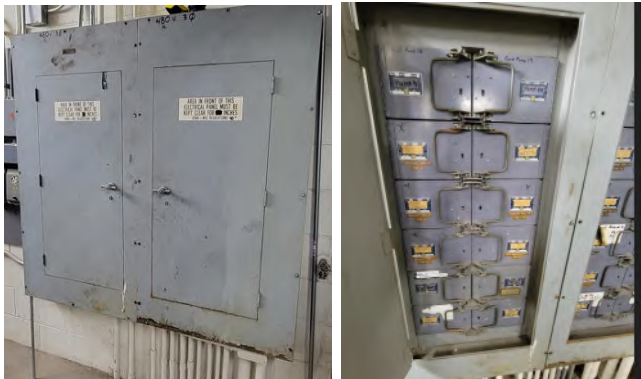
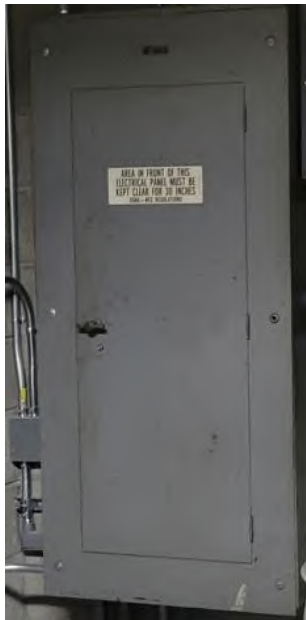
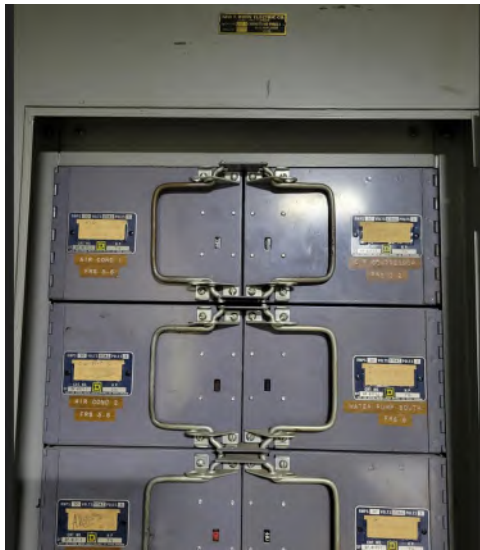
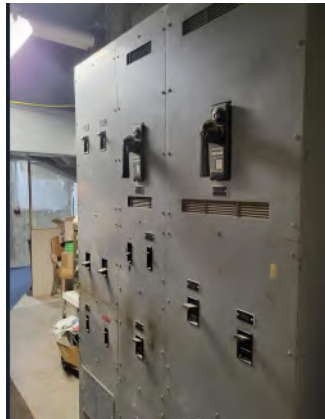
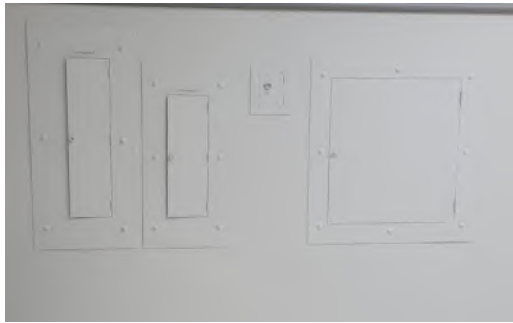
The facility distribution is a mixture of 480/277 Volt and 208/120 Volt. The 480/277 Volt distribution system serves the large mechanical loads such as supply fans, cooling equipment and elevators. The 208/120 Volt distribution serves lighting and receptacle loads with some smaller equipment loads. Overall, the electrical distribution equipment including switchboards, distribution and panelboards appears to be in poor condition for equipment installed prior to the 1990's renovation and in fair condition for equipment installed in the 1990's renovation. The distribution gear is in poor condition is mostly due to age, being obsolete, dust and, in some cases, rust.

Distribution Equipment, late 1960's and prior Addition & Renovations	Poor	Obsolete panels, but still in operable condition. Recommended for replacement in the near future.
Distribution Equipment, 1990 and later Addition & Renovations	Good	Good condition other than age. Should be considered for upgrade as part of future renovations.

Although still functional, given the age of the equipment throughout, it is recommended that this equipment be replaced in kind in the near future. Some of the major equipment is located within dedicated rooms or other back of house spaces which should allow for straight forward replacement. Unfortunately, these spaces do not have much room to install new equipment near the existing so, in most cases, existing gear will need to be removed to make space for the new unless space can be designated for this use. Regardless of the replacement plan implemented, the process will require shutdowns that affect large areas of the facility. Many of the original field panelboards installed throughout the facility are mounted in walls and many times in public locations so the interiors of these panels should be replaced to preserve the current wall construction, if desirable, or new panel locations should be chosen.

During the replacement of the electrical gear, replacement of the conductors between these pieces of equipment as well as field devices is recommended since life expectancy for wiring is approximately 70 years. During conductor replacement, dedicated grounding conductor would be installed in each feeder to ensure proper grounding and not only relying on raceway as the grounding path/means.

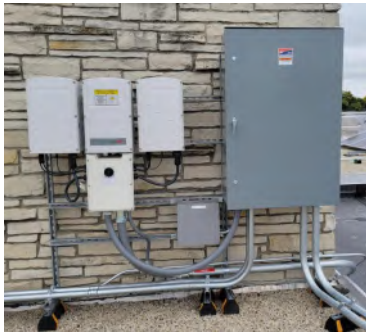
Solar system has been installed on the roof as well as the solar system inverters as of April 2021. Current solar system is a net metering set-up rated at 300 kW and offsets the current facility electrical use by approximately 40%. It should be noted that under a significant renovation project the existing roofing system should be replaced with new which means the solar system would need to be removed and stored to allow new roofing system to be installed then re-installed.

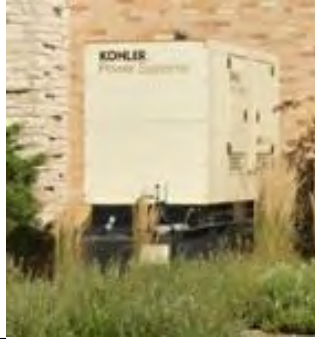
There are two emergency generators for this facility. The original facility 15 kW Kohler natural gas generator is still potentially operational but is no longer connected, tested/ran and used for emergency power. The current generator is 480/277 Volt, 3 phase, 4 wire 100 kW Kohler diesel generator in a weathertight enclosure with a base tank. Generator is located on the southwest corner of facility near garage entrance. The 150 amp 480/277 volt emergency feeder is routed through the garage to the loading dock area to a 200 amp generator power panel board. From the generator panel board there is a 480 volt feeder to a 15 kVA step down transformer that serves the existing transfer switch and emergency panels (NEC Article 700 - Emergency Systems) that was previously served by the 15kW generator. The loads appear to be mainly lighting loads but may have some receptacle loads. From the generator panel

The 150 kW generator is exercised regularly. If new loads are added as part of any renovation, the current load for each of these generators should be measured and reviewed with any proposed new loads to ensure capacity is available. The distribution equipment for emergency power is the same as used for normal power and is in similar condition to the normal power equipment for the facility.

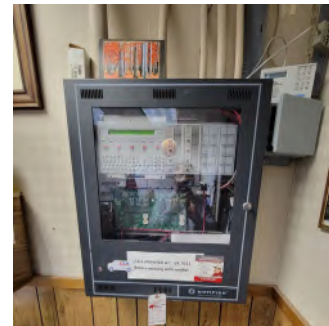
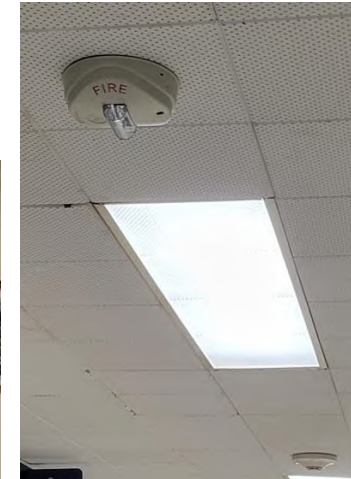
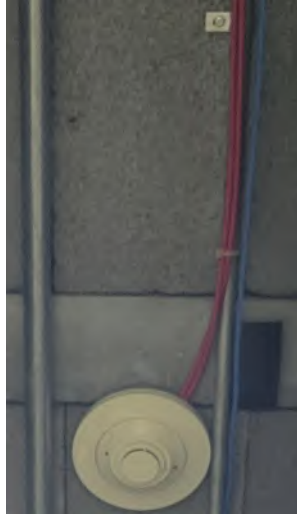
The detection and initiation devices throughout the facility appear to be in fair to good condition. Commercial detection devices have a typical service life of 10-15 years after which time they should be replaced. The facility does not have a sprinkler system, so detection of smoke and fire is even more important for the protection of facility occupants and property. Additional fire detection devices are recommended to limit the impact of fire conditions and to provide early warning for facility occupants. One example of additional detection may be to provide corridor smoke detection coverage throughout the facility.

DESCRIPTION	CONDITION	COMMENTS
Main Fire Alarm Control Panel	Fair to Good	Addressable system with horn type notification appears to be functioning adequately. Control panel is in fair to good condition. Voice fire alarm system is recommended.
Fire Alarm Initiation/Notification	Fair	Detection devices that are 10 -15 years or older should be replaced. Additional detection and notification recommended.
Fire Alarm Code Compliance	Fair	Additional fire detection devices are recommended to cover more of the facility footprint for early warning. Additional notification devices would be required to comply with today's codes.

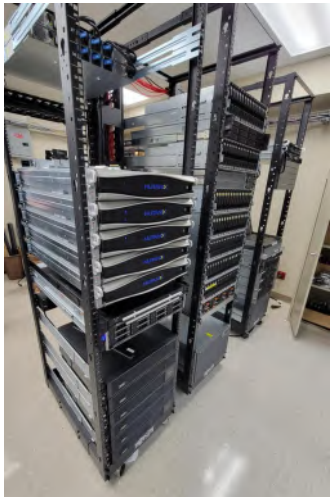
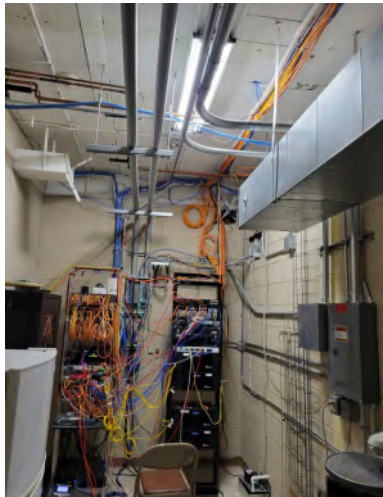
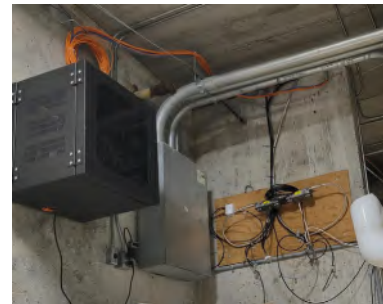
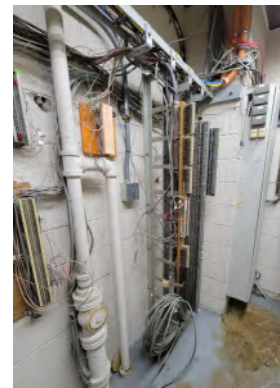
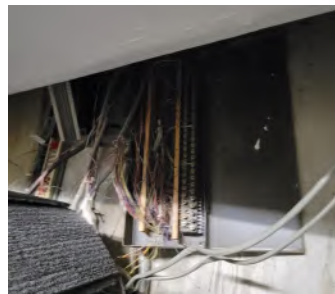
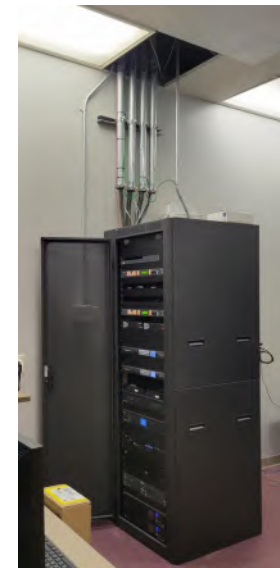
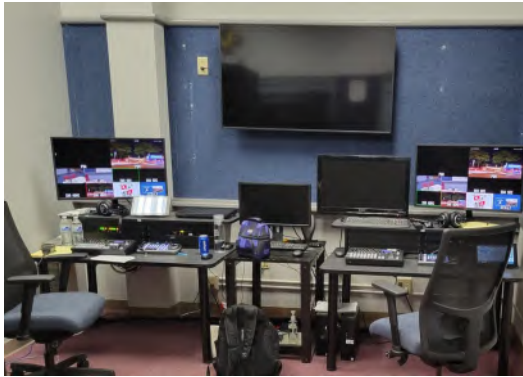
The facility main Server Room, original phone room, and IT offices is located on the ground floor east of the garage area and interior loading dock area. The IT office area is a dedicated space with controlled access required to the telecommunications equipment. The Server Room, original phone room, and IT offices have their own cooling. These spaces are connected to the generator power system. The Server Room also has uninterruptible power supply to support critical equipment. Additional low voltage distribution is provided throughout the facility using wall fields and cabinets in mechanical spaces, and remote wall mounted racks in other areas of the facility.

DESCRIPTION	CONDITION	COMMENTS
Telecom Rooms	Fair to Good	Main rooms are dedicated to telecom installations. They include controlled access as well as their own cooling and UPS backup. Some cable tray cleanup would be beneficial.
Telecom Equipment	Fair to Good	Replacement of equipment including cabling should be considered for renovated areas
Telecom Pathways	Poor	Minimal cable tray or other pathways for future changes

It is recommended for renovations that a new Entrance Facility Room be established to be the main demark room for the entire facility which would house the main utility copper and fiber services and become the main server room for critical functions. Recommend that new Telecommunications Rooms be strategically placed throughout facility under renovations to serve new individual drop locations. These new Telecommunication Rooms would be served from the new Entrance Facility Room with new copper and fiber cables. The goal would be to eliminate unused cables, old cable types and organize system layouts to facilitate future changes. The existing equipment in the affected rack(s) and wall cabinets should be reviewed at the time of renovation to assess if the equipment or any specific components should be replaced including the cabling. It is also recommended that all future projects include modern cabling constructions such as those in the CAT 6 family or greater.

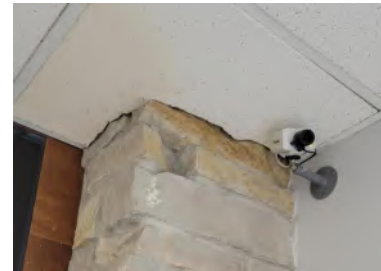
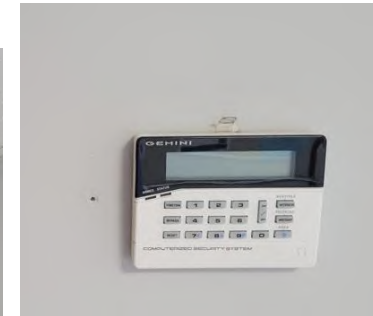
The facility currently has an access control system installed by BAYCOM. At this time there are about 12 doors being controlled throughout the facility by the access control system which ranges from department interior doors, entry, and IT spaces. There is also a security keypad at the main entry.

DESCRIPTION	CONDITION	COMMENTS
Access Control	Fair	Additional doors interior and exterior could be added to enhance the overall coverage of the system
Cameras	Fair	Camera layout is limited to main entry points, garage and IT/Server areas. Ongoing replacements should continue to take advantage of new technology.

Camera system technology has advanced significantly over the past several years. For any expansive remodel efforts, replacement of existing camera monitoring or expansion to increase total area coverage should be considered. Raceway infrastructure is recommended to be installed out to the parking lot area for future addition of area cameras.
