Agreement for the Menomonee River Levee System Accreditation

Design Report – Replacement of the Storm Sewer/Outfall on Honey Creek Parkway between 70th and 72nd Streets and Rehabilitation of the Schoonmaker Creek Culvert

- Inspected from North to South, heading downstream
- Objective: to capture defects, describe their location and size

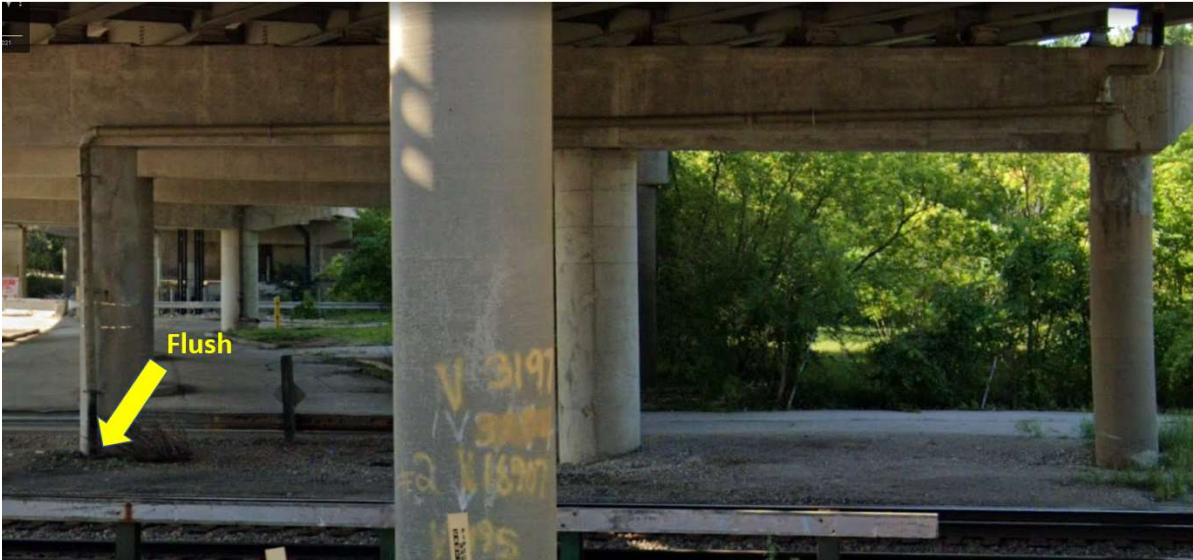
Figure 2-2 Box Culvert Flush Test Location for North Hawley Road Bridge Inlet Drain

Michels Investigation: On September 2, 2022, Michels attempted to flush with water a pipe connected to a drain from the overhead bridge of North Hawley Road to determine where it connects to the box culvert. The actual inlet on the bridge was clogged, so Michels flushed water around the pipe as it went below ground (See Figure 2-2 and Figure 2-3), but the volume of water entering the drain pipe was limited. No infiltration was observed in the box culvert; therefore, the point of connection from the bridge drain into the box culvert was not determined. Because this bridge deck drain is likely connected to an underground pipe that is clogged or collapsed (based on the 2020 TREKK CCTV inspections of the box culvert connections in this area) and based on discussions with the District, Arcadis recommends managing the drainage from the bridge deck at this location by reconfiguring the bridge deck drains to discharge to an appropriate location at grade and abandoning the below grade pipe.

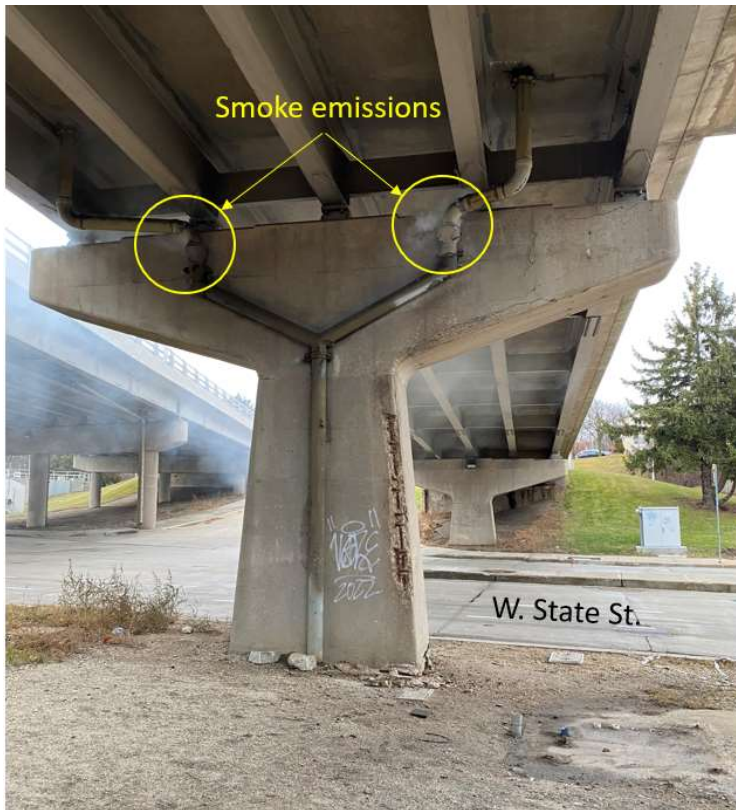
Figure 2-4 Smoke Emissions from Box Culvert Connection UNK-2-B-4-6 (aka 152019)

Mid City Investigation: On December 12, 2022, Mid City (accompanied by the District and the Arcadis team) performed smoke testing of two connections to the box culvert that were considered potentially active. Smoke testing the 133_TOP_EAST connection did not result in any observed smoke emissions at grade, in nearby Saz’s restaurant, or on the North Hawley Road bridge deck. As shown in Figure 2-4, smoke testing UNK-2-B-4-6 (aka 152019) resulted in smoke emissions observed on the overhead bridge deck drain, thereby confirming this is an active connection.

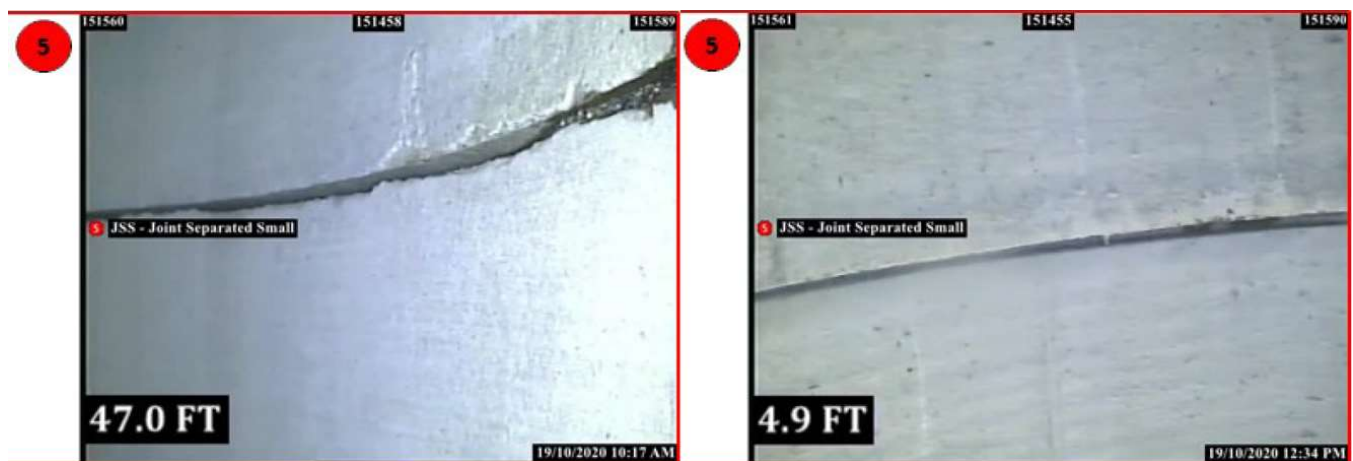
Figure 2-5 Examples of JSS from Master Plan

According to the PACP definition of joint separations, small separations are not coded in sanitary or stormwater sewers and are only used in a dam or levee system where there is “noticeable separation between pipe segments, but no gap is visible.” The PACP condition score for a JSS associated with a dam or levee is 5, which is the most severe rating. According to EM 1110-2-2902, a condition rating of 5 would require mitigation. Figure 2-5 shows examples of joints coded as JSS in the Master Plan that received condition grades of 5. However, because these joints show no evidence of infiltration or root intrusion, Arcadis believes they appear to be sound joints that do not require mitigation.

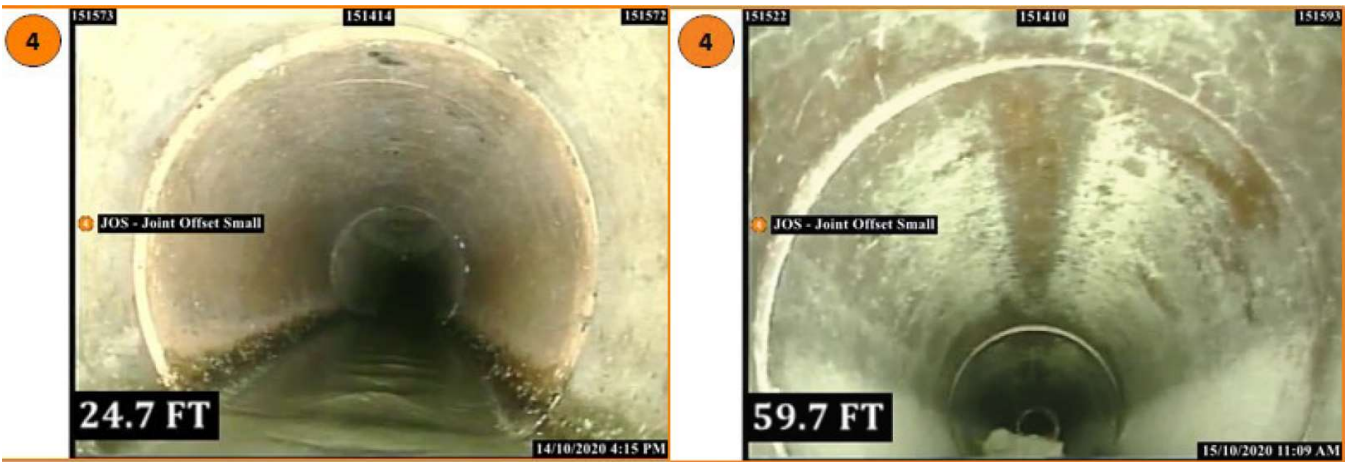
Figure 2-6 Examples of JOS from Master Plan

The Master Plan identified the pipes shown in Figure 2-6 as having small offset joints, which is a PACP condition grade of 4, which requires mitigation per EM 1110-2-2902. Arcadis believes these joints do not reflect an offset condition that warrants mitigation.

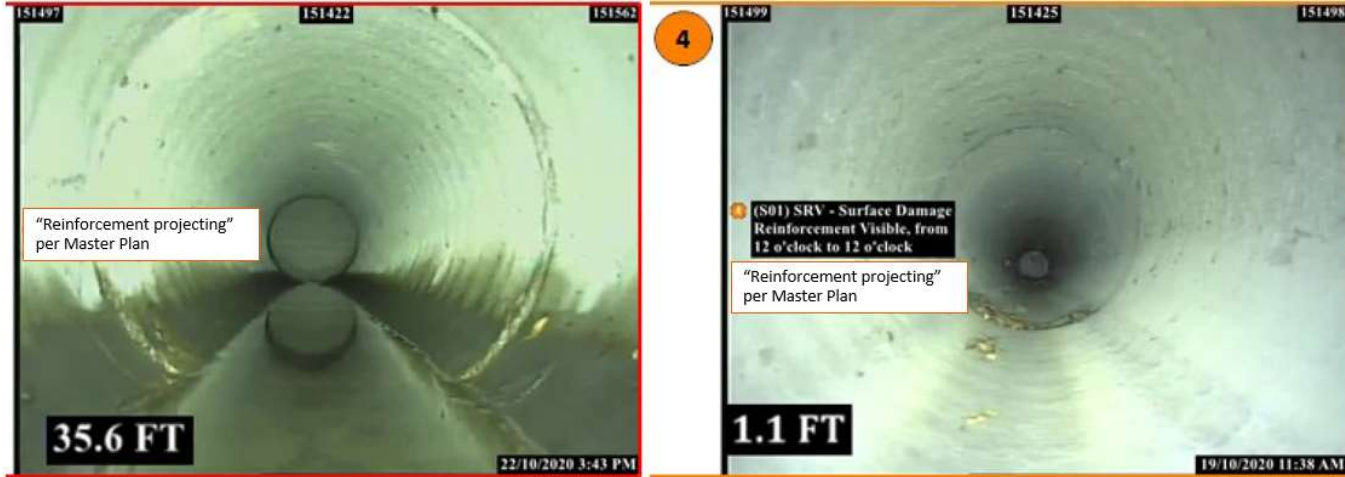
Figure 2-7 Examples of Reinforcement Projecting from Master Plan

The Master Plan incorrectly identified the conditions shown in Figure 2-7 as reinforcement projecting with a PACP condition grade of 4, which requires mitigation per EM 1110-2-2902. The reinforcement in these pipes is not visible or projecting. Therefore, Arcadis believes these appear to be sound pipes that do not require mitigation.

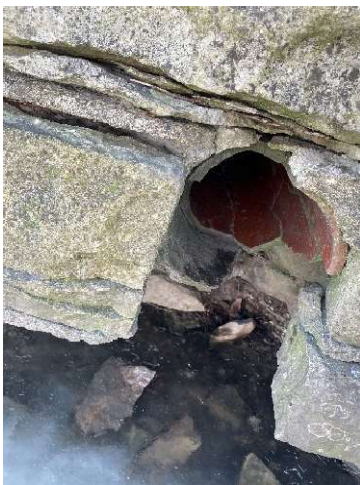
Figure 2-1. Existing VCP Penetration of WPA Wall

OTIE reviewed Trekk Design Group's 2020 CCTV inspection of this approximately 68-foot long, 8-inch diameter storm sewer pipe run and noted that the inspection was truncated because of a large offset joint at 48.7 feet from Honey Creek Parkway and because of a large joint separation at 2.8 feet from the Menomonee River WPA wall, leaving about 16 feet of the pipe uninspected. The existing sewer material is reinforced concrete pipe (RCP) from the Honey Creek Parkway end and transitions to vitrified clay pipe (VCP) at 30.8 feet. During the January 13, 2022 site visit, the OTIE field staff also observed VCP at the outfall (see Figure 2-1). The CCTV inspection identified numerous longitudinal cracks and joint separations along the portions of the pipe that were accessible by the CCTV crawler. The pipe material change suggests earlier repairs to the sewer. The Milwaukee Metropolitan Sewerage District (MMSD) was unable to provide plans for the sewer, so its age and the date of the apparent repairs are unknown. Given its location, the sewer apparently is owned by Milwaukee County Parks.

Based on the project goals and inspection findings, the Arcadis team recommends repairing some of the WPA wall stone masonry, improving the WPA wall penetration, and removing the existing RCP/VCP piping and replacing it with new SDR-35 PVC 8-inch storm piping using the existing alignment. The stone masonry repair would be limited to the area surrounding the 8-inch storm piping outfall (See Figure 2-2: WPA-era Wall at Honey Creek Parkway between 70th and 72nd Streets Storm Sewer Outfall). Permits will be required for storm sewer construction from Milwaukee County Parks (park access), WDNR (Chapter 30 permit), City of Wauwatosa (erosion control). Consultation with the City of Wauwatosa's Historic Preservation Commission, Milwaukee County, and the State Historic Preservation Office will be required to confirm jurisdiction and permits required for modifications to the WPA wall. This would allow for a good and consistent sewer run using modern materials and would minimize disturbance to the stone and mortar WPA wall and project costs.

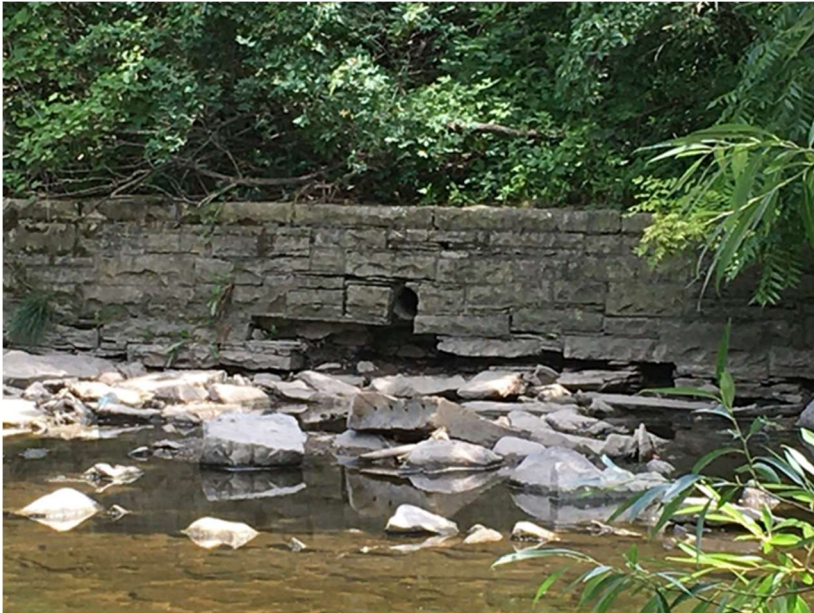
Figure 2-2. WPA-era wall at HPS-9 storm sewer outfall (July 2021)

As shown in **Error! Reference source not found.**, the wall section at the HPS-9 storm sewer outfall shows considerable deterioration. Many of the face stones directly below the outfall and at the waterline are missing, exposing the rubble/hearthing between the face stones. At the time of the inspection, OTIE was unable to determine the extent of the deterioration at or below the waterline due to the frozen water surface; however, given the age of the wall, OTIE assumes that the entire wall has some degree of deterioration.

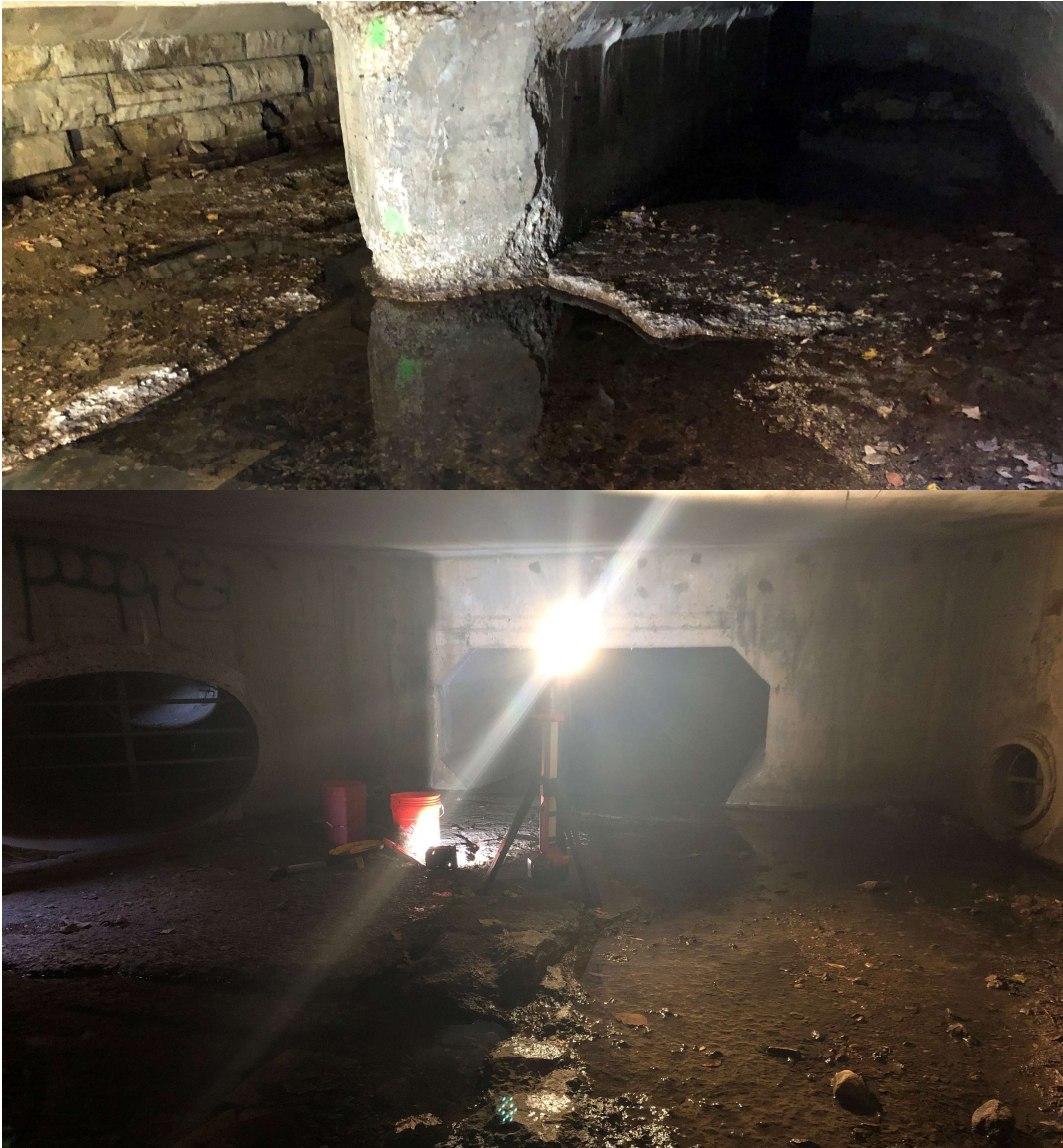
Dividing Wall

- Top Defect/ missing wall:
- Height: 18"
- Depth: 14"
- Width: 4'5"
- Bottom defect/ missing wall:
- Height: 27"
- Depth: 14"
- Width: 4'5"

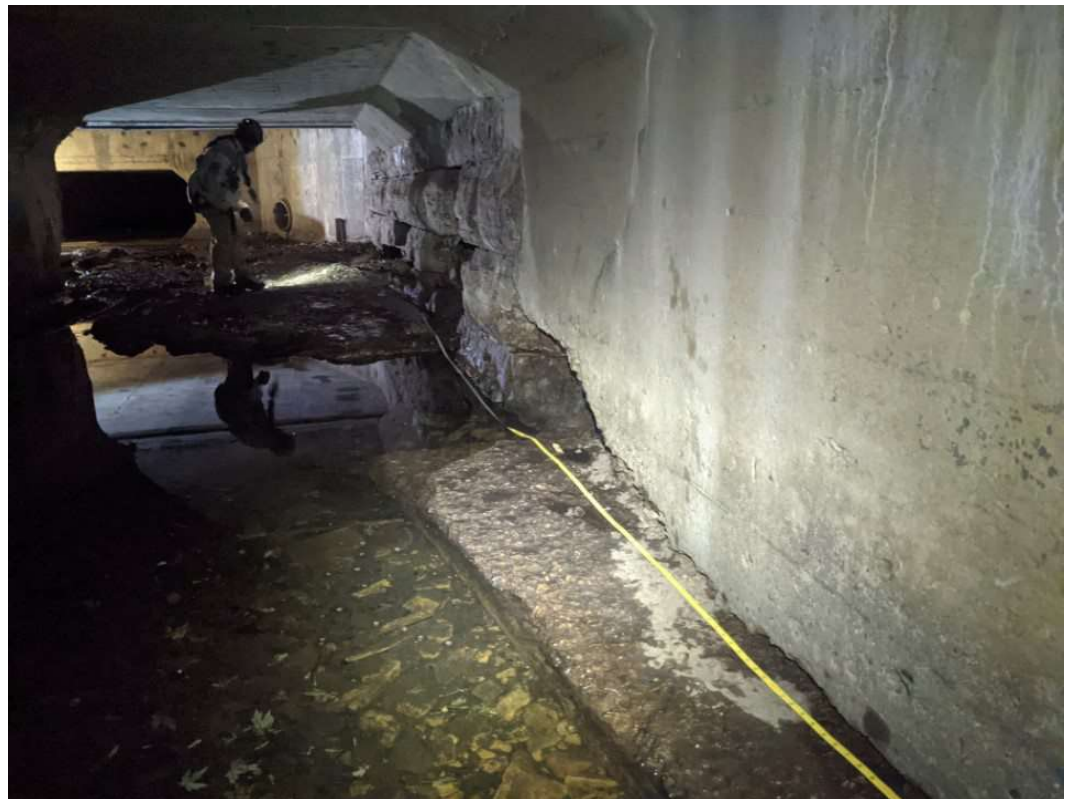
Joint 0 to Joint 1: 15'

- Vertical fracture 3'4" from ceiling on north wall
- Inlet pipe at 2'10", diameter 1'7"
- 10'6" vertical fracture from top to bottom of chamber
- Sediment and floor defect continuous from joint 0 to joint 4

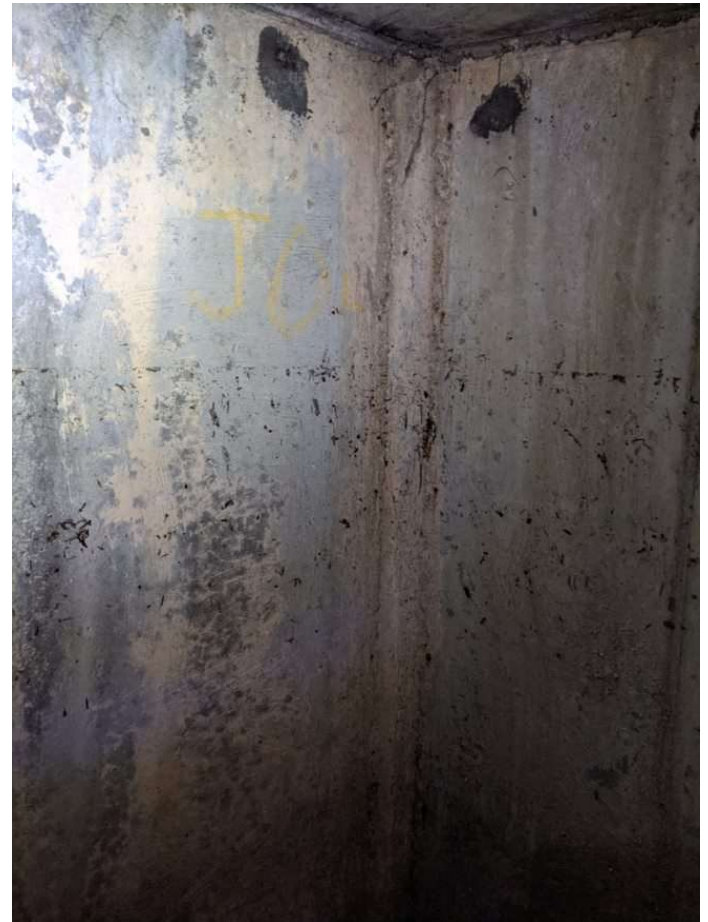
Joint 0 to Joint 1

Vertical fracture on North
wall near trapezoidal inlet
channel

Length: 3'4" from ceiling

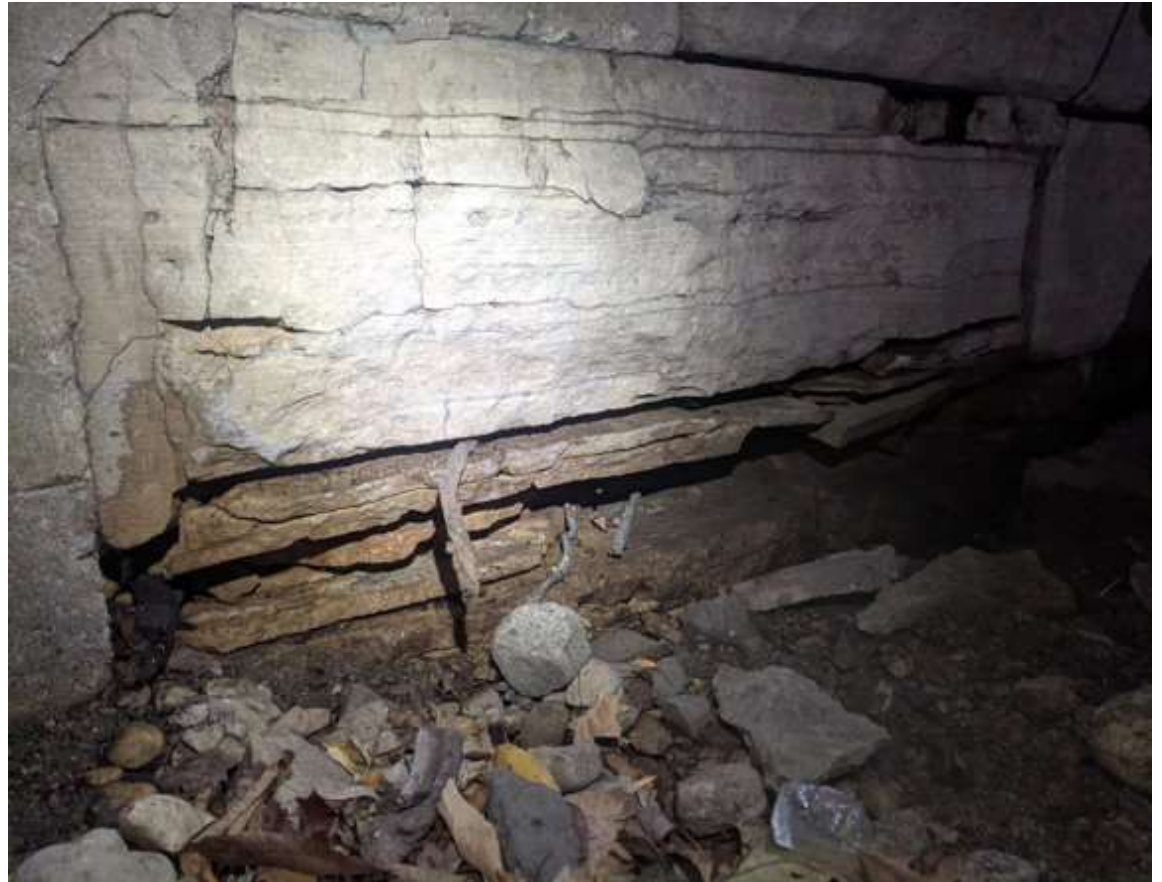
Joint 1 to Joint 2

- Starting 4" from joint 1, the first large piece of missing wall is 46" in length, 10" tall, and varies from 1" to 11" in depth (6" average depth)

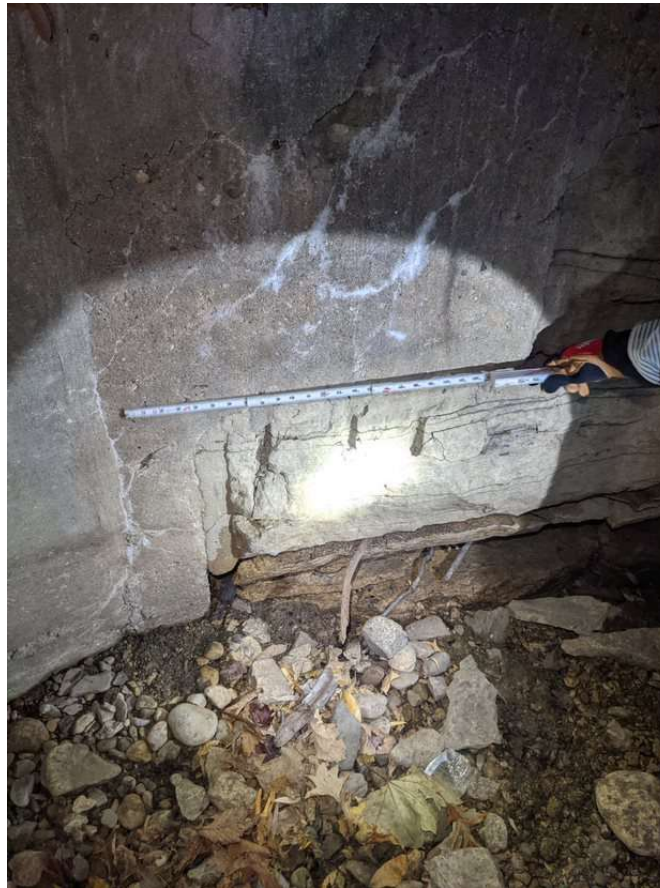
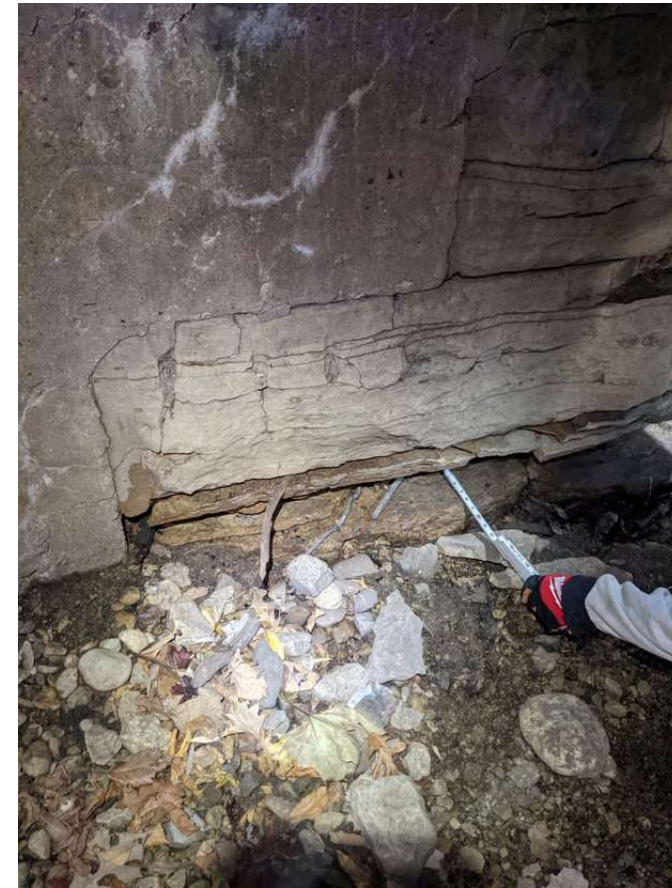
Joint 1 to Joint 2

- Starting 4" from joint 1, the first large piece of missing wall is 46" in length, 10" tall, and varies from 1" to 11" in depth (6" average depth)

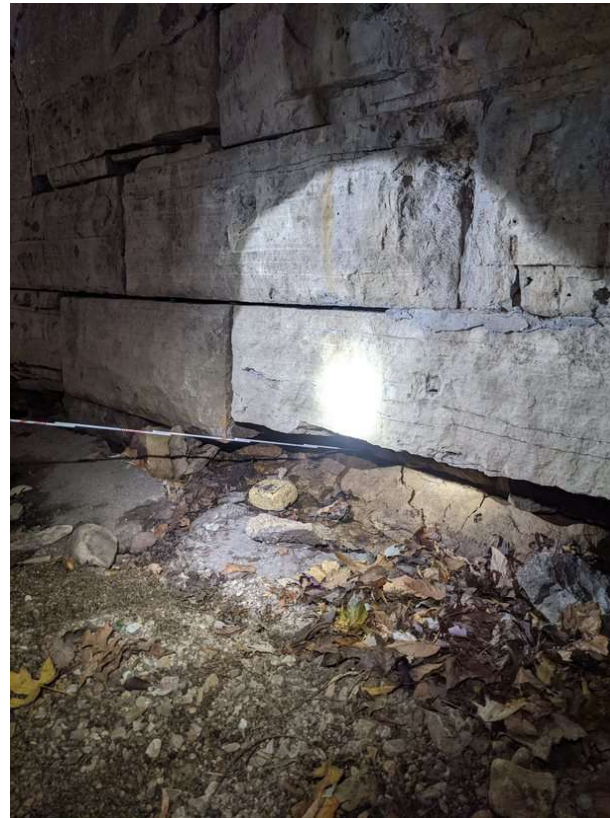
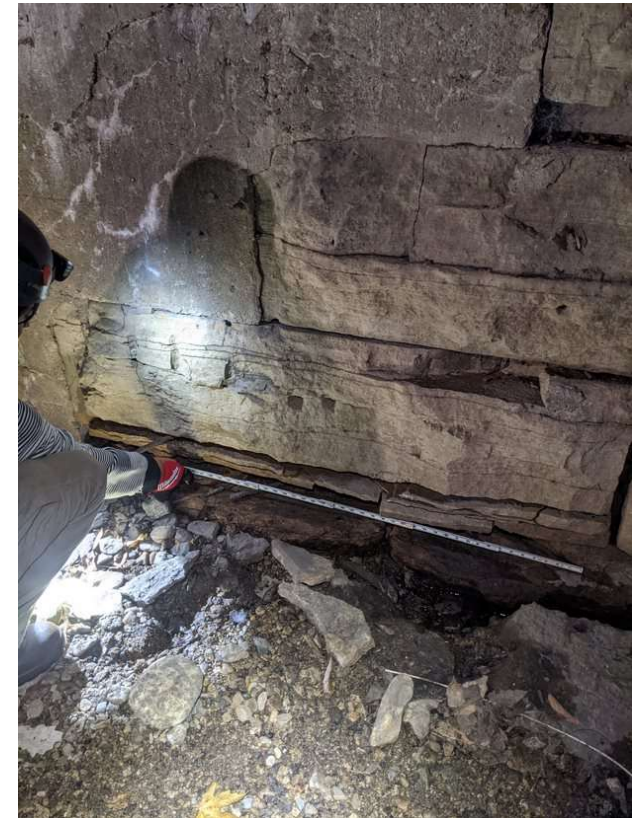
Joint 1 to Joint 2

Second Section of missing wall:

Starting at 13'5" from Joint 1, there is an 11' long hole along the floor, 1' tall, and varies in depth from 5" to 17" (average 11" depth)

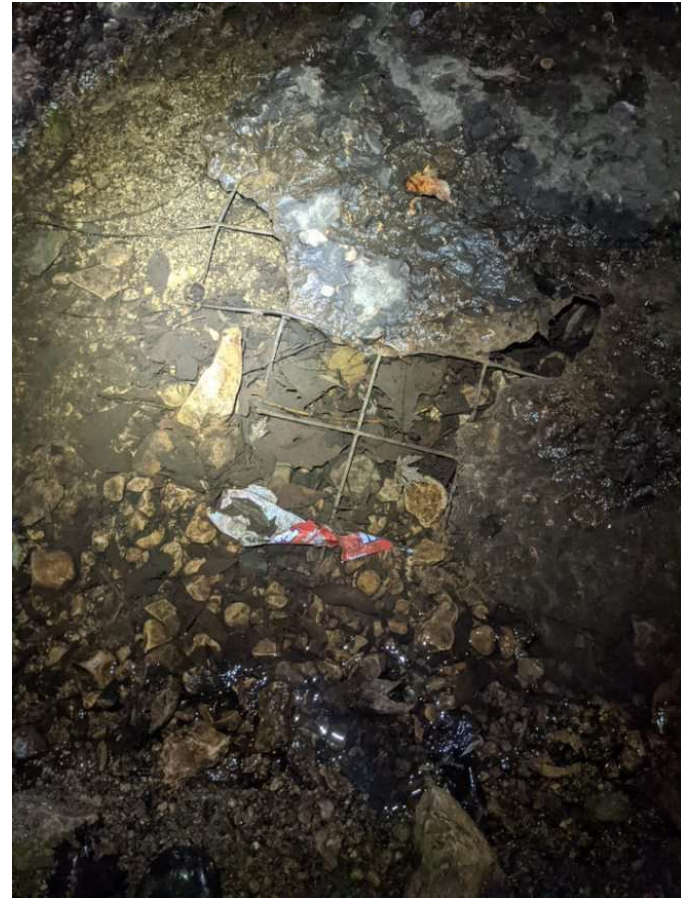
Joint 1 to Joint 2

- At 8'10": Wire mesh visible on floor
- Length: 1'8"
- Width 2'1"

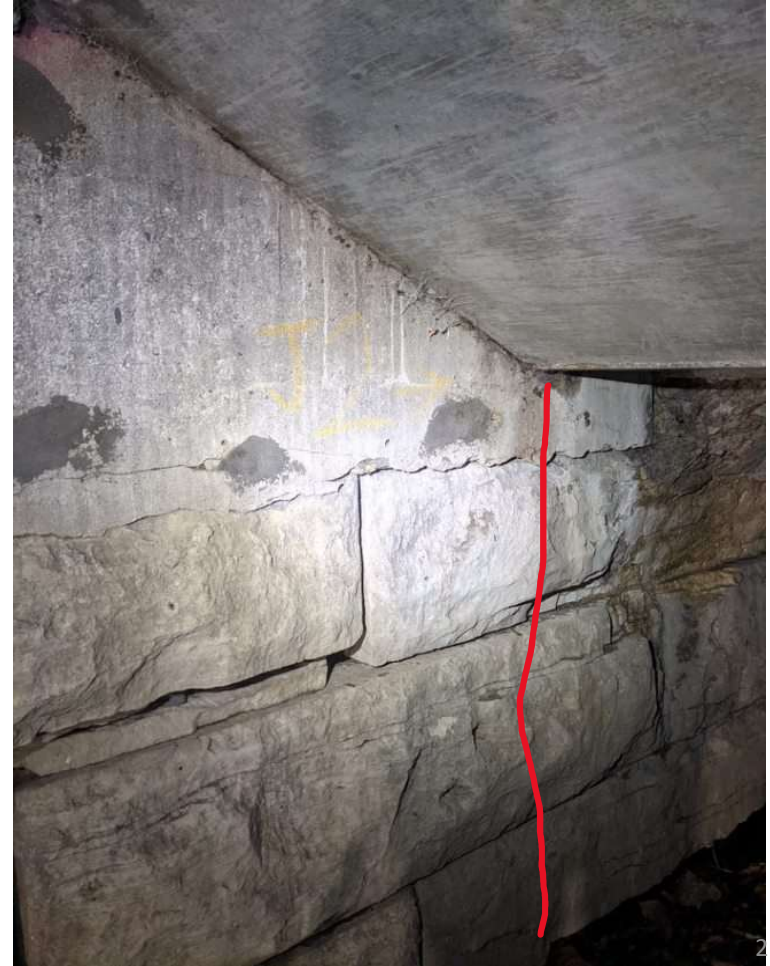
Joint 2 to Joint 3 – 30'

The distance/ 'joint'
at which the
trapezoidal channel
section begins was
labelled Joint 2

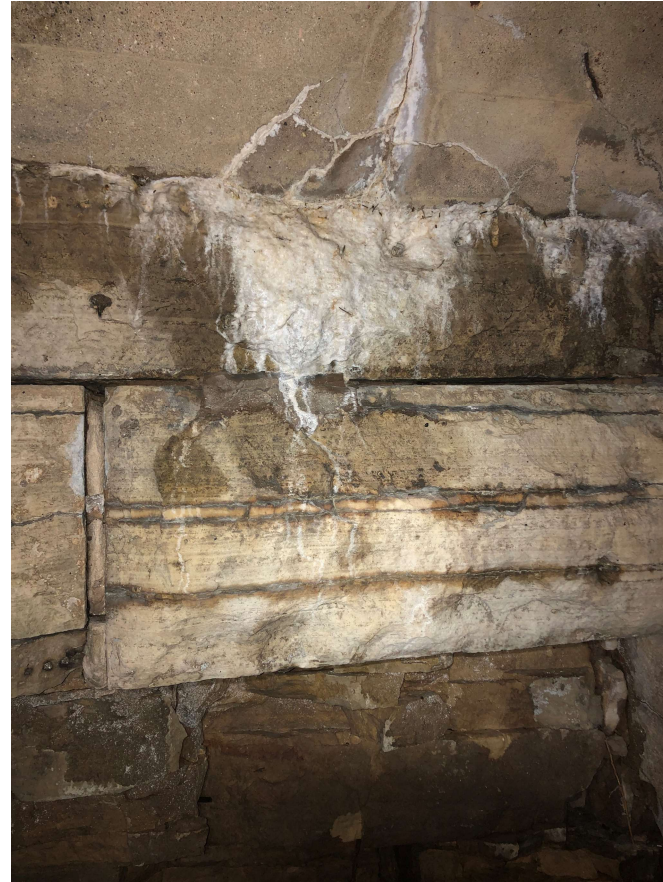
Joint 2 to Joint 3

- Calcium deposits begin from joint 2 and continue to Joint 3 along the top of the east and west walls

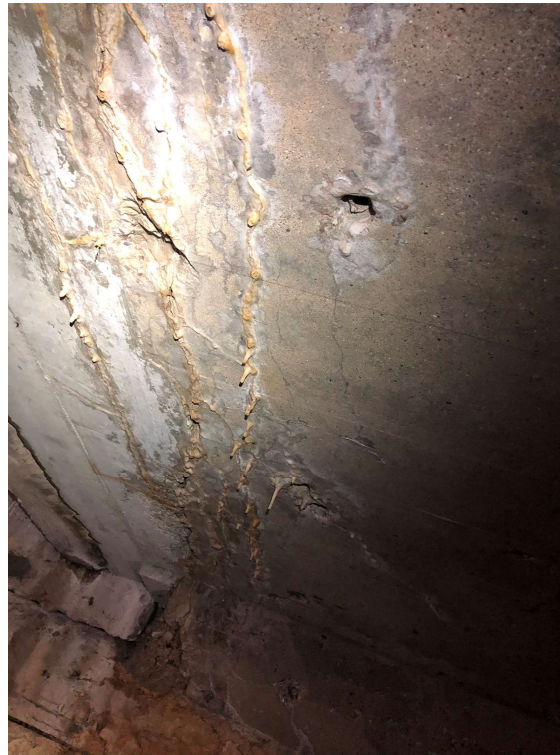
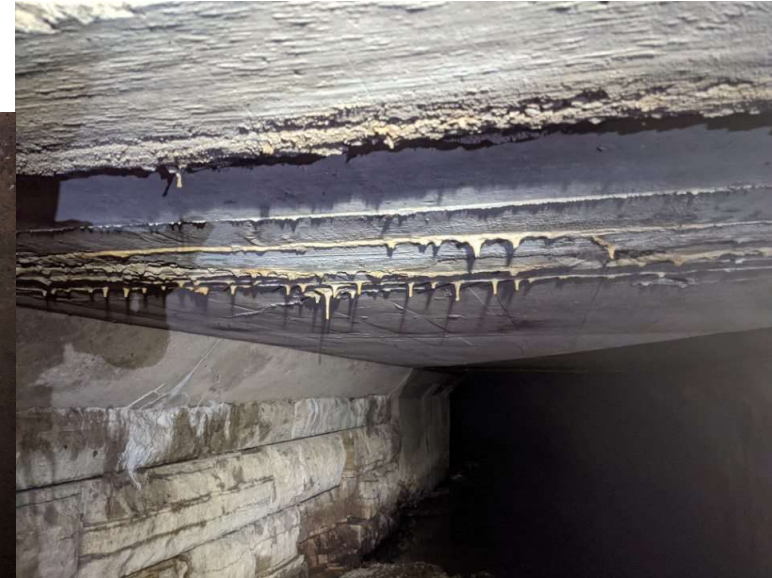
Joint 2 to Joint 3

- At 2 ft from Joint 2: circumferential crack with calcium deposits, especially severe on roof
- Defect width: 1'3"
- Possibly Intentional holes in ceiling of channel, 6 total

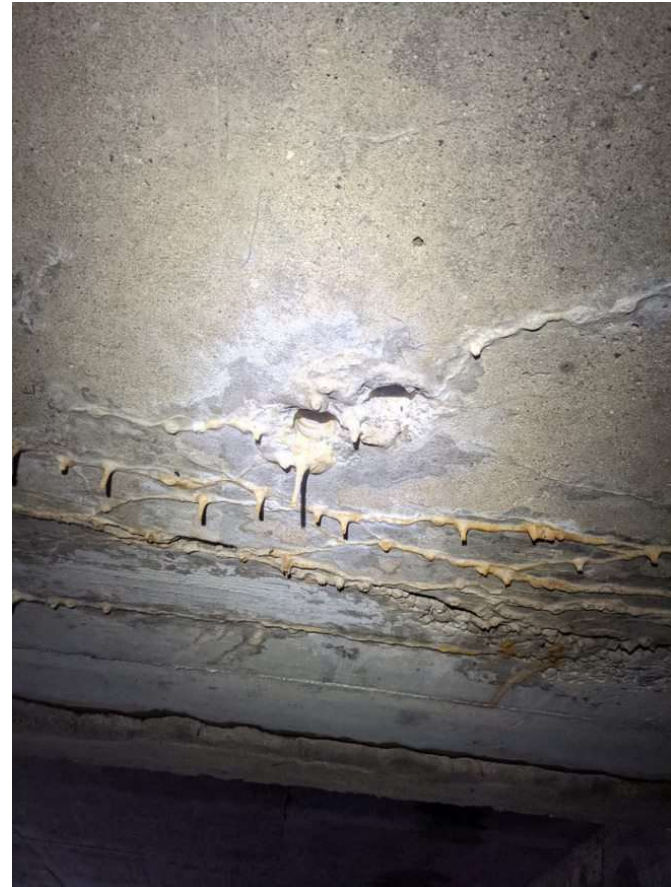
Joint 2 to Joint 3

At 2 ft from Joint 2:
circumferential crack with
calcium deposits, especially
severe on roof

Defect width: 1'3"

Possibly Intentional holes in
ceiling of channel, 6 total,

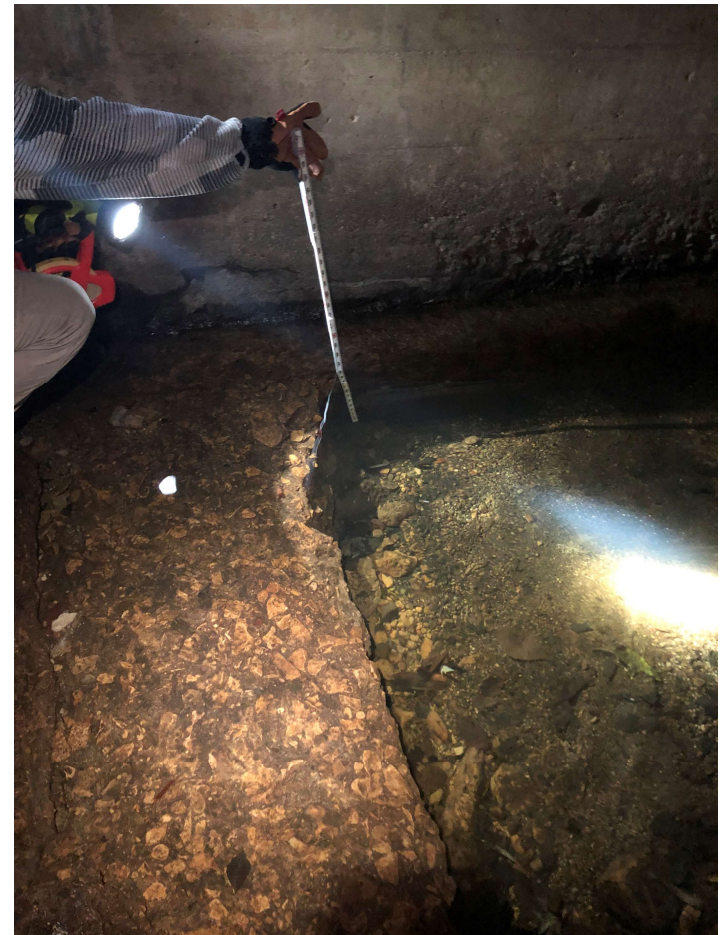
Joint 2 to Joint 3

- At 16 ft from Joint 2:
Large missing section of floor creating pool of standing water. Ends at Joint 3
- Length: 14'
- Width: 9'
- Depth: Average 15" (19" at deepest)
- 2-3" sediment in places

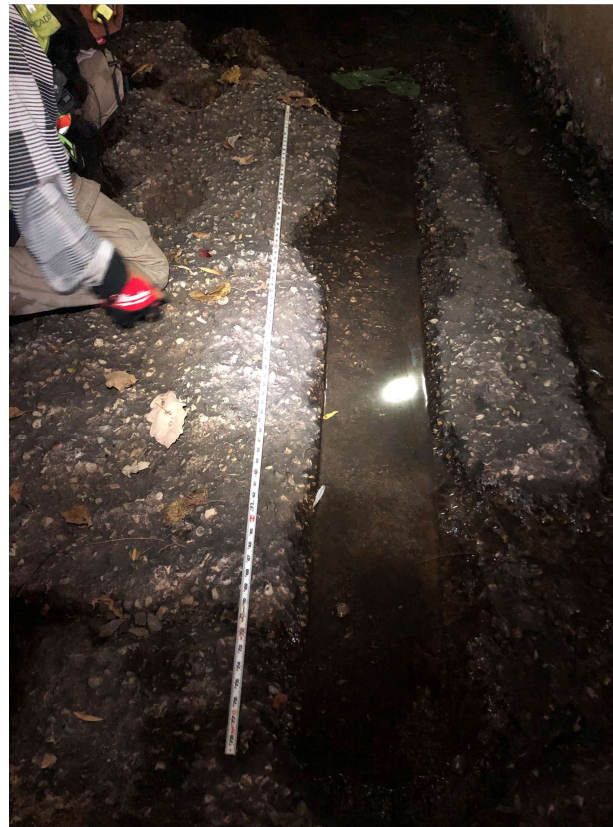
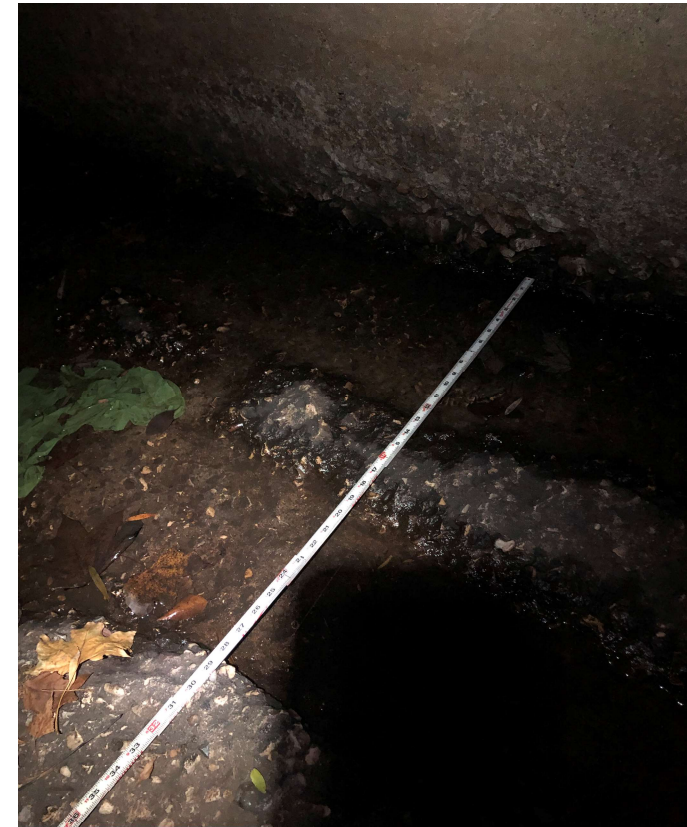
Joint 2 to Joint 3

- A smaller region of damaged floor at the entrance of the eastern trapezoidal channel on the west side (likely caused by vehicle/ equipment) :
- Measures 28" wide, roughly 8' in length, with a depth of 1"

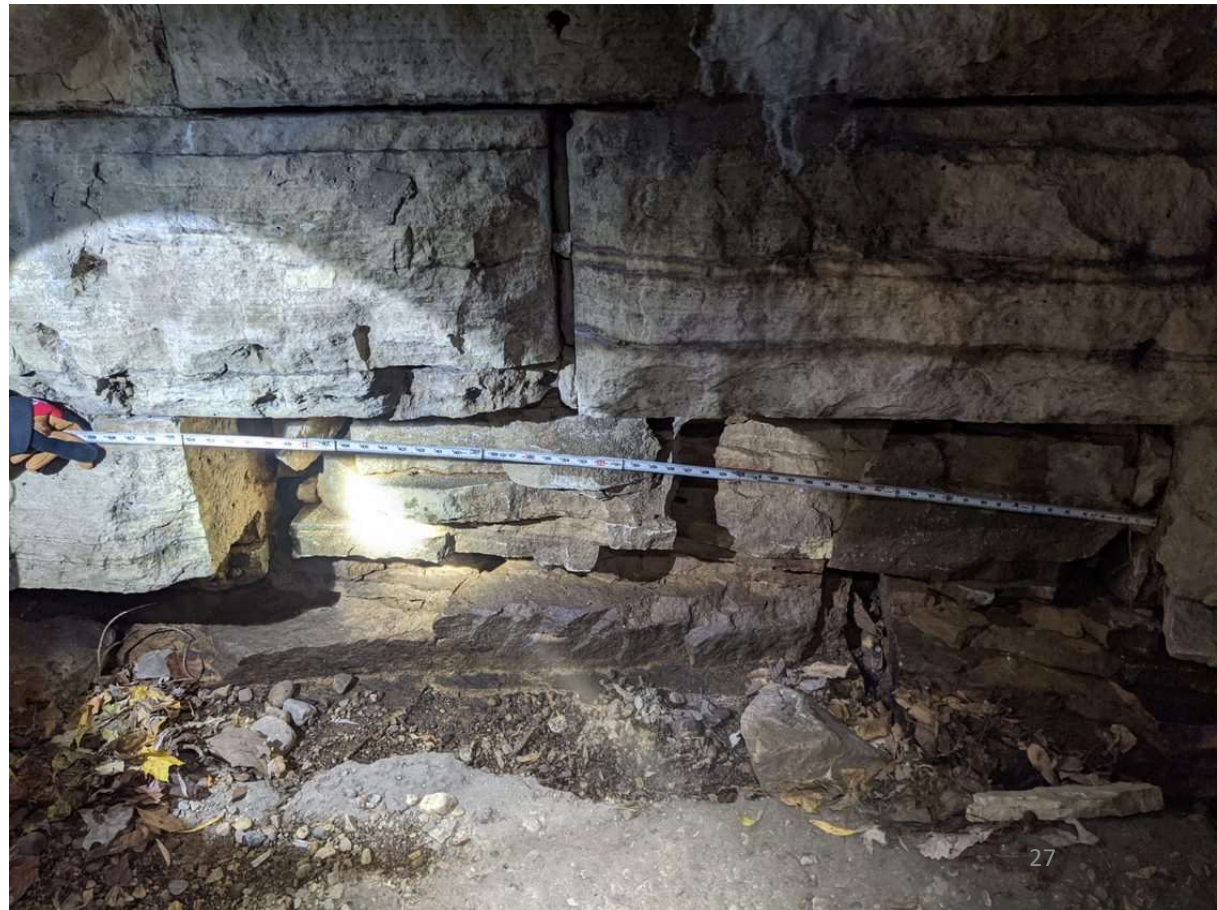
Joint 2 to Joint 3

At 5' from joint 2: missing
section of stone wall

Height: 27"

Depth: 10" average

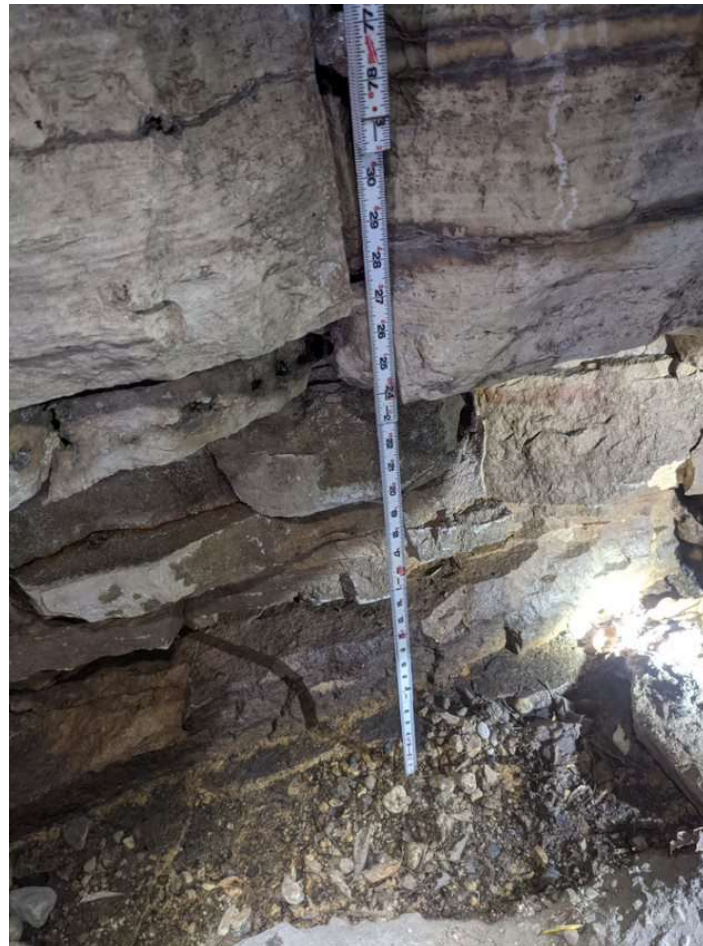
Joint 2 to Joint 3

At 5' from joint 2:
missing section of
stone wall
Length: 4'6"
Height: 27"
Depth: 10" average

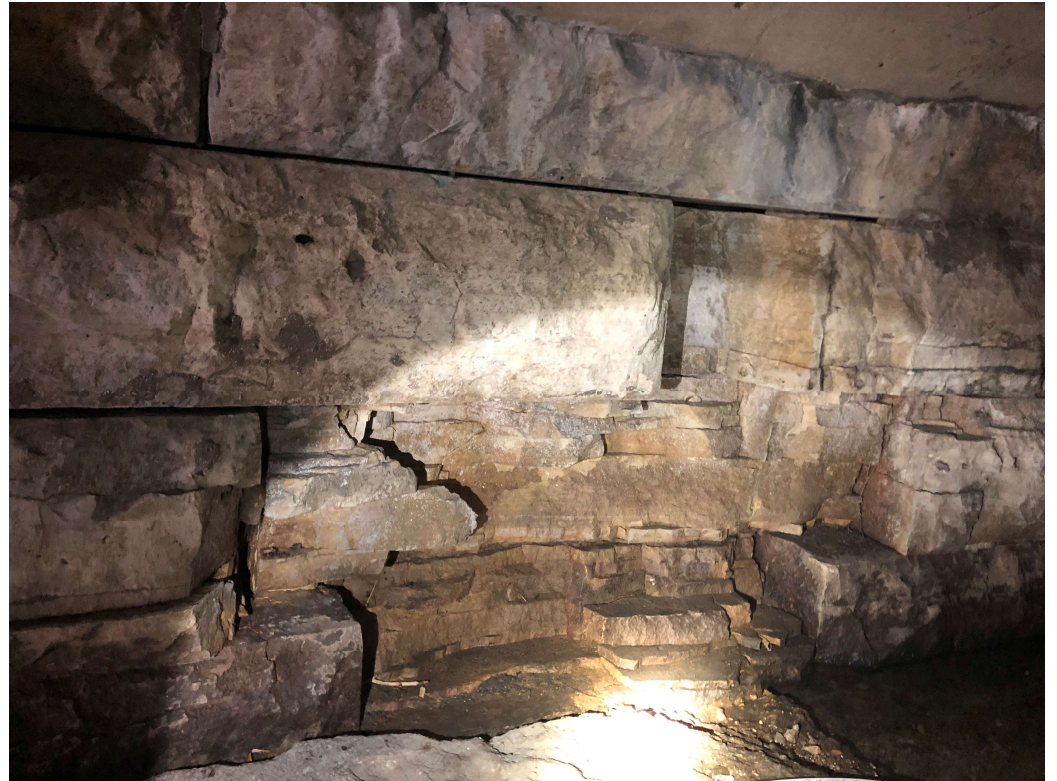
Joint 2 to Joint 3

- 11' from joint 2: missing section of stone wall
- Irregular shape
- Height: 37" at highest
- Width: 60" at widest
- Depth: 8" average

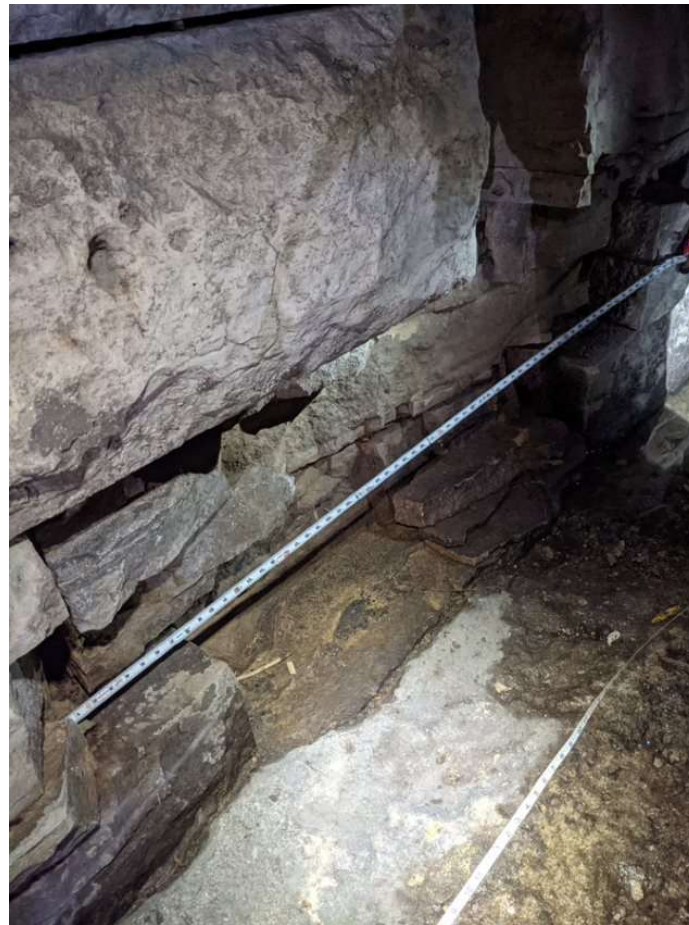
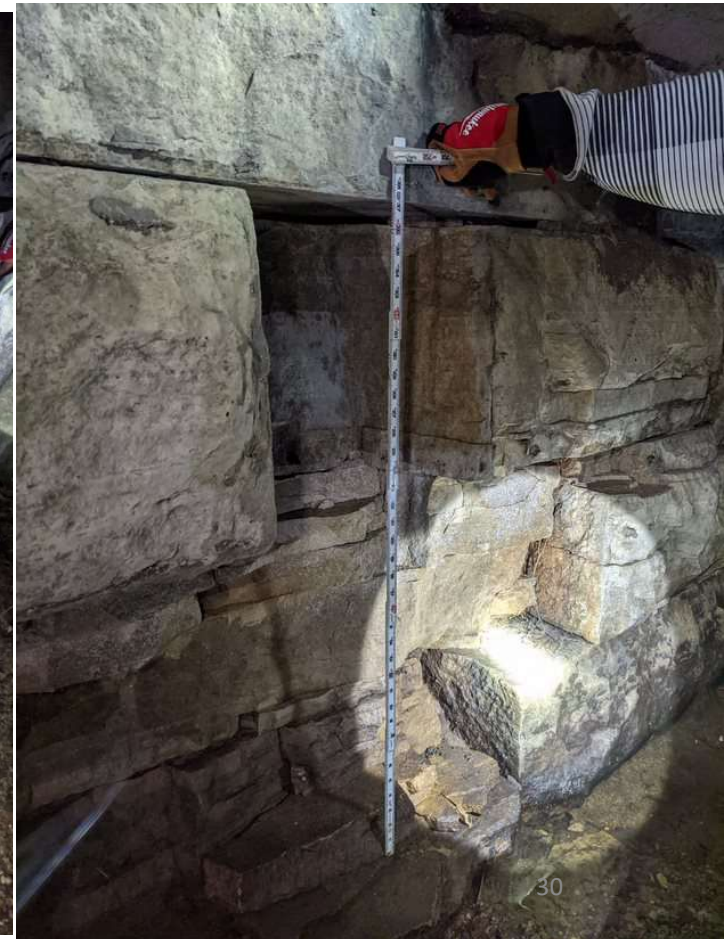
Joint 2 to Joint 3

11' from joint 2: missing section of stone wall

- Irregular shape
- Height: 37" at highest
- Width: 60" at widest
- Depth: 8" average

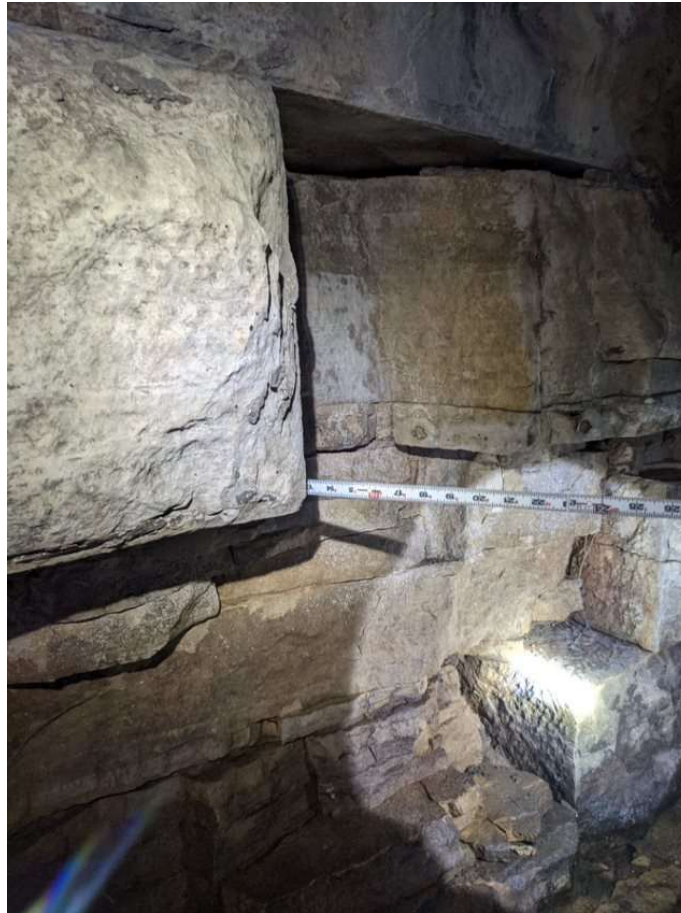
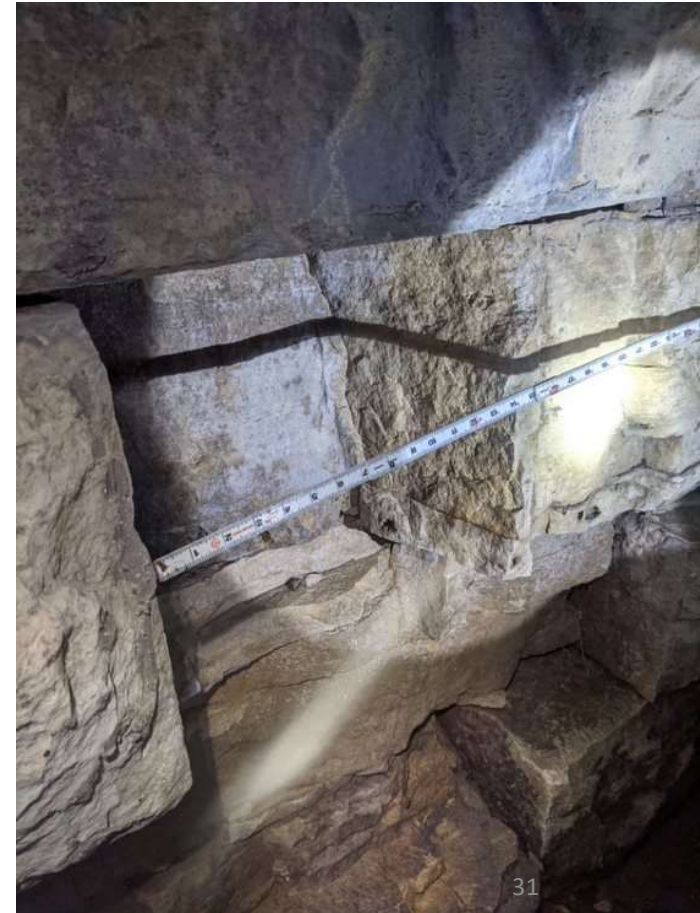
Joint 2 to Joint 3

11' from joint 2: missing section of stone wall

- Irregular shape
- Height: 37" at highest
- Width: 60" at widest
- Depth: 8" average
