Agreement for the Menomonee River Levee System Accreditation

Design Report – Replacement of the Storm Sewer/Outfall on Honey Creek Parkway between 70th and 72nd Streets and Rehabilitation of the Schoonmaker Creek Culvert

- Inspected from North to South, heading downstream
- Objective: to capture defects, describe their location and size

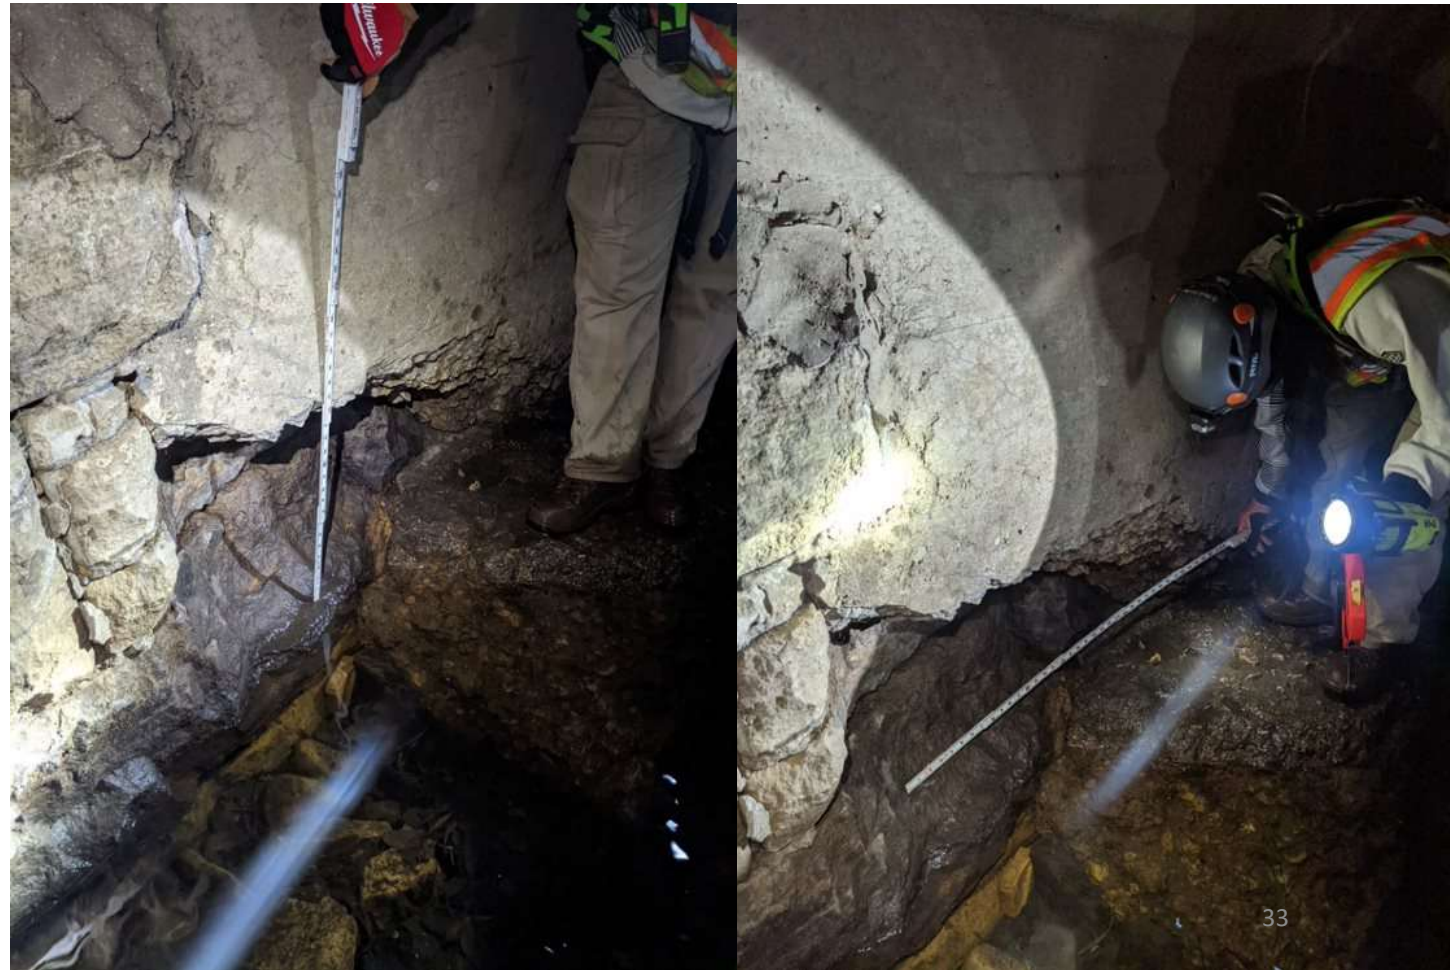
Joint 2 to Joint 3

At 20' from joint 2:
missing section of
concrete wall.

- Length: 40"
- Height: 2' tall
- Depth: 8" average (2" to 14")

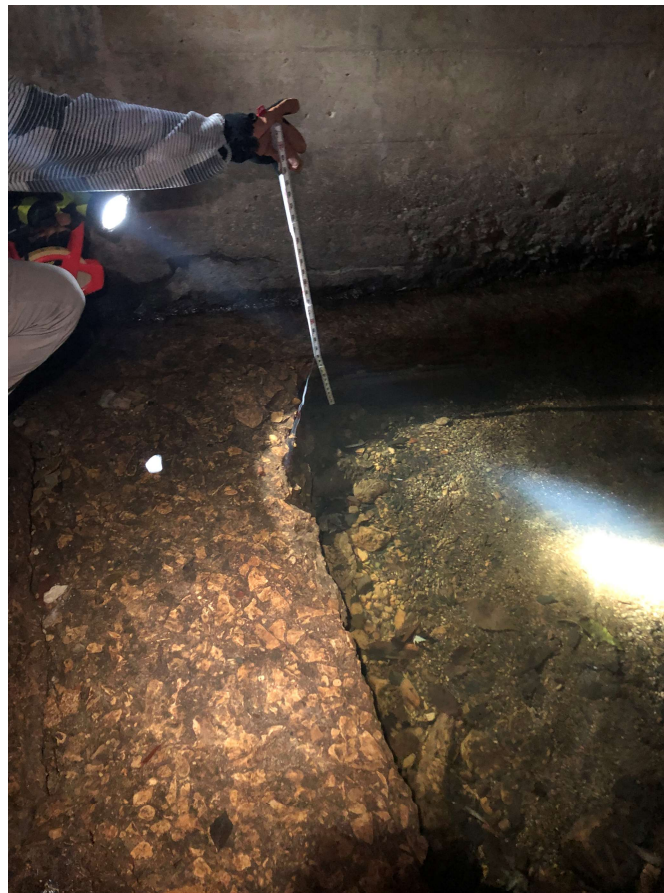
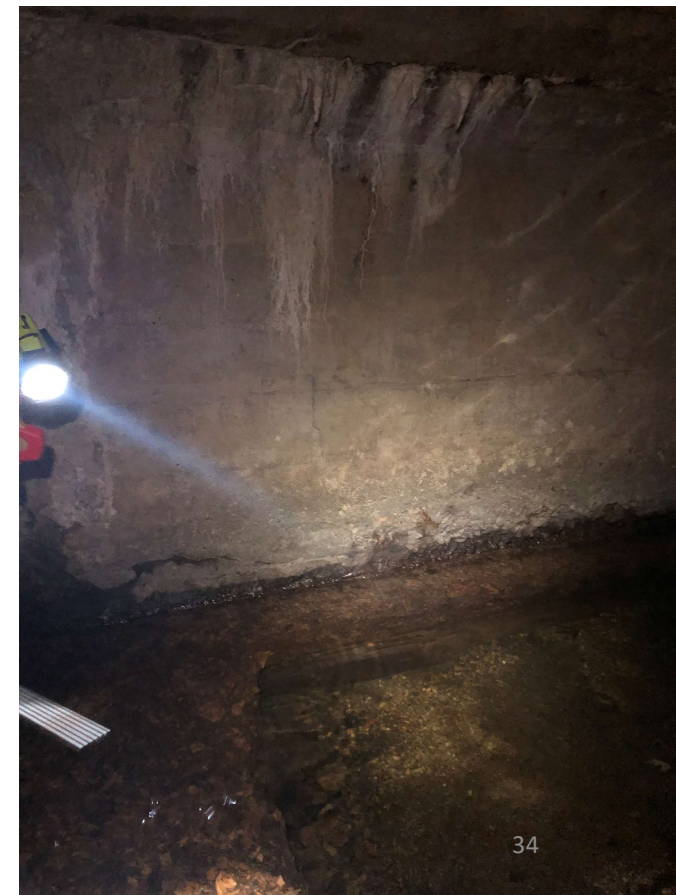
Joint 2 to Joint 3

West wall:

- Missing wall/ wall defects along bottom of west wall.
- Height: 5" on average
- Starting at Joint 2, ends at Joint 3

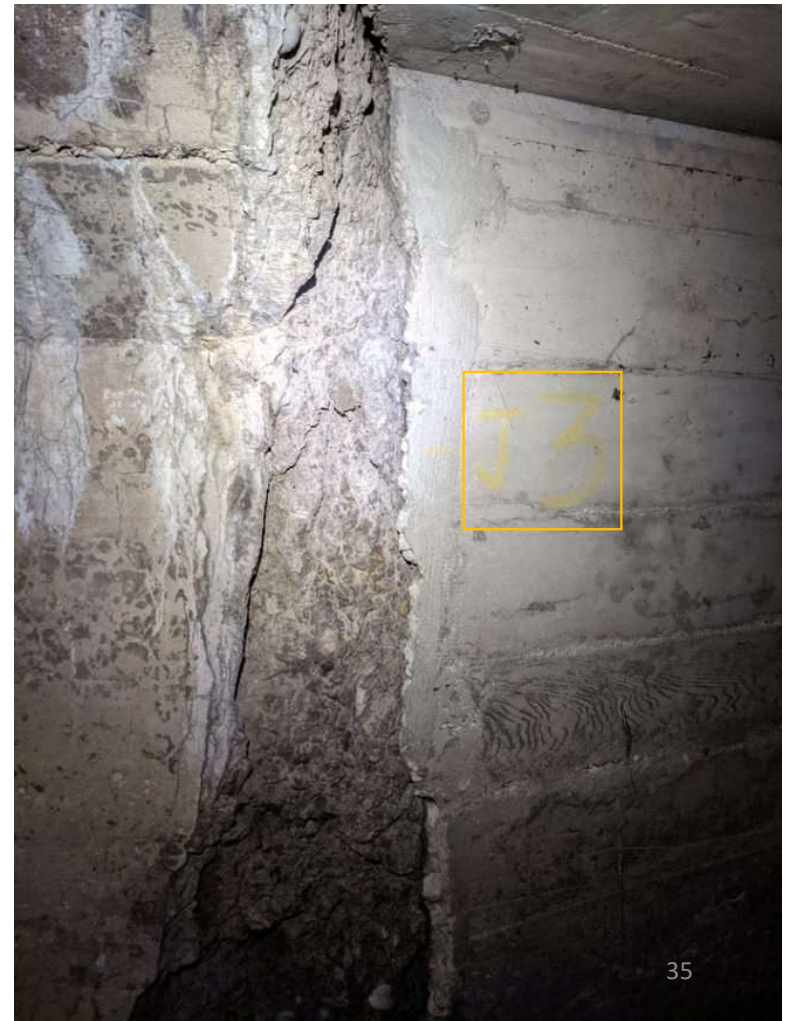
Joint 3 to Joint 4: 24'

Defect overview (photo shows J3 on east wall)

1' after joint 3: 2'8" tall crack from bottom of channel

Rebar visible at joint 4 (roof)

12'4" capped inlet in center of ceiling 12" diameter

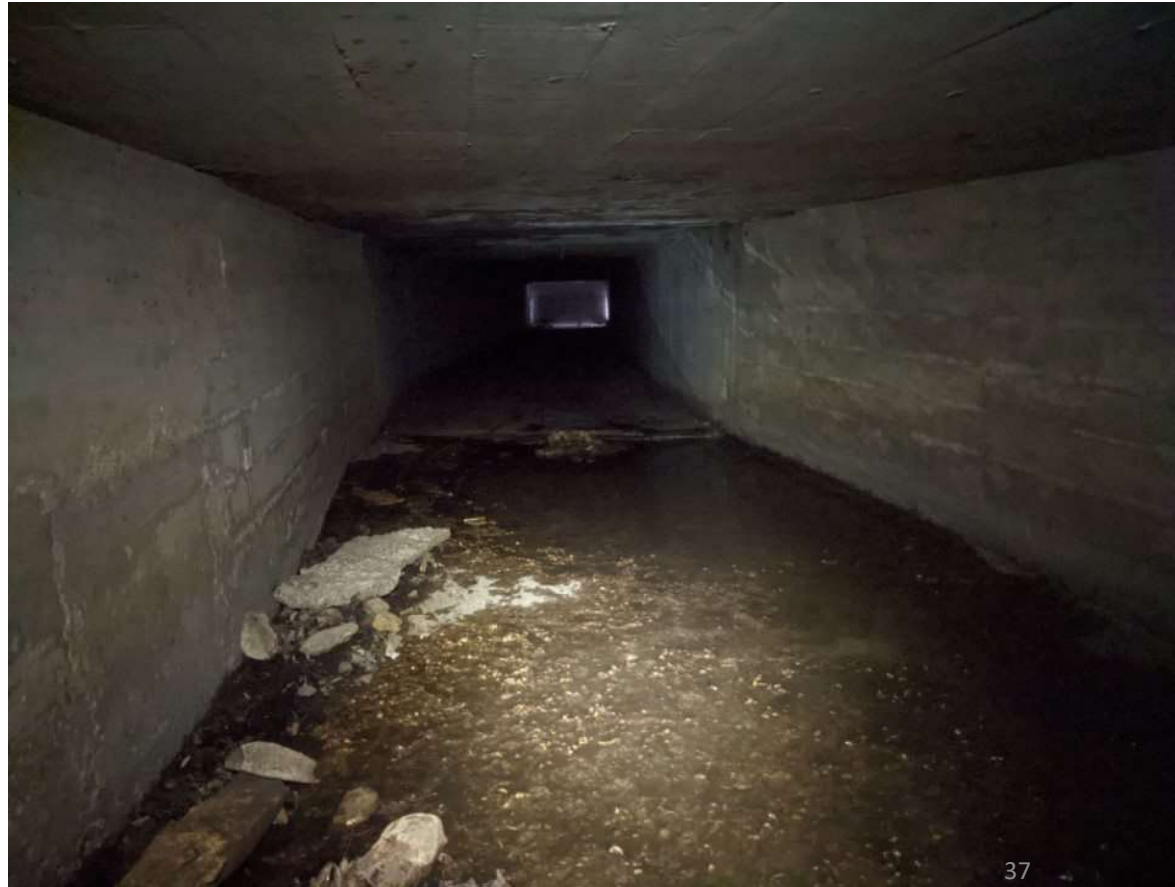
Joint 3 to Joint 4

- A region of missing floor with standing water, continuous from Joint 3 to 4
- Measures 24' in length, 9' width, and depth of 1-2"

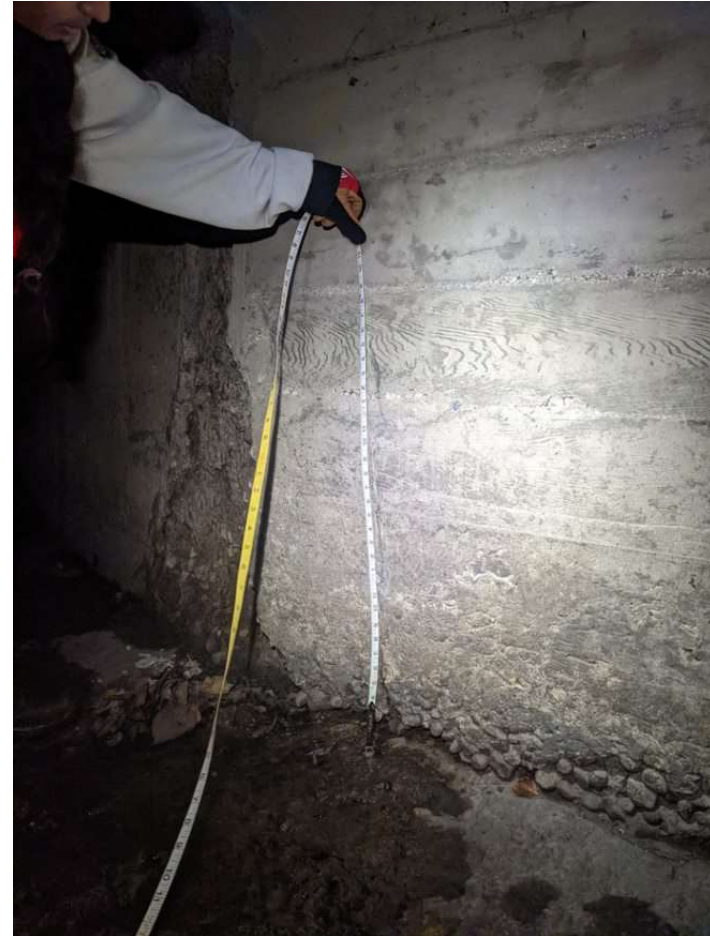
Joint 3 to Joint 4

- 1' after joint 3:
- 2'8" tall crack from bottom of channel

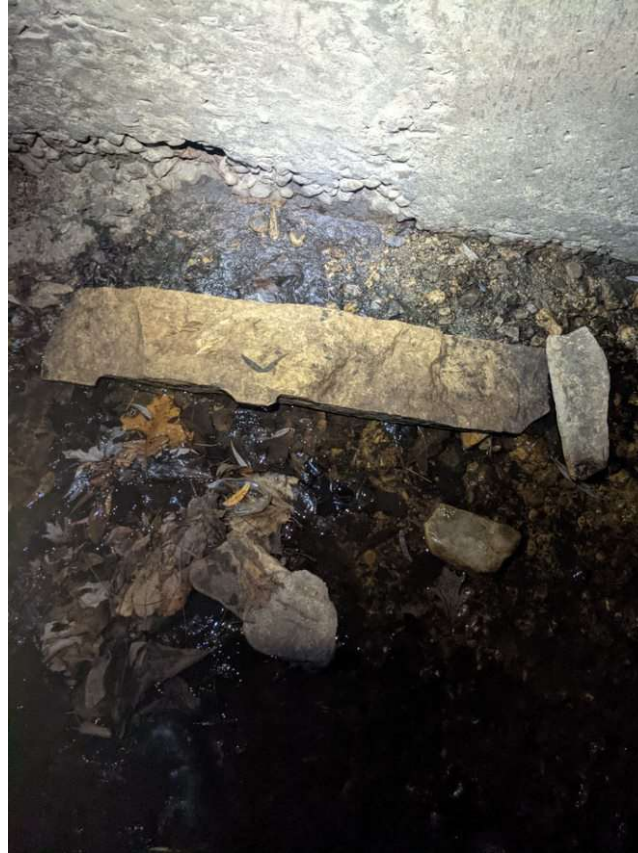
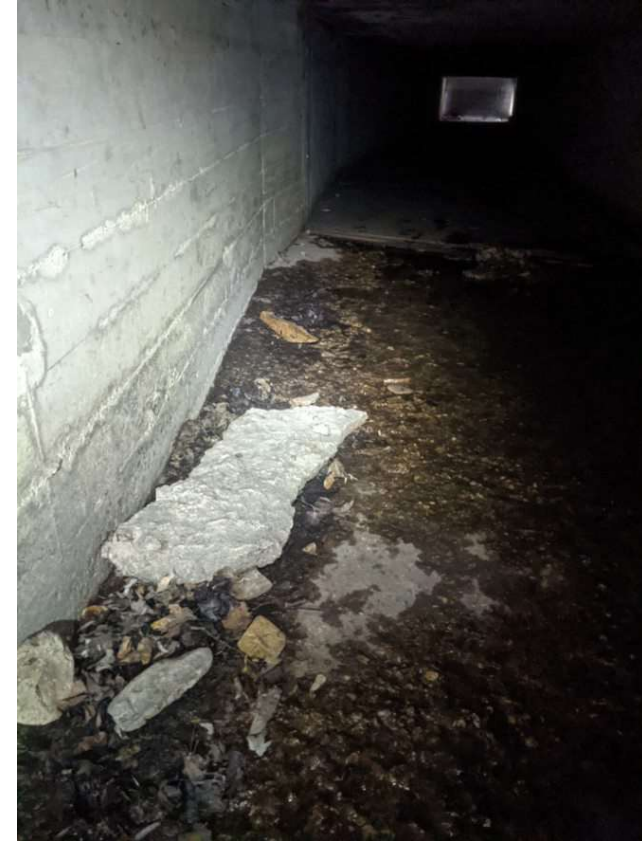
Joint 3 to Joint 4

- 4' from Joint 3:
- Some debris visible along eastern side of channel, 5' in length, 2 large stone/concrete blocks

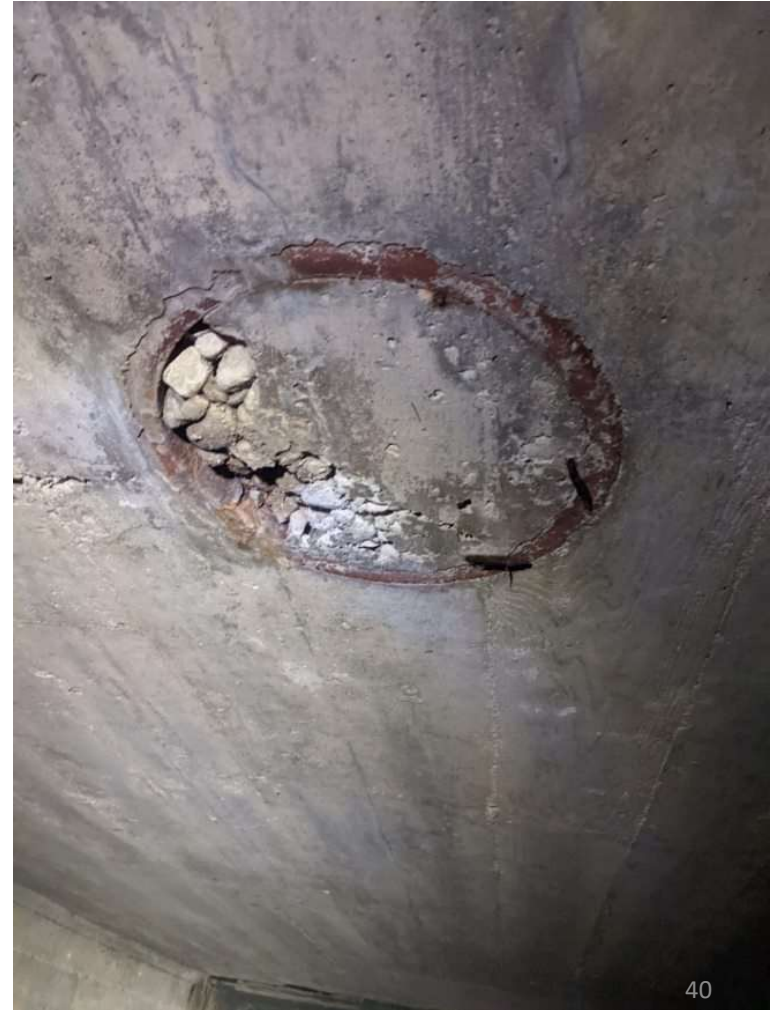
Joint 3 to Joint 4

- 12'4" from Joint 3:
- Capped inlet in center of ceiling 12" diameter

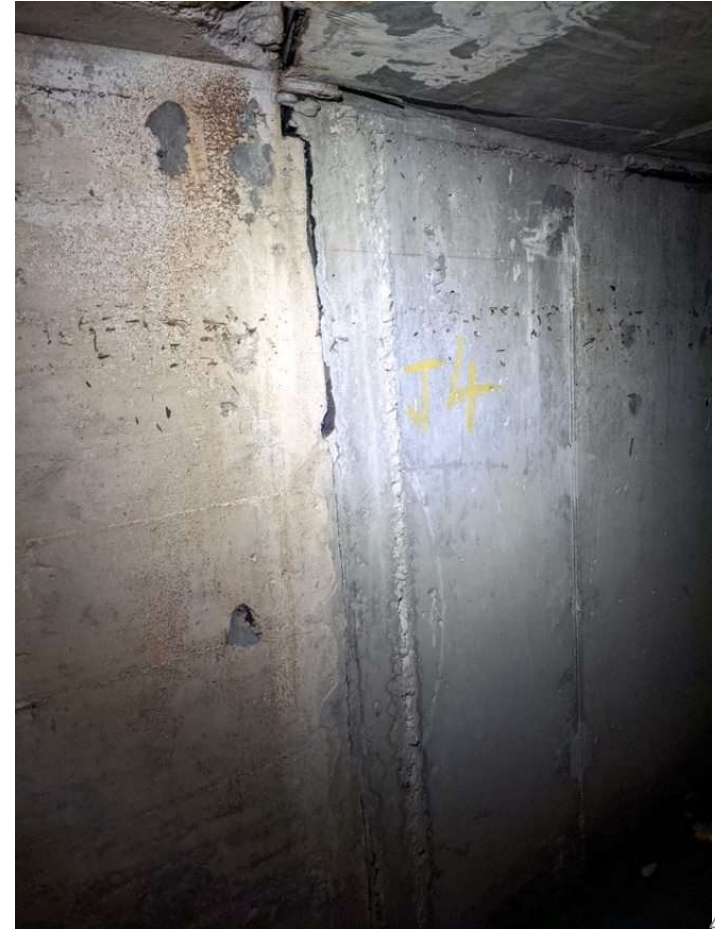
Joint 4 to Joint 5 – 10'

Circumferential fracture around joint 4 with rebar showing

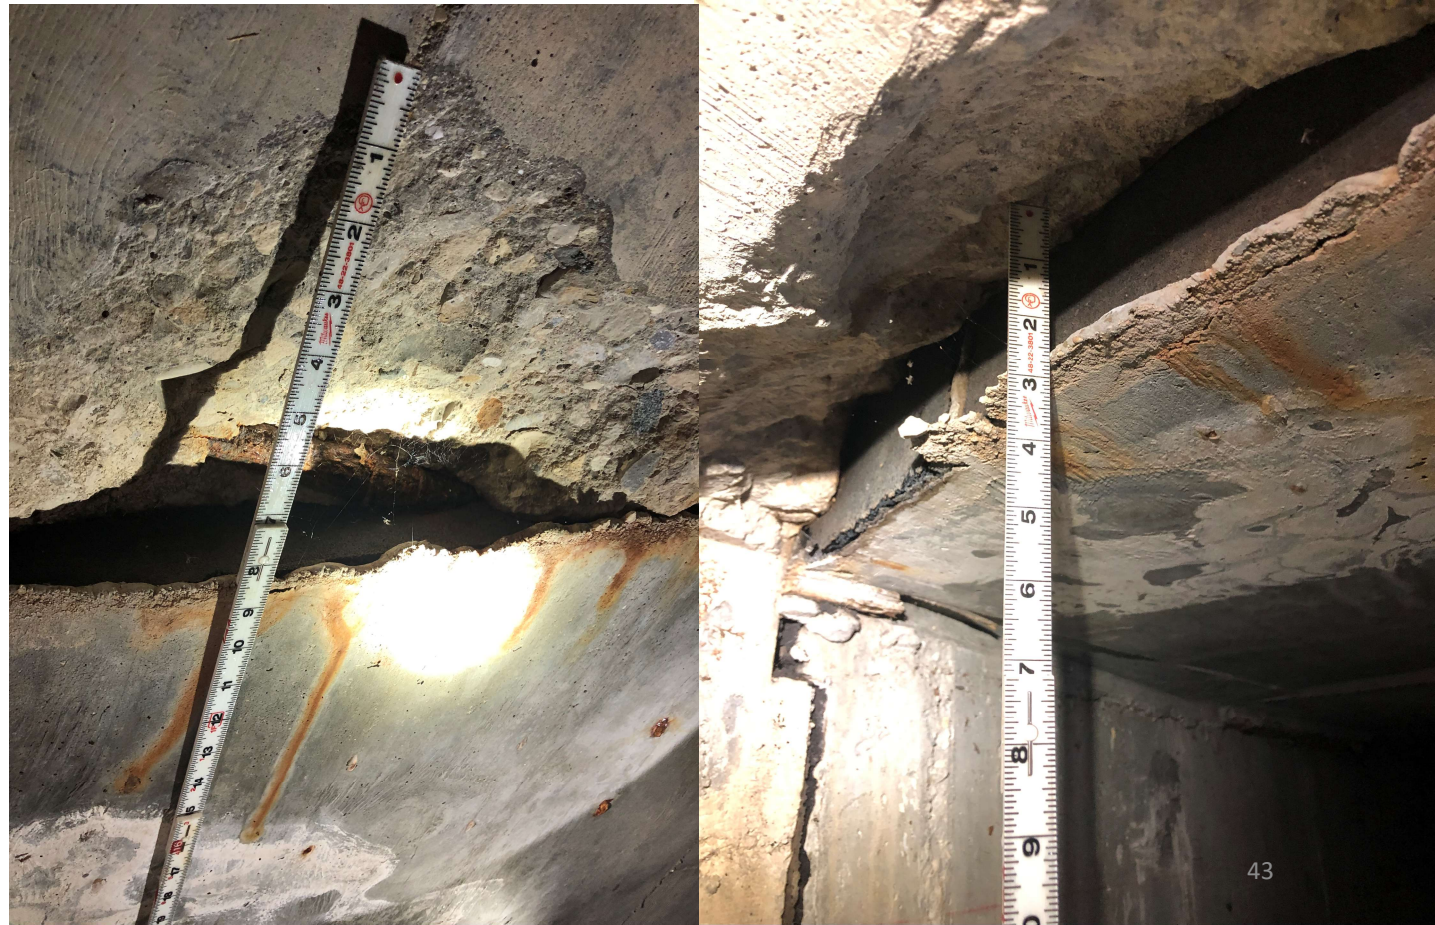
Joint 4 to Joint 5

Circumferential fracture and hole with rebar visible on ceiling of channel.

- 1' width, 2 ft length, 2" depth, center of ceiling

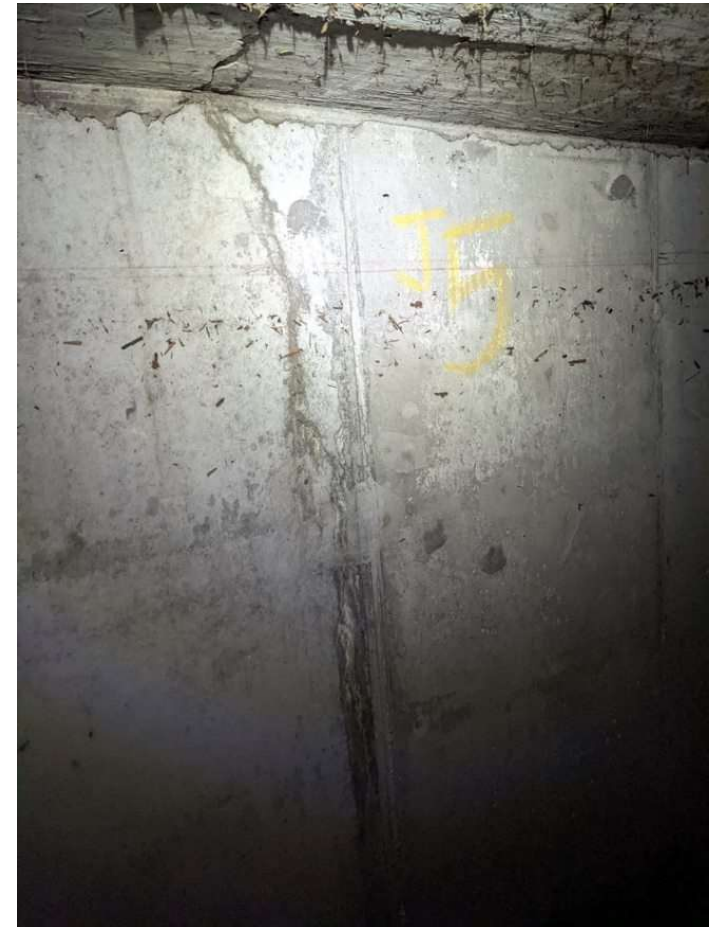
Joint 5 to Joint 6 – 24'

Crack along joint connection at Joint 5: joint at ceiling slightly offset from joints all walls

Some bumps from patch work on east wall of channel

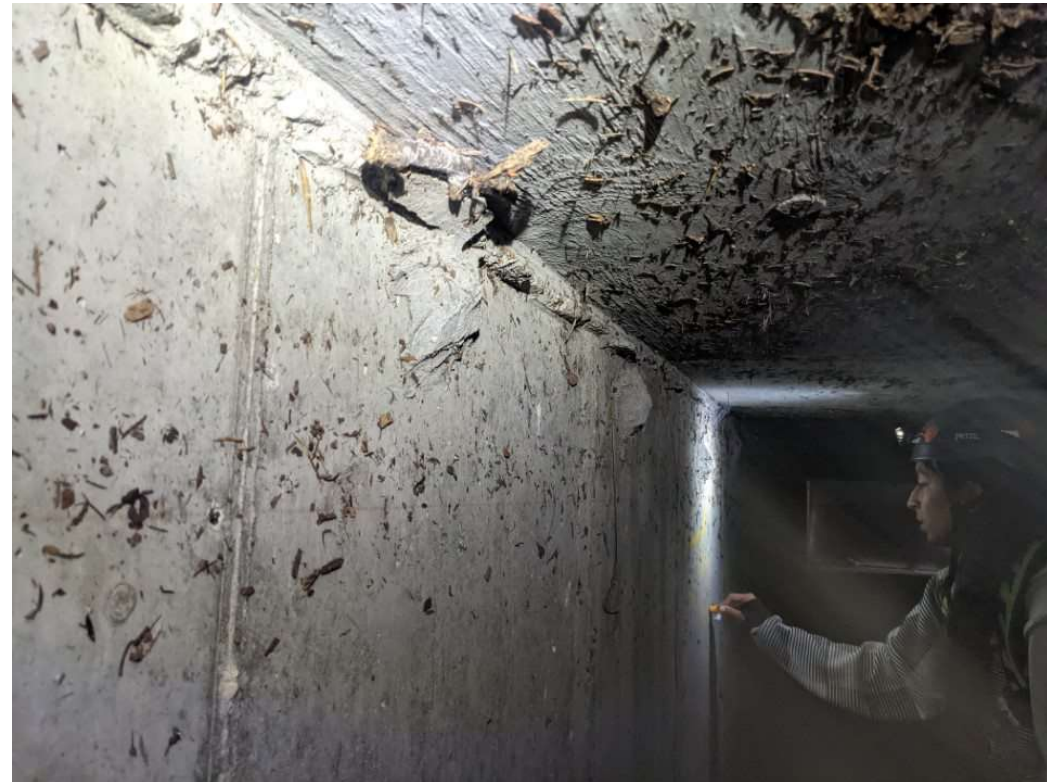
Joint 5 to Joint 6

- Some bumps from patch work on East wall of channel

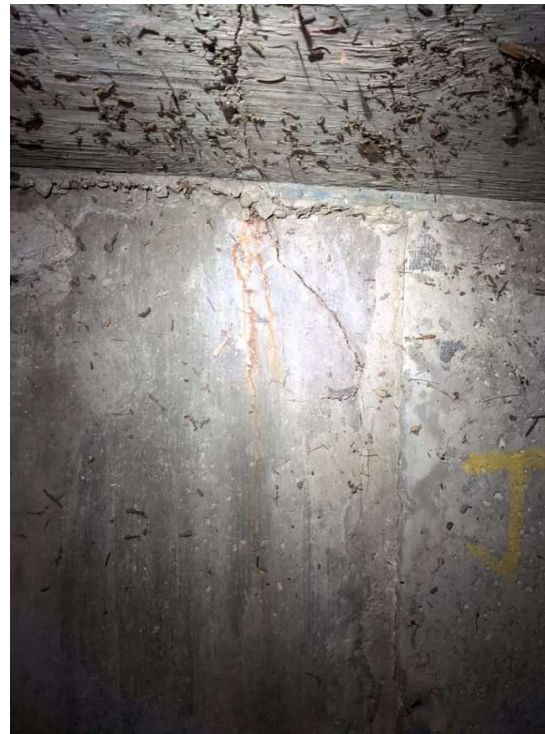
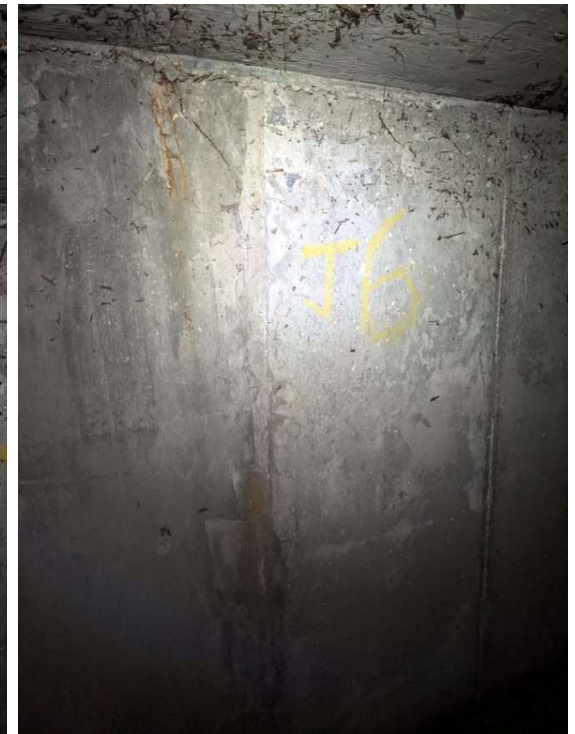
Joint 6 to Joint 7– 24'

Small crack along joint connection at joint 6 (joint at ceiling offset from joint at walls) infiltration stain

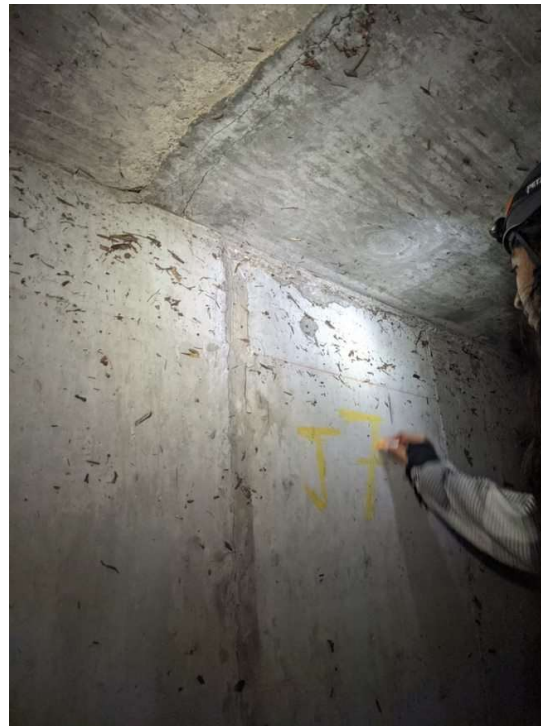
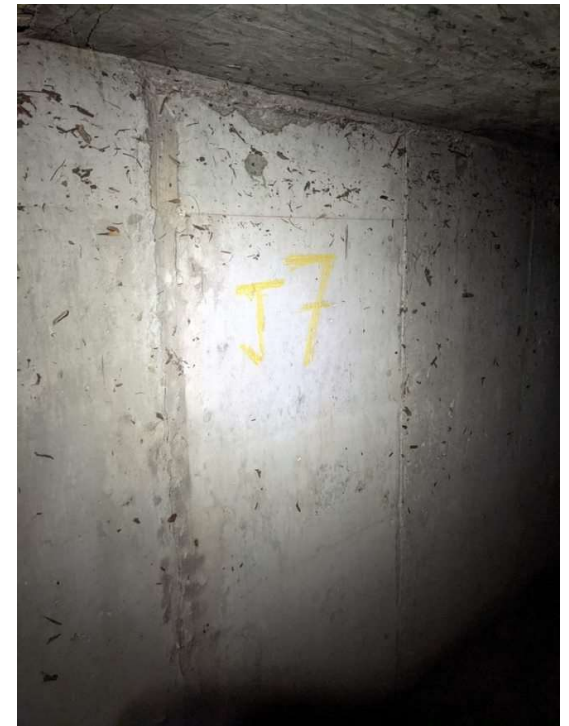
Joint 7 to Flood Gates – 24'

Small crack at joint connection at joint 7
(joint at ceiling
offset from joint at
walls)

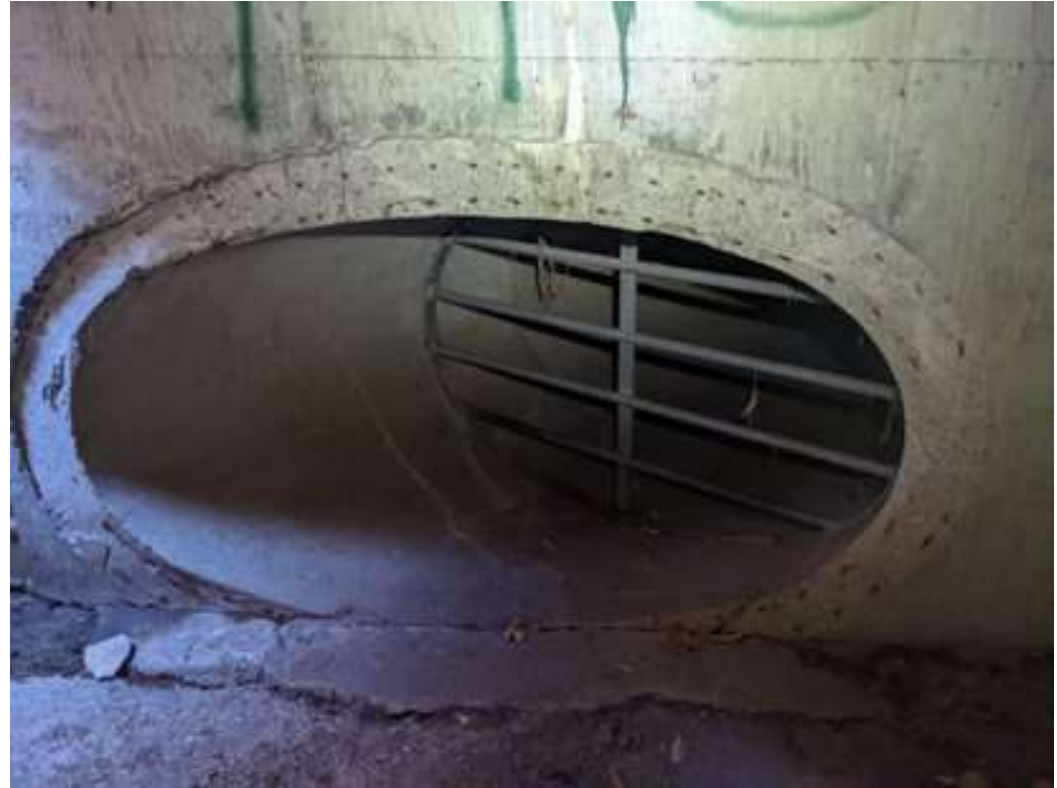
Joint 0 to Joint 1 – 15'

- At 5'3": Elliptical Inlet pipe, 6'10" width, 3'7" height

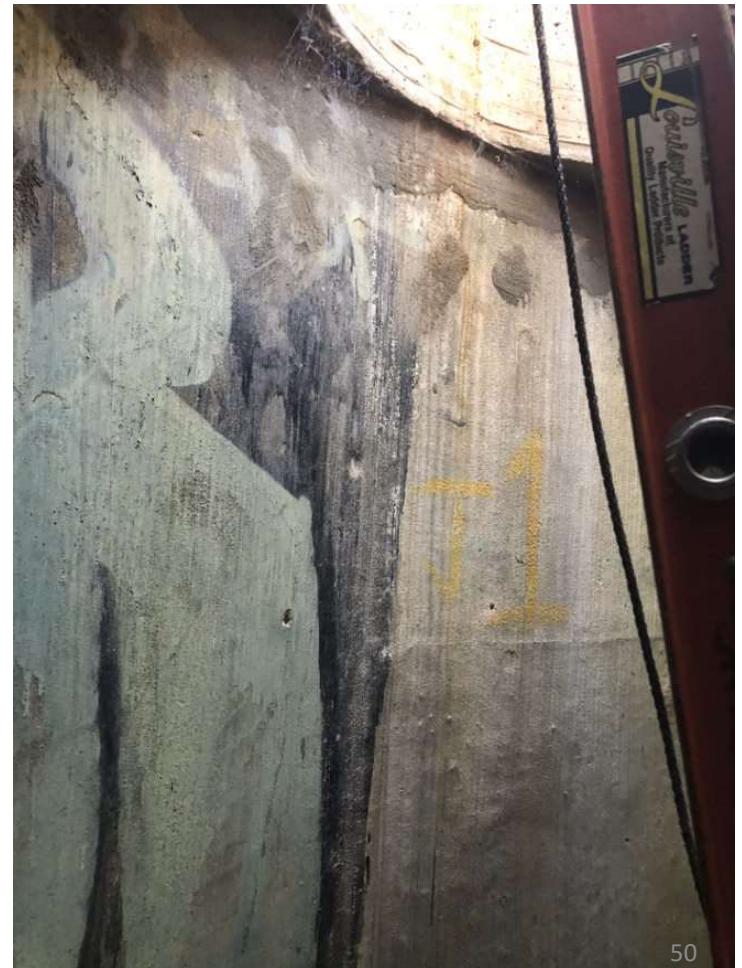
Joint 1 to Joint 2

- Joint 1 is at the manhole entrance,
- Channel wall makes a turn here (trapezoidal shape in plan view)

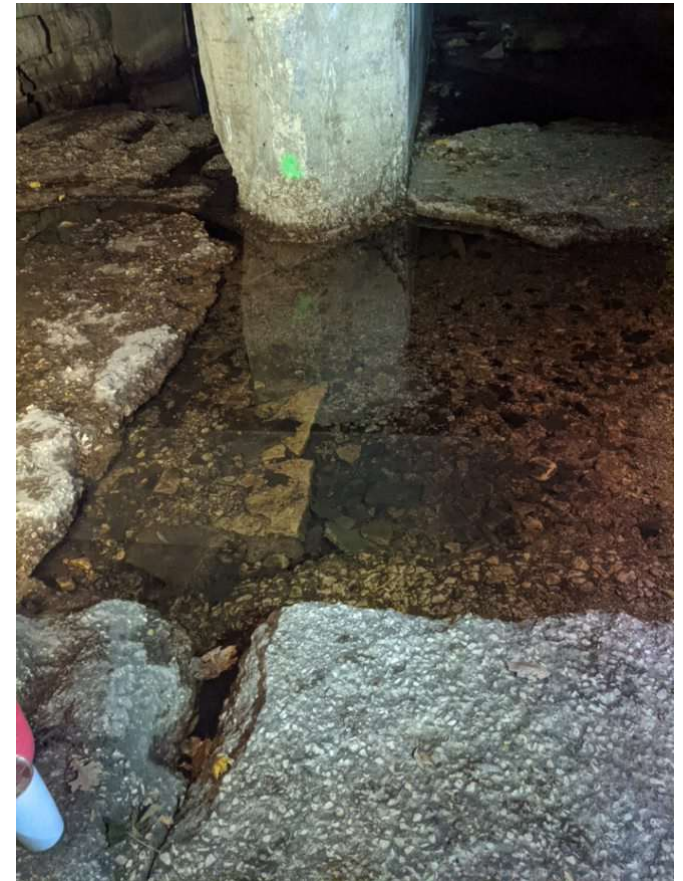
Joint 1 to Joint 2 – 11'

- Overview:
- Floor is missing
- Circumferential crack at joint 2
- Calcium deposits continuous defect from joint 1 to joint 4

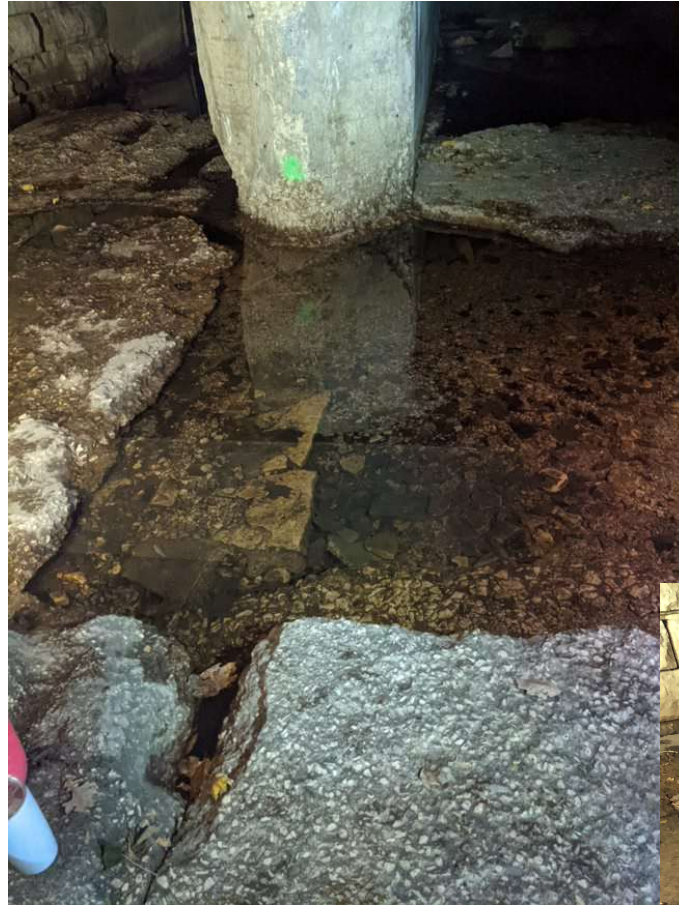
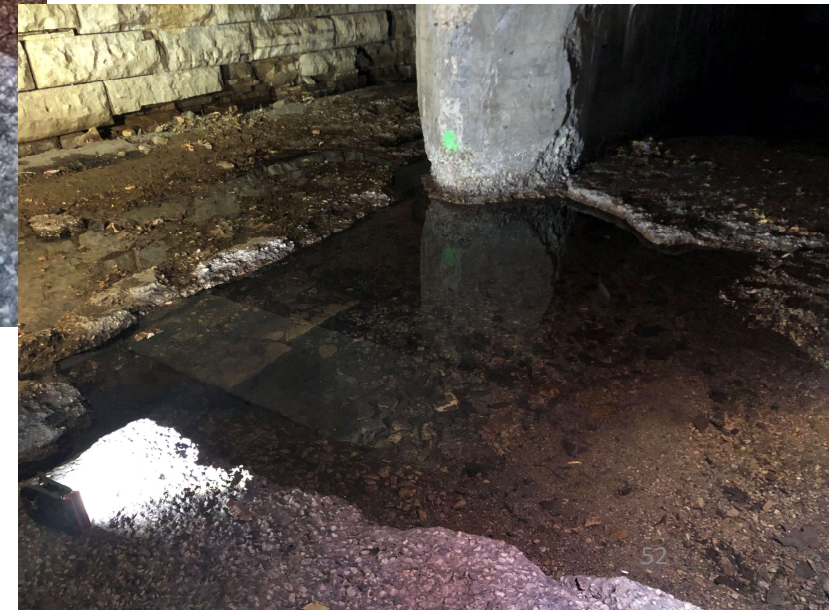
Joint 1 to Joint 2

Large pool near
dividing column
on west side of
north main
chamber

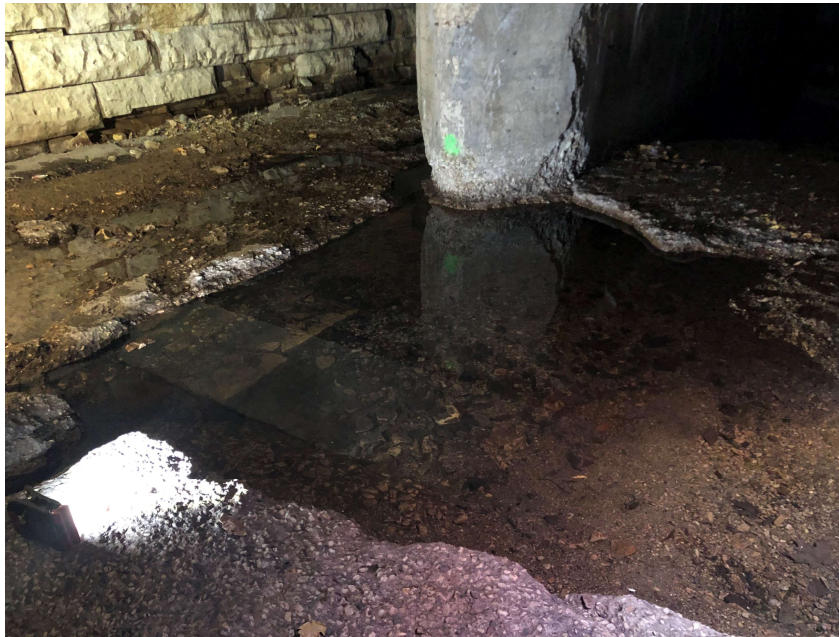
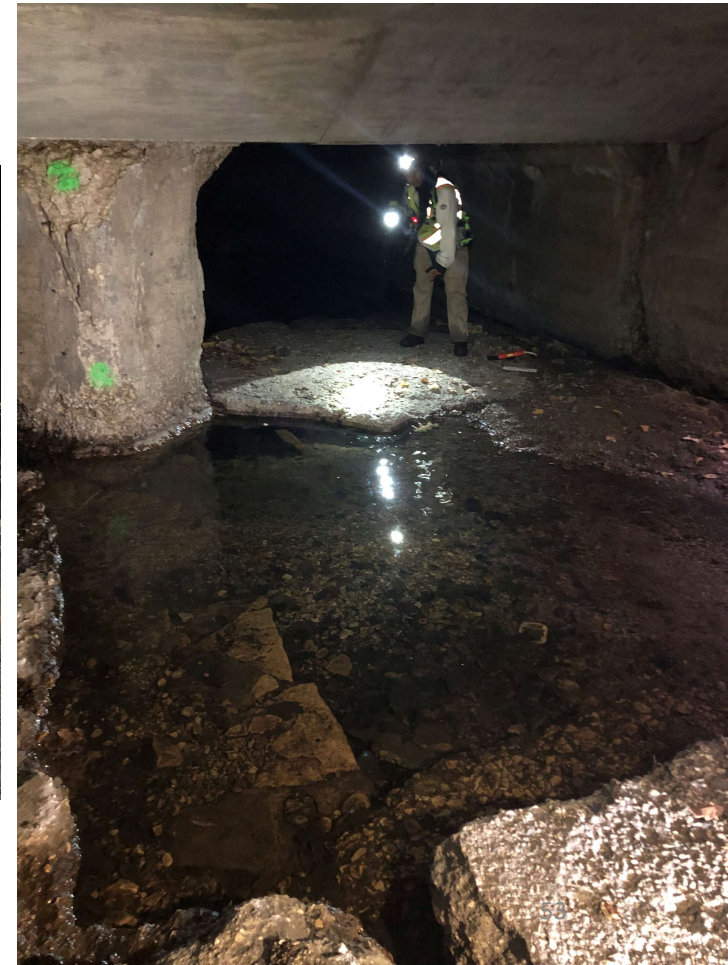
Joint 1 to Joint 2 – 11'

Floor defect:

- Approximate rectangle with length 11 ft and width 10 ft.
- Average depth 12"
- (ranges from 6" to 21" depth)
- Deepest point just near dividing column

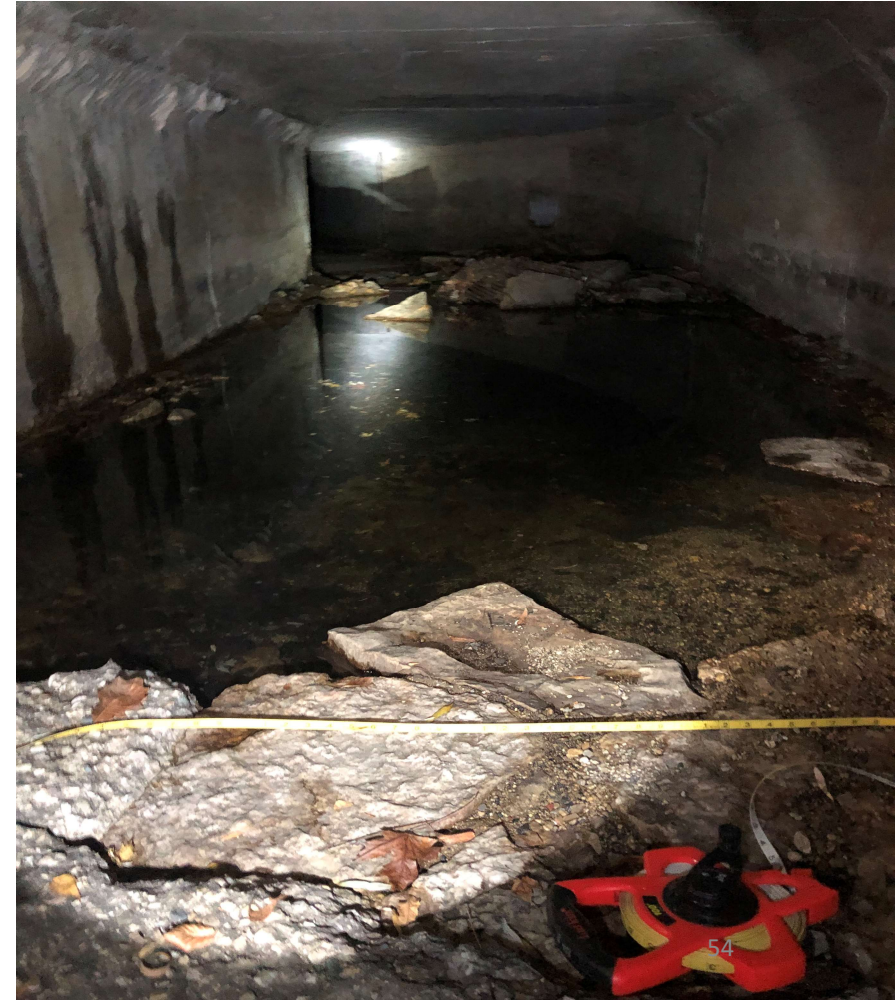
Joint 2 to Joint 3 – 29'6"

- Aggregate visible width is 1.5' on both walls, ceiling has deposits and cracks, 1' width
- Water depth is 21" at base of column, deep holes until joint 3
- Calcium deposits along walls and ceiling
- 2' oval hole that goes through column
- 4.5' to 6' vertical cracks on west wall with calcium
- 6' vertical crack on east wall with hole
- 18' vertical crack on west wall
- 20'6" vertical crack that runs entire height on east wall
- 20' large debris pile

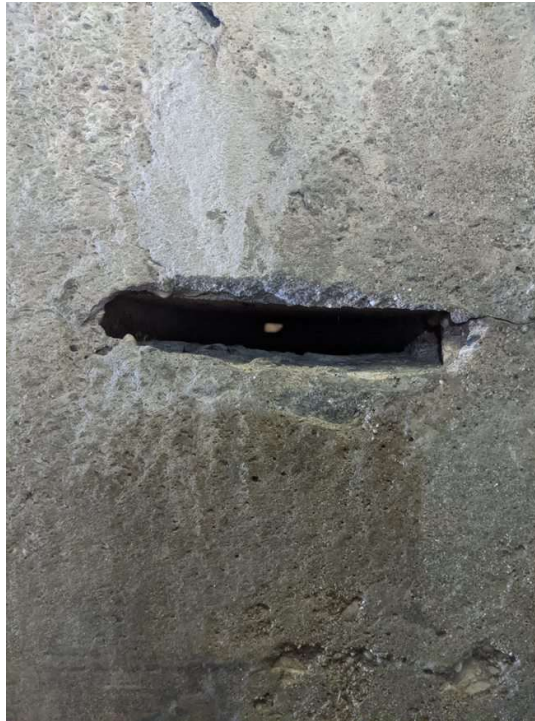
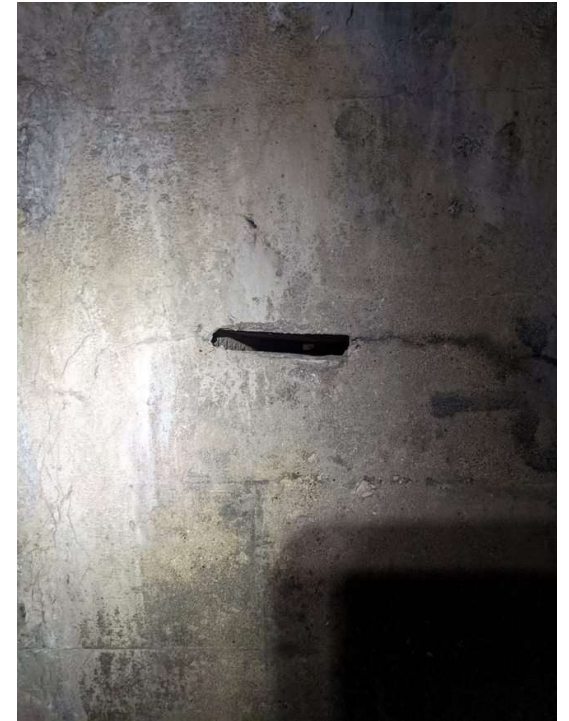
Joint 2 to Joint 3

- 2' from Joint 2:
- Hole that goes through the column

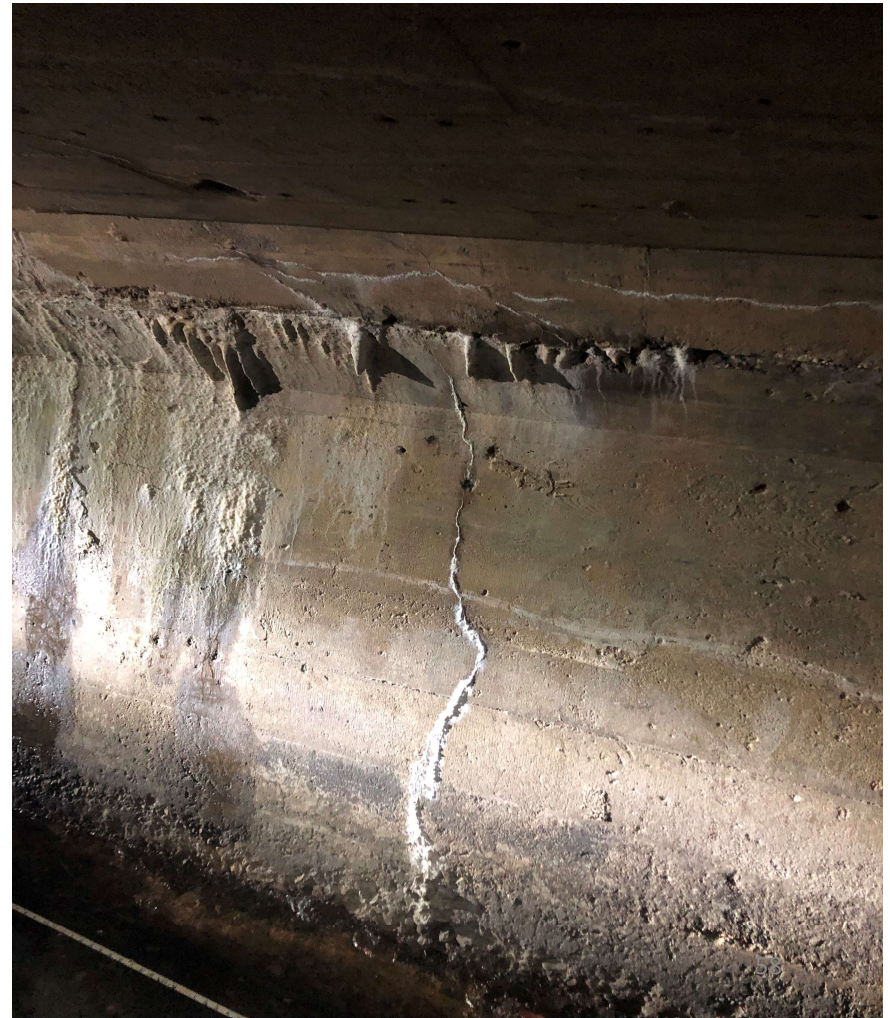
Joint 2 to Joint 3

- Continuous spall along bottom of east and west walls from joint 2 to joint 3,
- Image and defect dimension of the east wall:
- Height: 6"-12", average 8"
- Depth: 1"

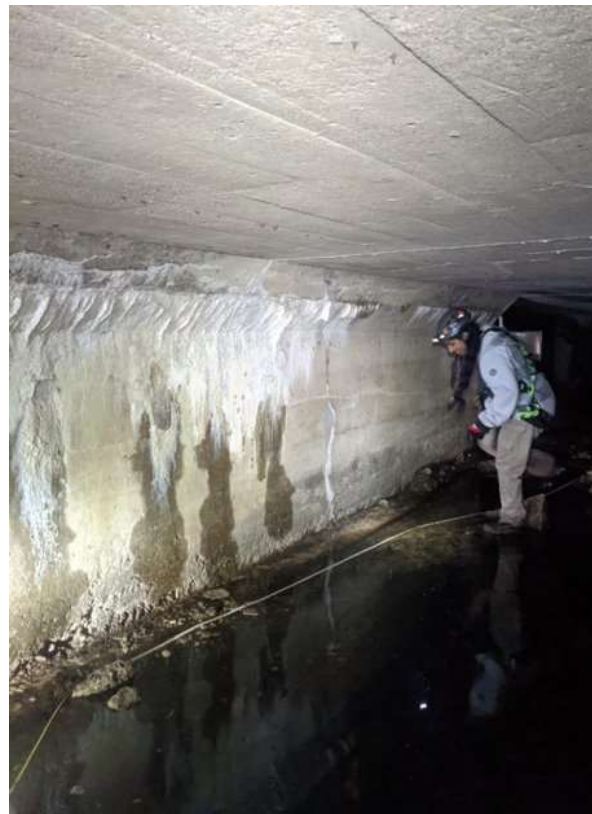
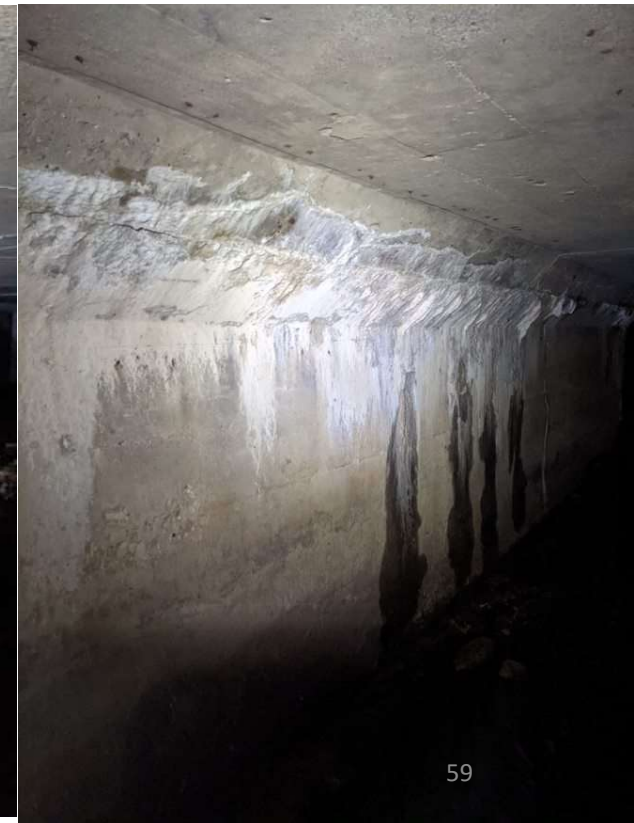
Joint 2 to Joint 3

- Calcium deposits continuous defect from joint 2 to joint 3, on both East and West walls of channel.
- Images on this slide are of the east wall

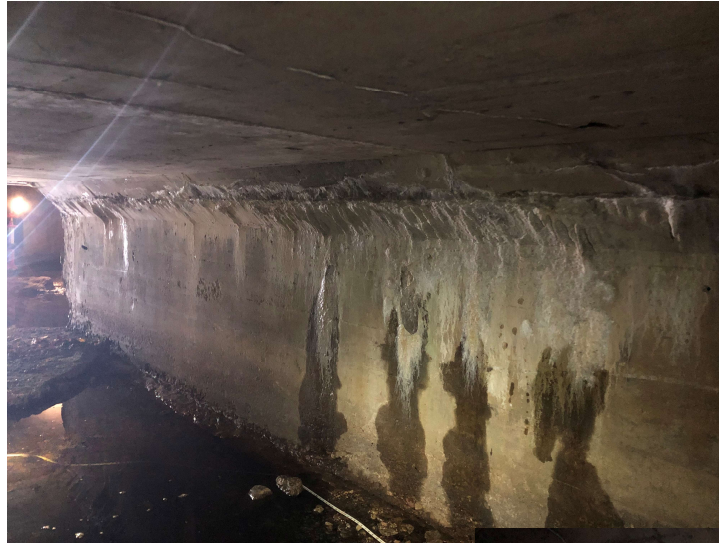
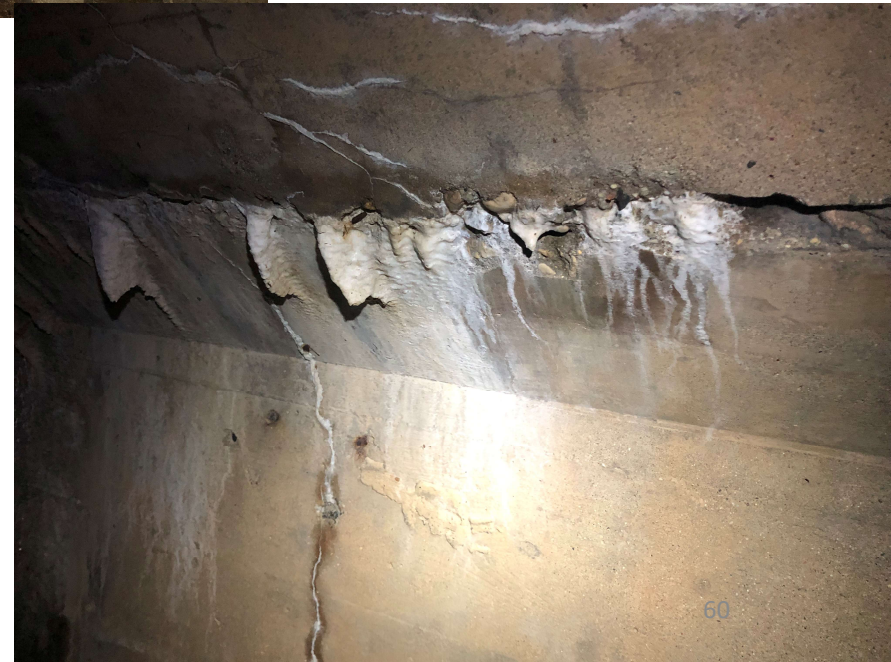
Joint 2 to Joint 3

- Calcium deposits continuous defect from joint 2 to joint 3, on both East and West walls of channel.
- Images on this slide are of the east wall.
- Horizontal crack on east wall from Joint 2 to joint 3 at 4' height. 1" depth at deepest point measured.
