Agreement for the Menomonee River Levee System Accreditation

Design Report – Replacement of the Storm Sewer/Outfall on Honey Creek Parkway between 70th and 72nd Streets and Rehabilitation of the Schoonmaker Creek Culvert

- Inspected from North to South, heading downstream
- Objective: to capture defects, describe their location and size

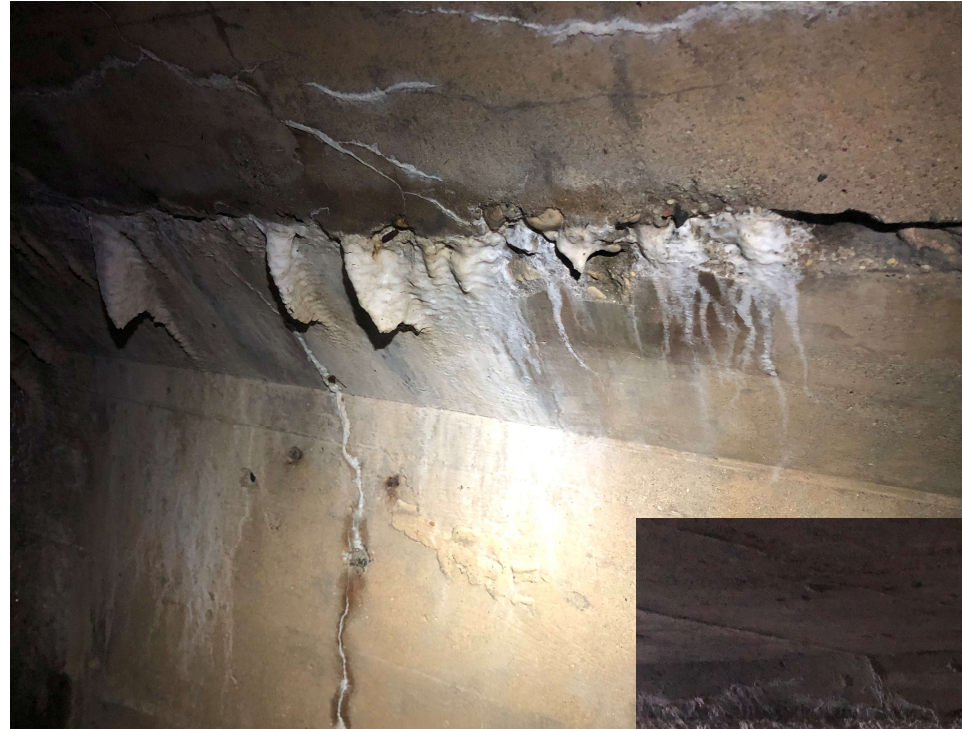
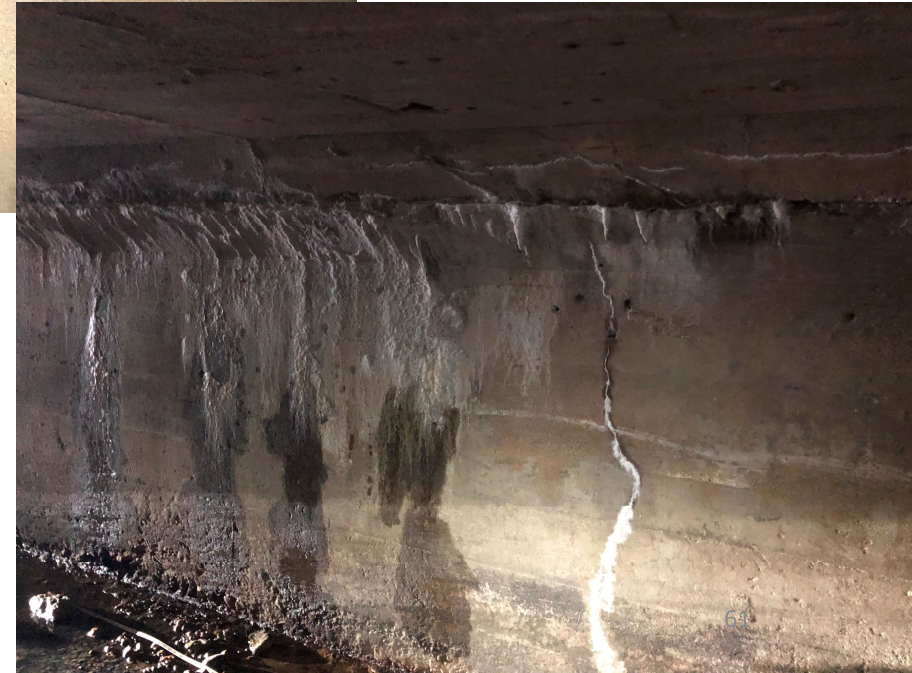
Joint 2 to Joint 3

- 20' from Joint 2: Vertical crack along east wall and roof of channel

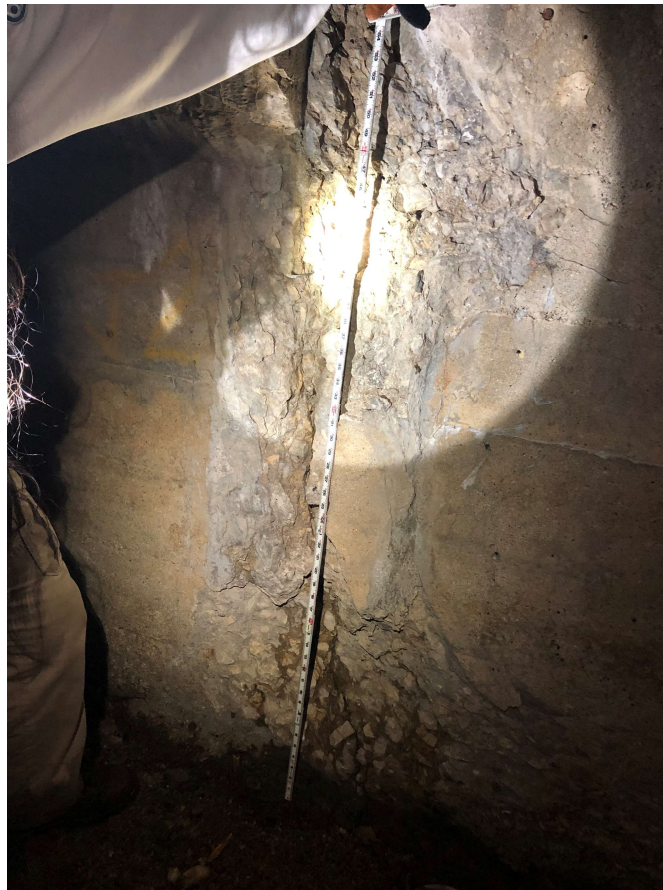
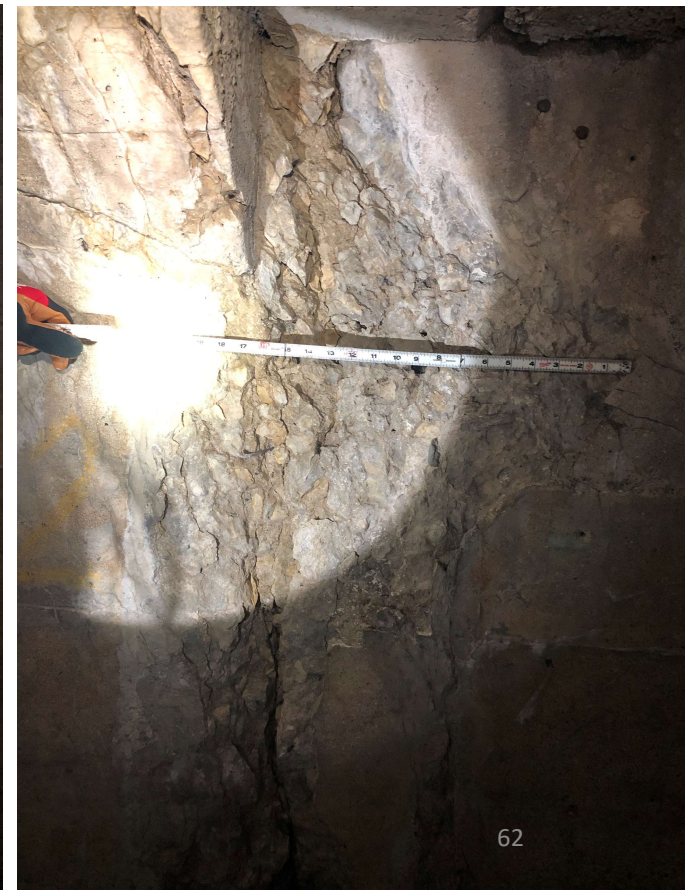
Joint 2 to Joint 3

Wall defect on west wall and roof at Joint 2:

Width: 2' at widest, 1 ft average

Depth: 5" average

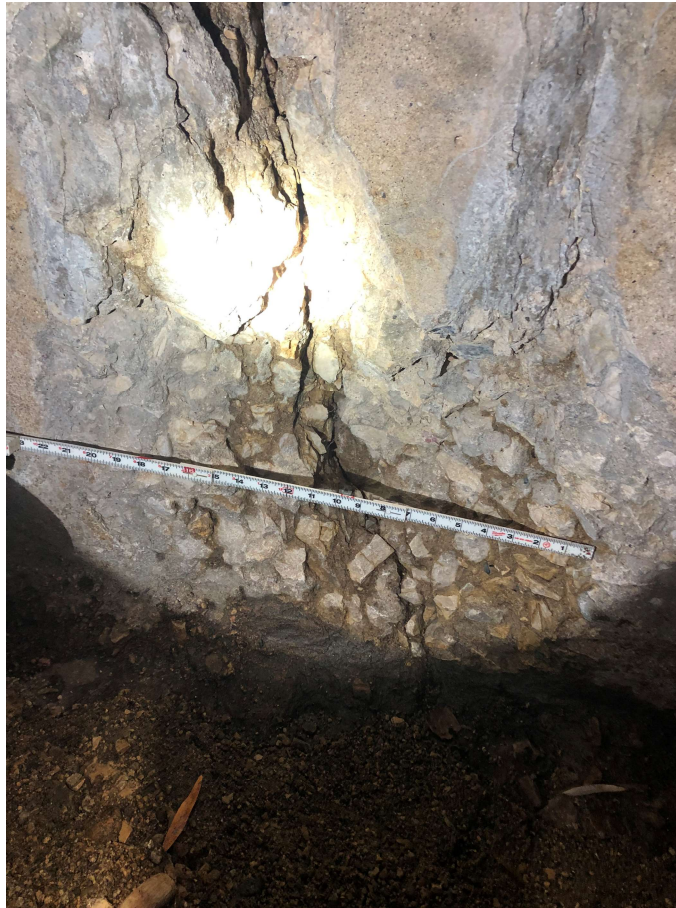
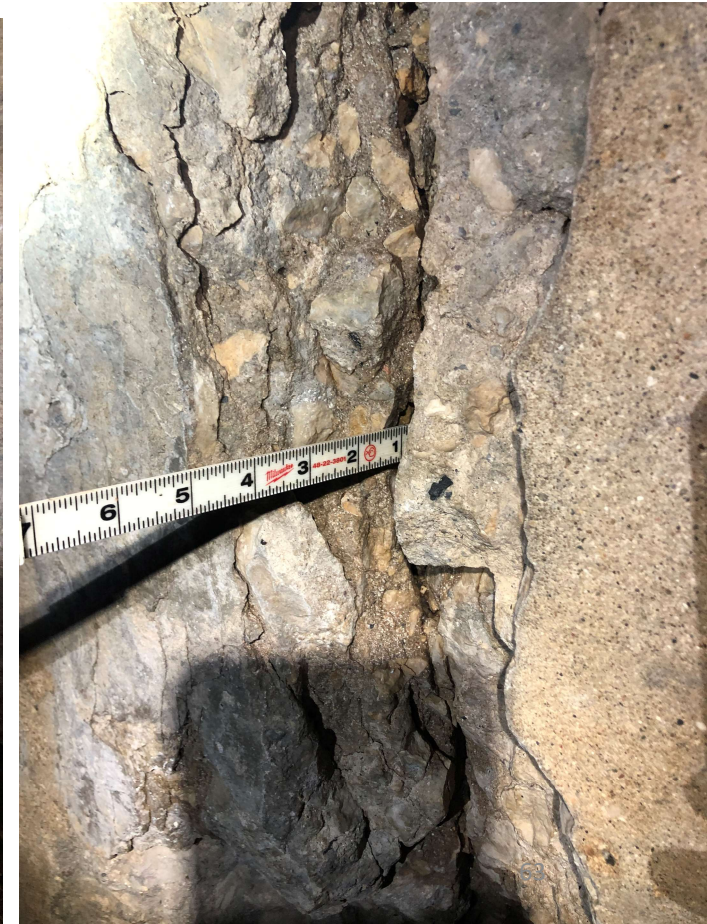
Joint 2 to Joint 3

Wall defect on west wall and roof at Joint 2:

Width: 2' at widest, 1 ft average

Depth: 5" average

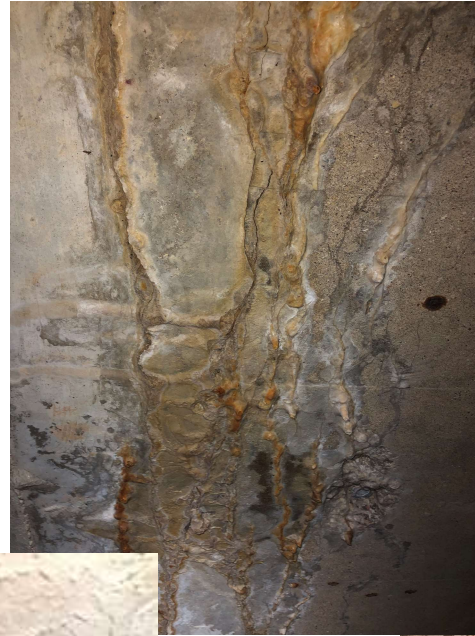
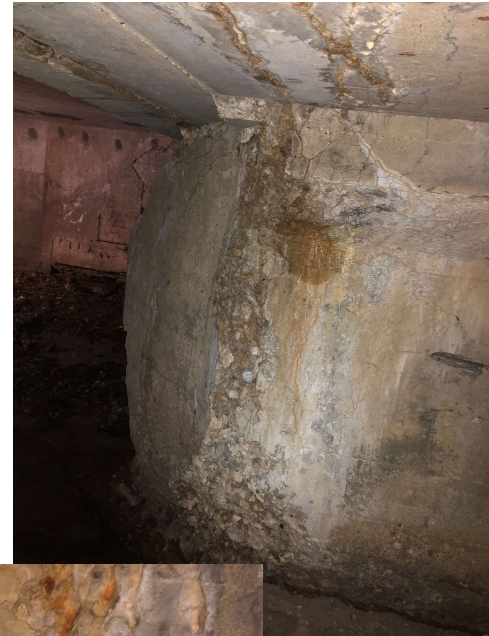
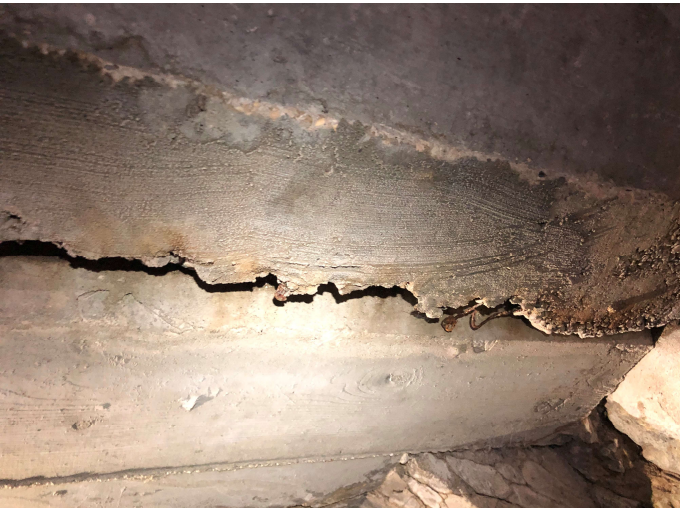
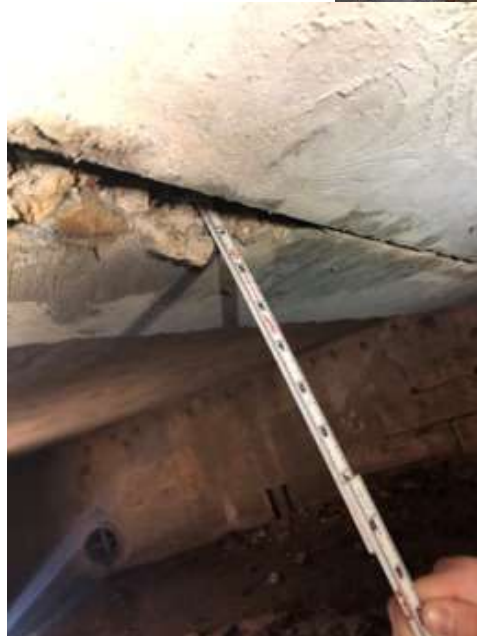
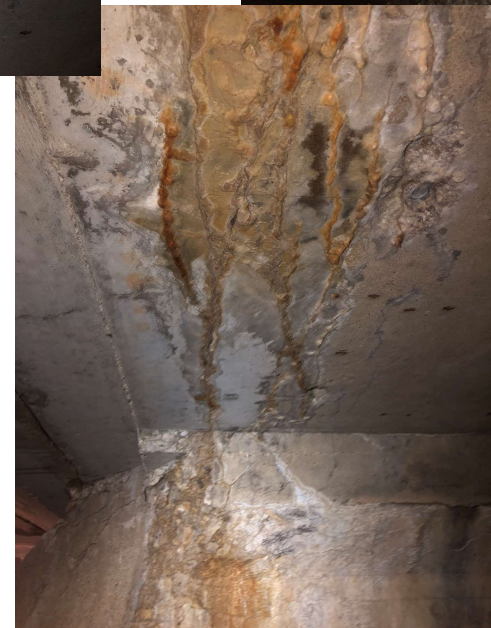
Joint 2 to Joint 3

At Joint 2, cracks and calcium deposits on roof:

Roof defect (hole):

Depth: 1"

Width: 3"

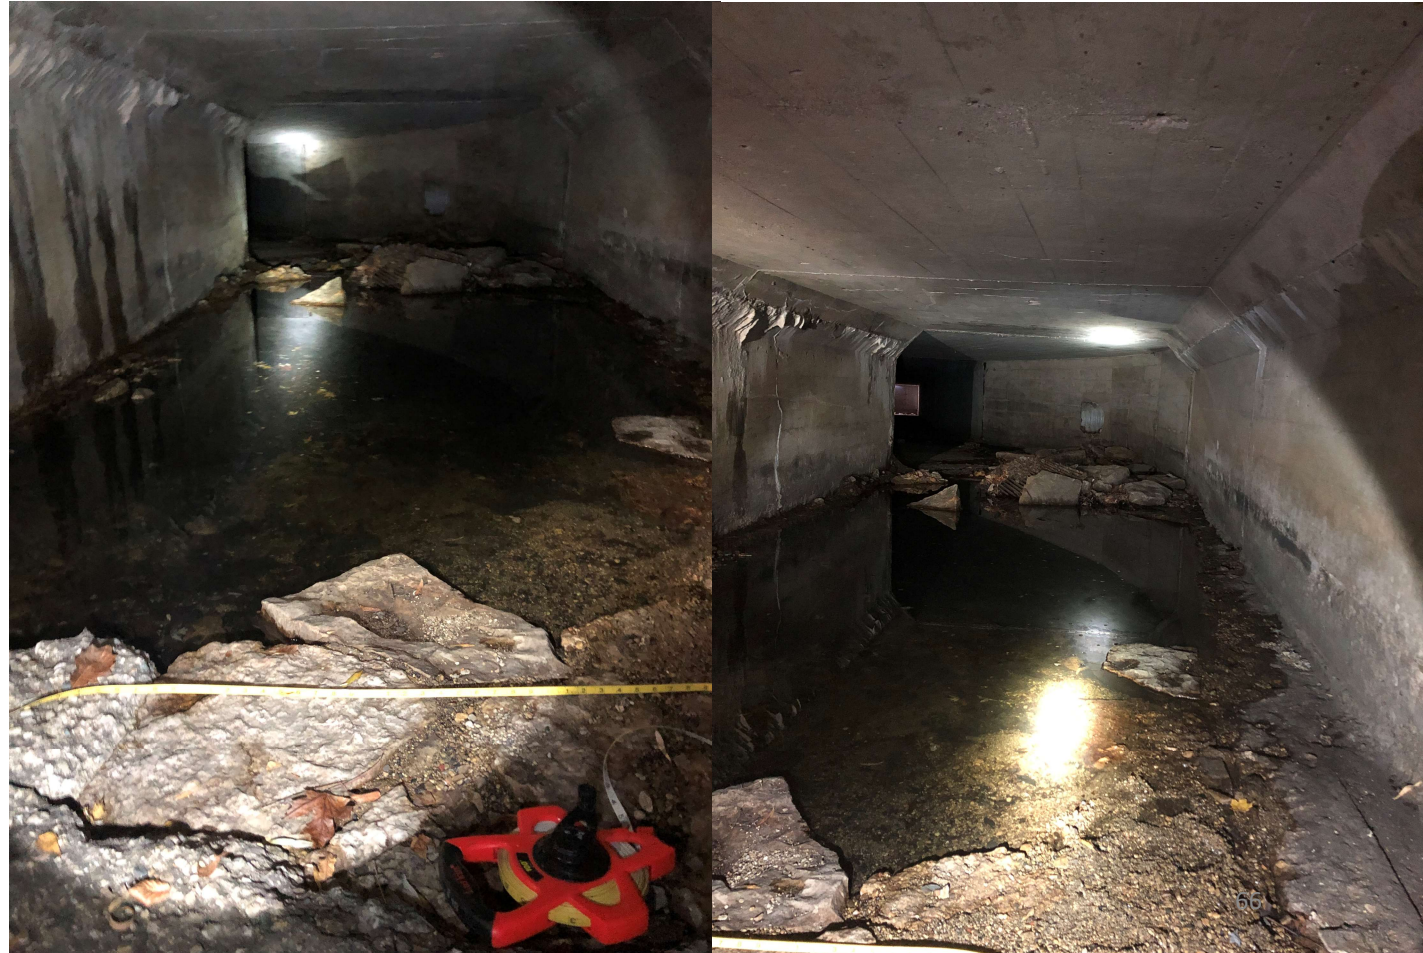
Joint 2 to Joint 3

- Pool/ floor defect starts at 4'8" from joint 2
- 9'6" width
- 9" average depth
- 26' length

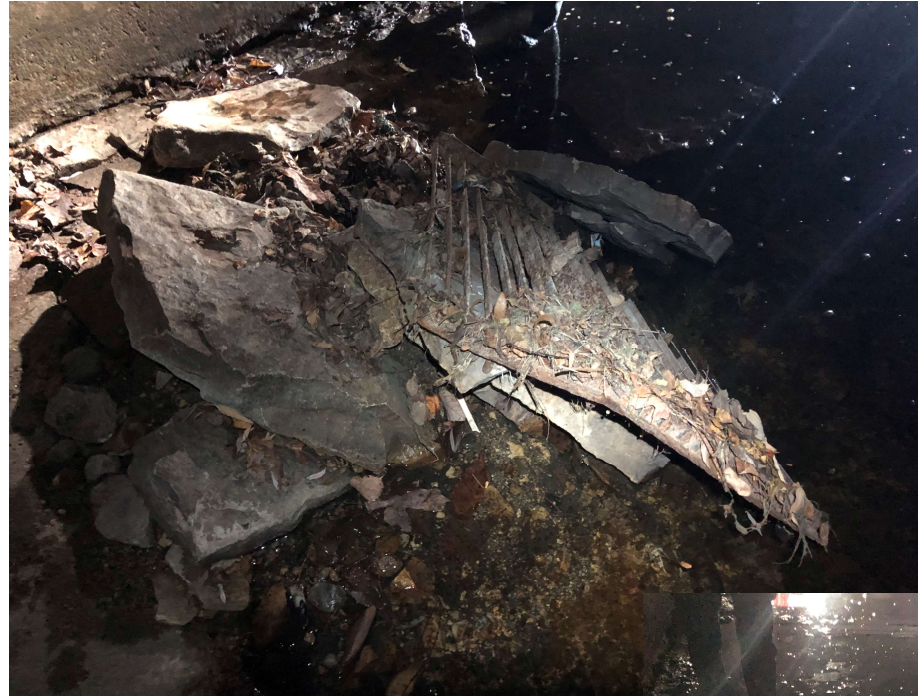
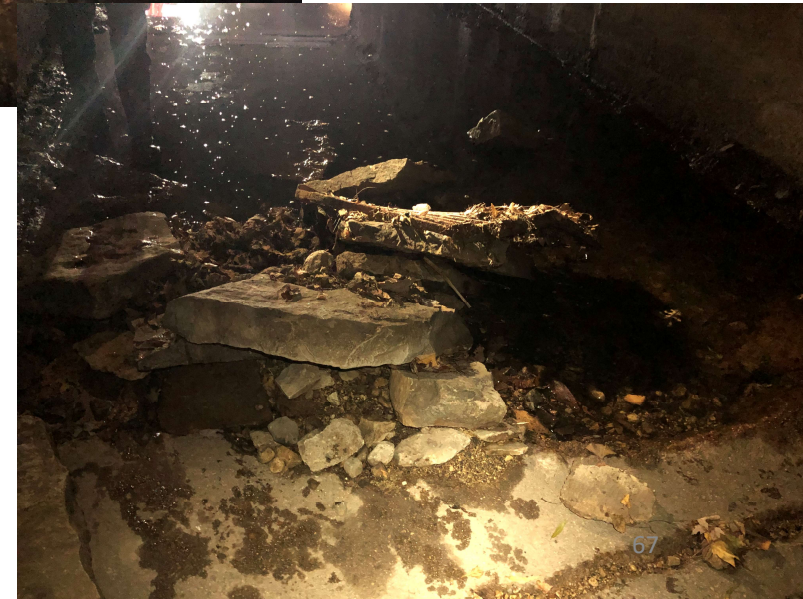
Joint 2 to Joint 3

- Extensive debris southern end of pool/ floor defect. Mostly concrete debris and one storm grate

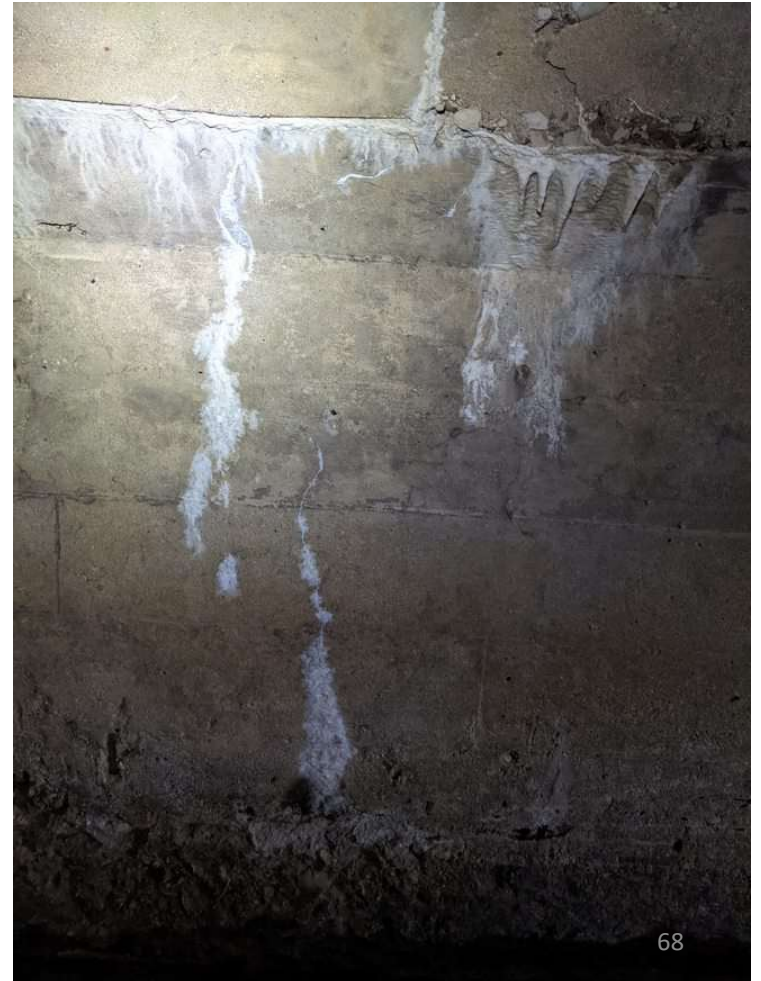
Joint 2 to Joint 3

- 4.5' to 6' from Joint 2:
- Vertical cracks on west side with calcium
- Length: 1 ft

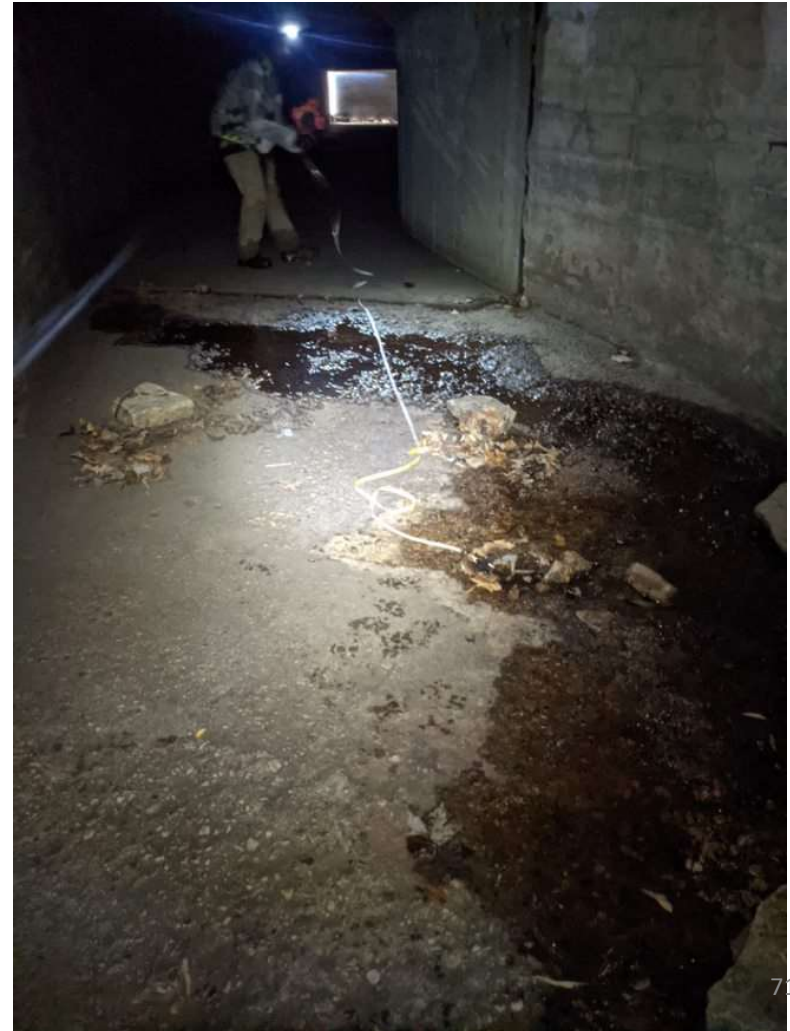
Joint 3 to Joint 4

- From Joint 3 to Joint 5:
- Floor defect/ Pool 22', average 1" depth standing water

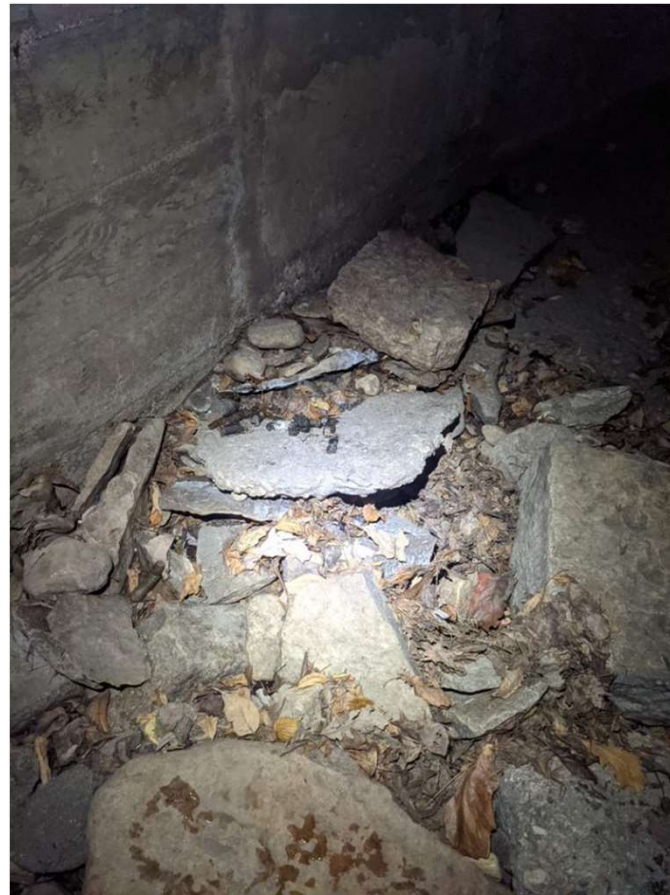
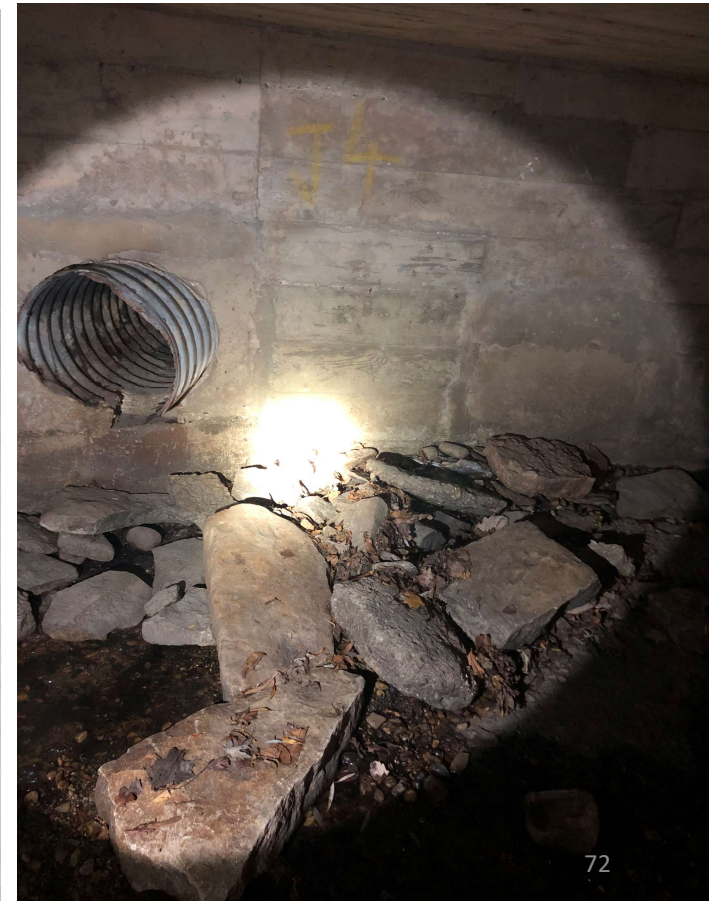
Joint 3 to Joint 4

Large debris pile
begins just before
joint 4

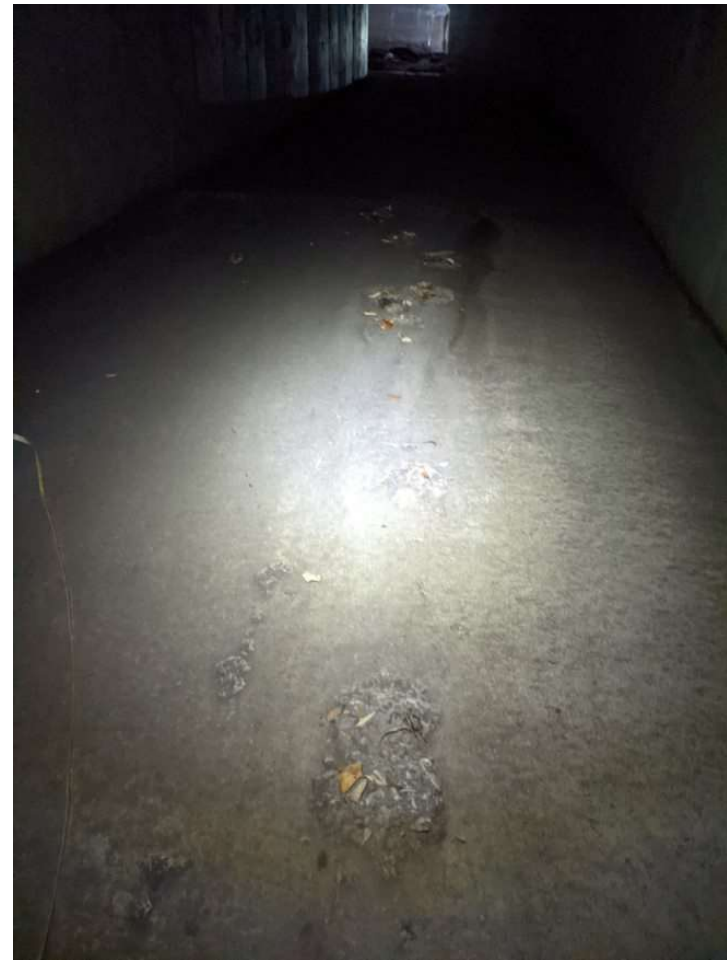
Joint 4 to Joint 5

- Bumps on floor, continuous from Joint 4 to Flood Gates, minor defects in floor

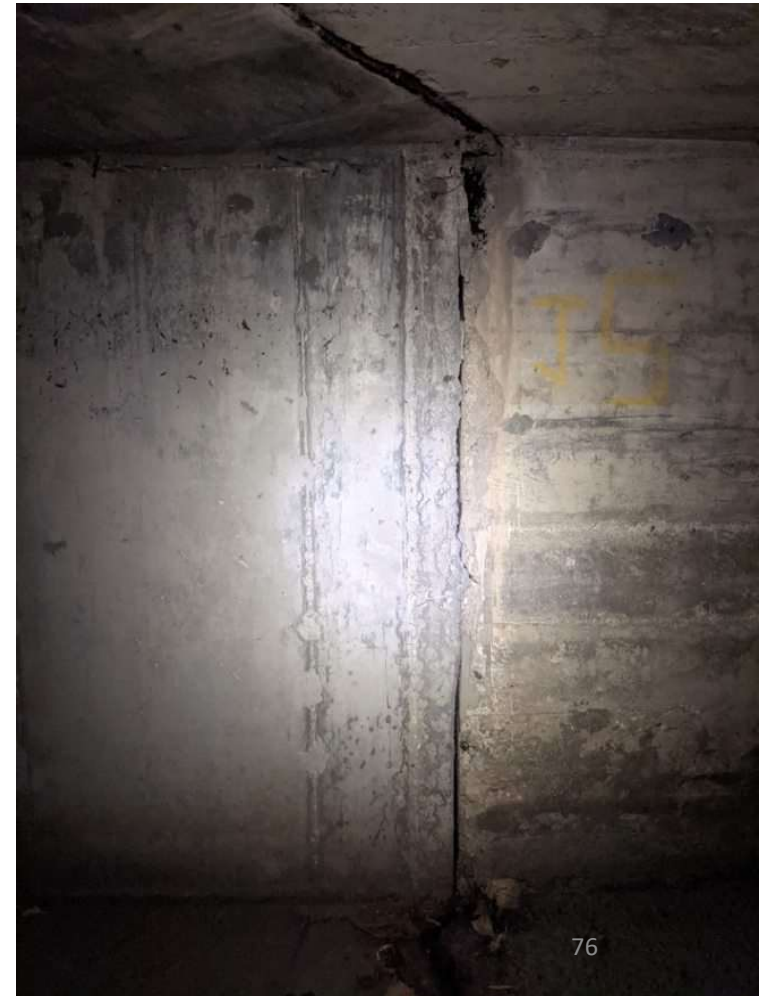
Joint 5 to Joint 6 – 15'6"

- Aggregate visible around joint, mastic showing, infiltration stain, 1' in width at widest point
- Lumber left from concrete pouring, infiltration stain
- Bumps on floor

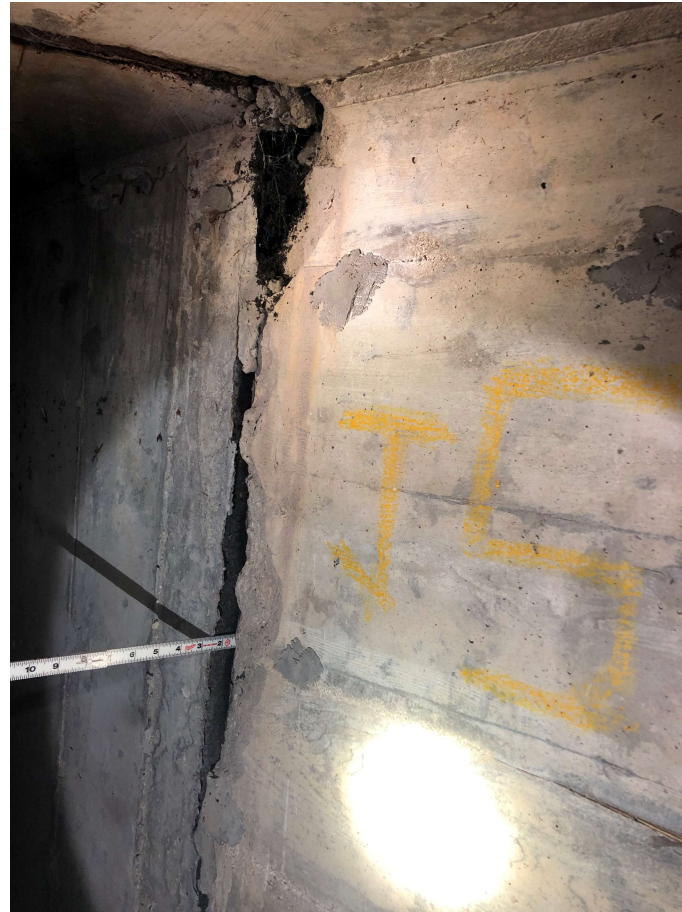
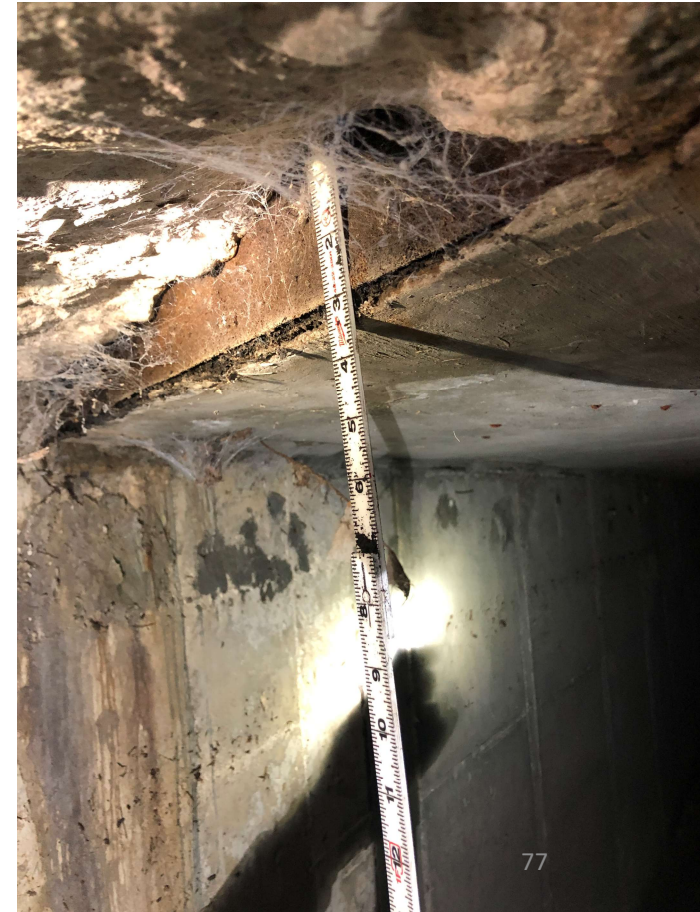
Joint 5 to Joint 6

- Aggregate visible around joint 5, mastic showing, infiltration stain, 1' in width at widest point. Average depth 2" (1" to 3")

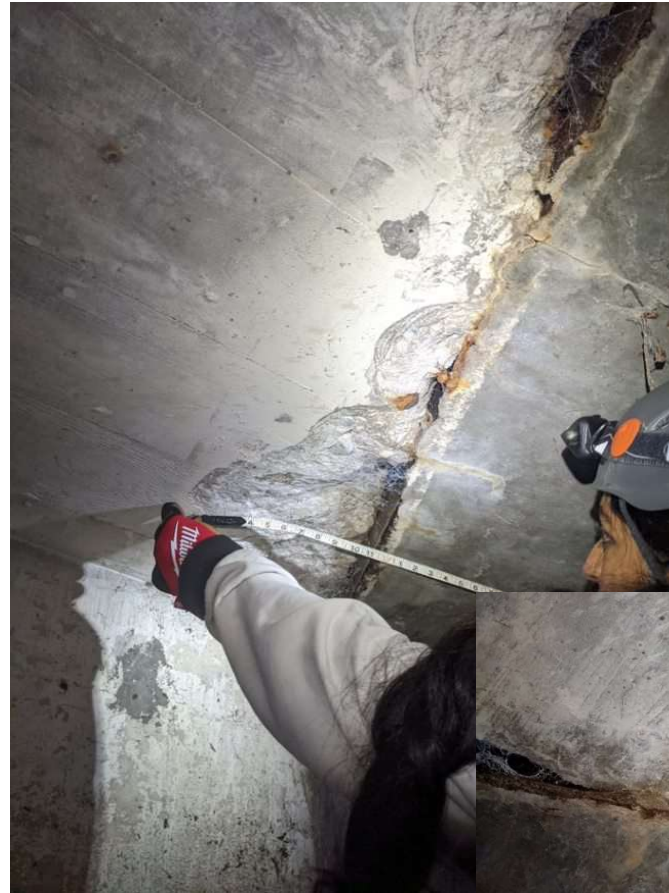
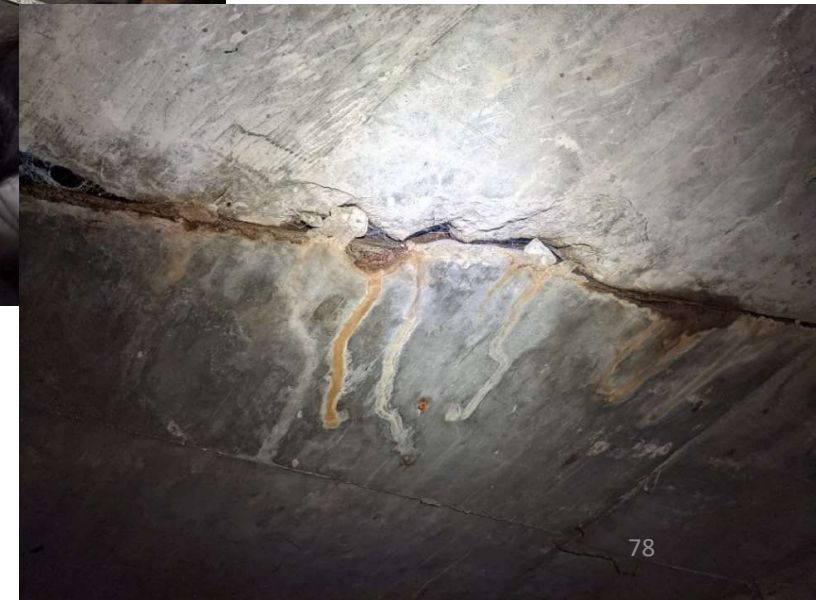
Joint 5 to Joint 6

Aggregate visible around joint 5, mastic showing, infiltration stain, 1' in width at widest point. Average depth 2" (1" to 3")

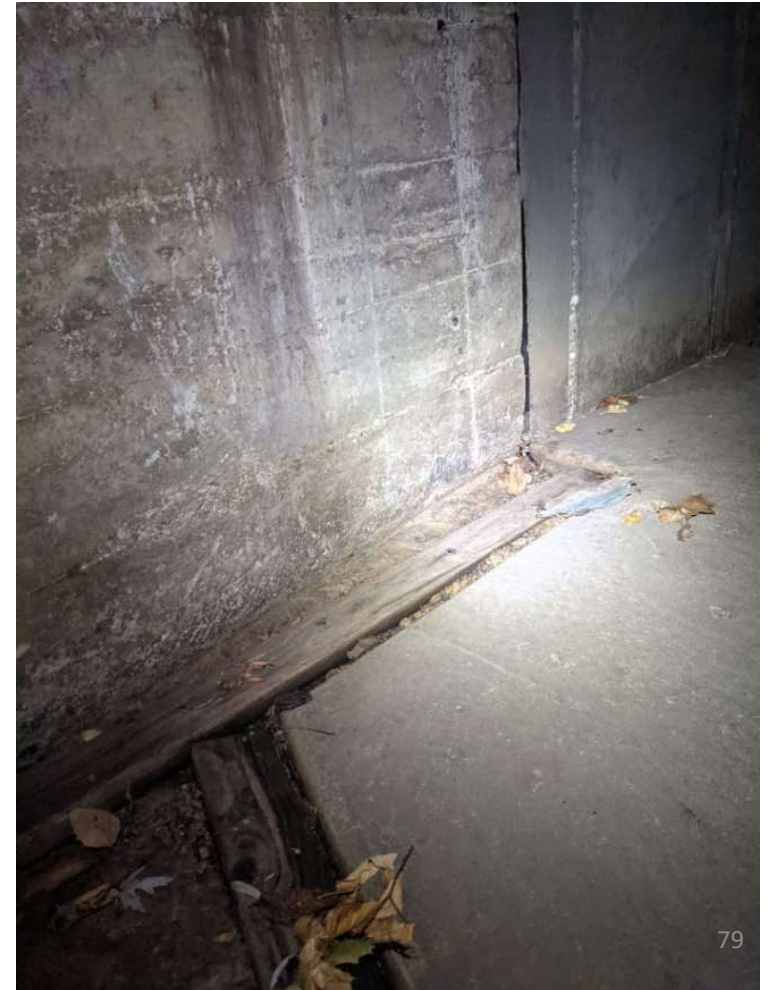
Joint 5 to Joint 6

- Lumber left from concrete pouring at Joint 5 on floor.
- Infiltration stain on east wall.

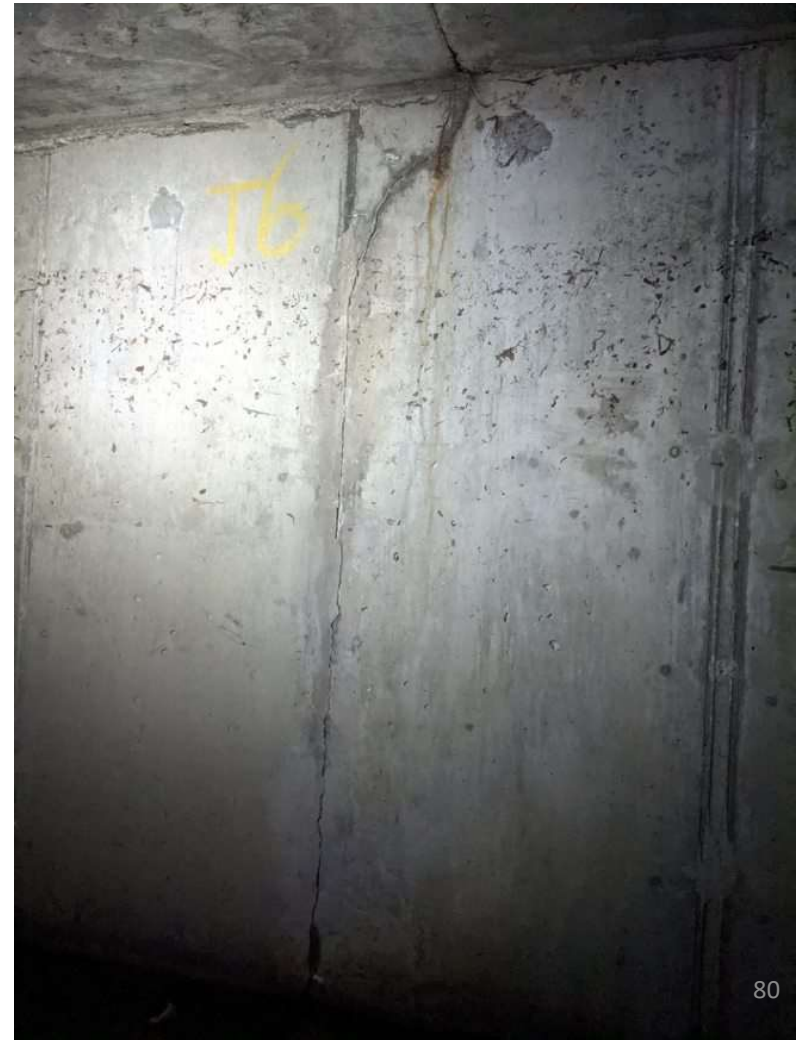
- Crack at joint 6
- Ceiling joint and wall joint are offset about 6"
- Cable showing on ceiling

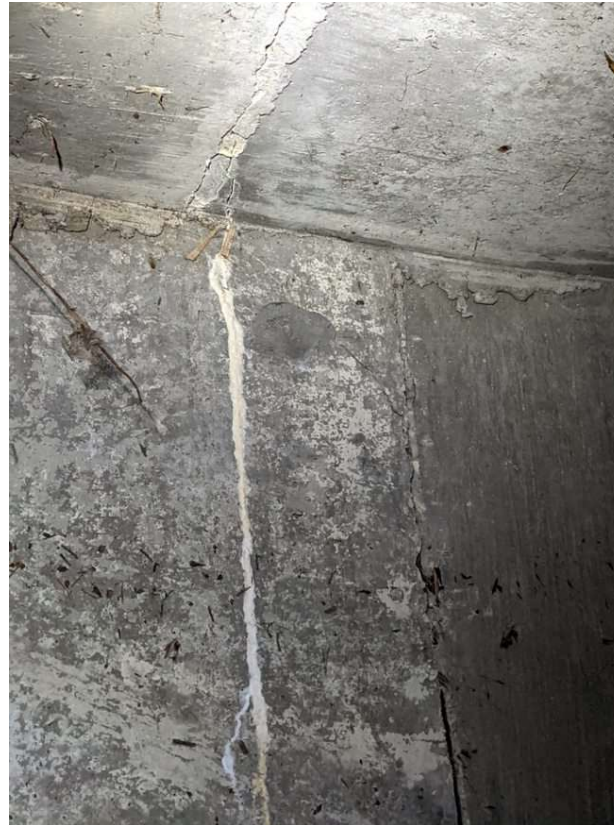
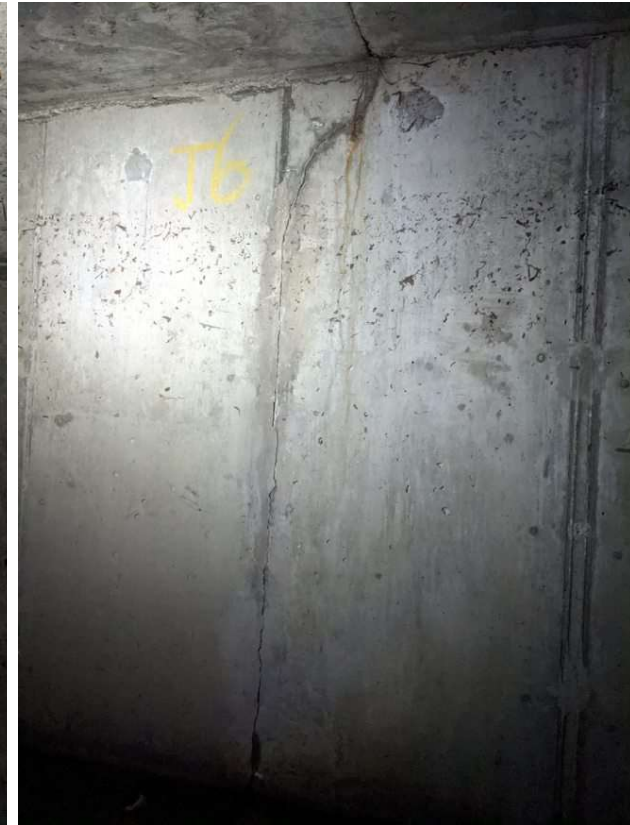
Joint 6 to Joint 7

- Crack at joint 6
- Ceiling joint and wall joint are offset about 6"

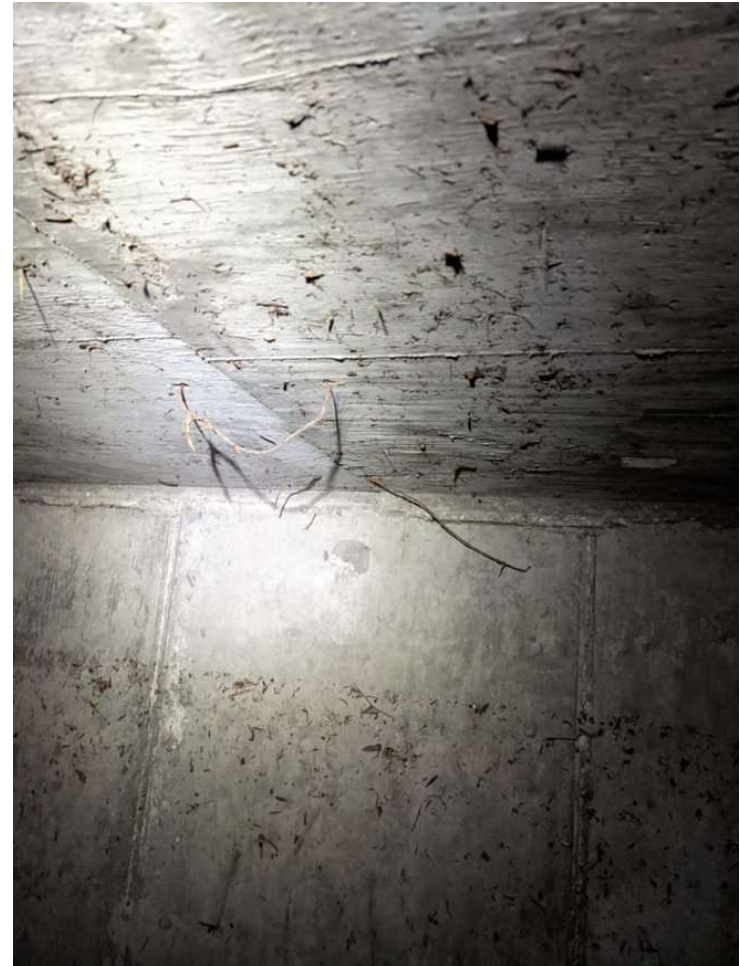
Joint 6 to Joint 7

- Cable showing on ceiling

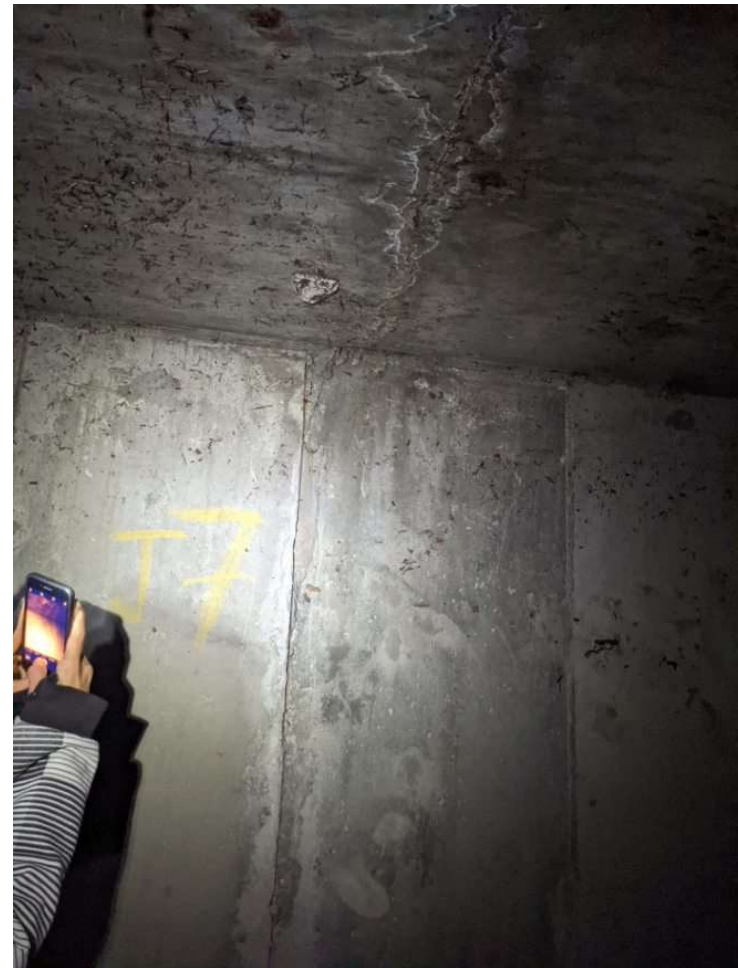
Joint 7 to Joint 8 – 24'

- Ceiling joint and wall joint are offset about 6"
- Signs of infiltration on ceiling
- Thin wires/cable showing on ceiling
- Bumps on floor .

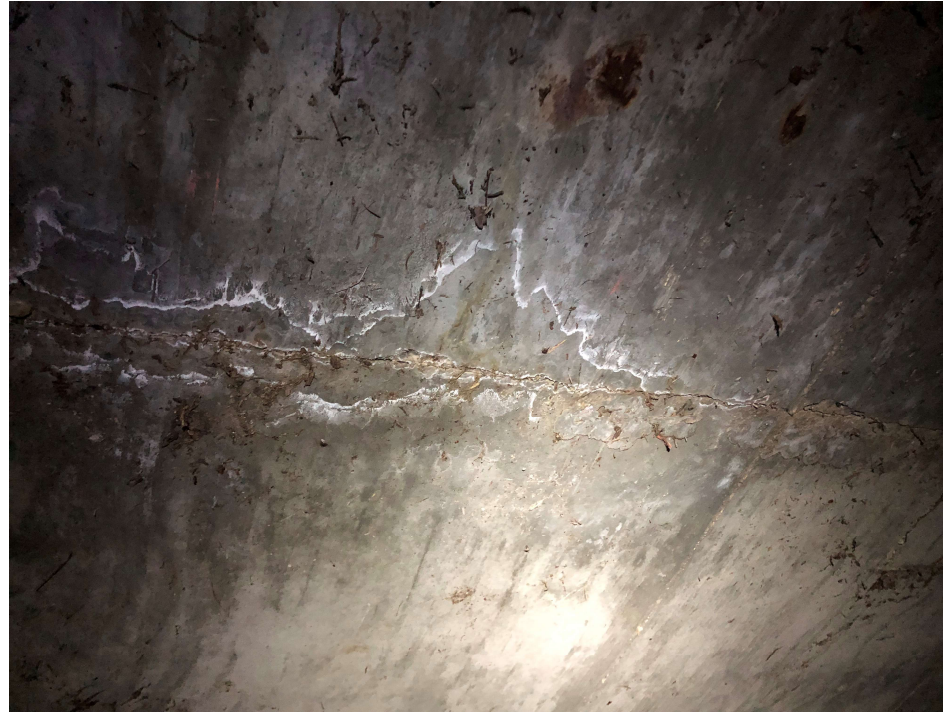
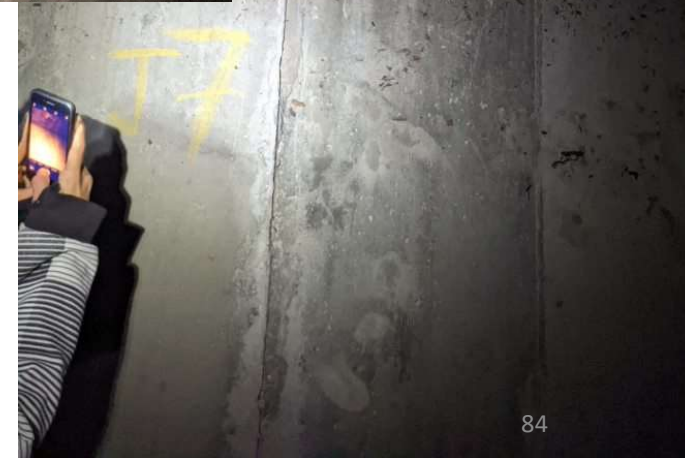
Joint 7 to Joint 8

- Signs of infiltration on ceiling

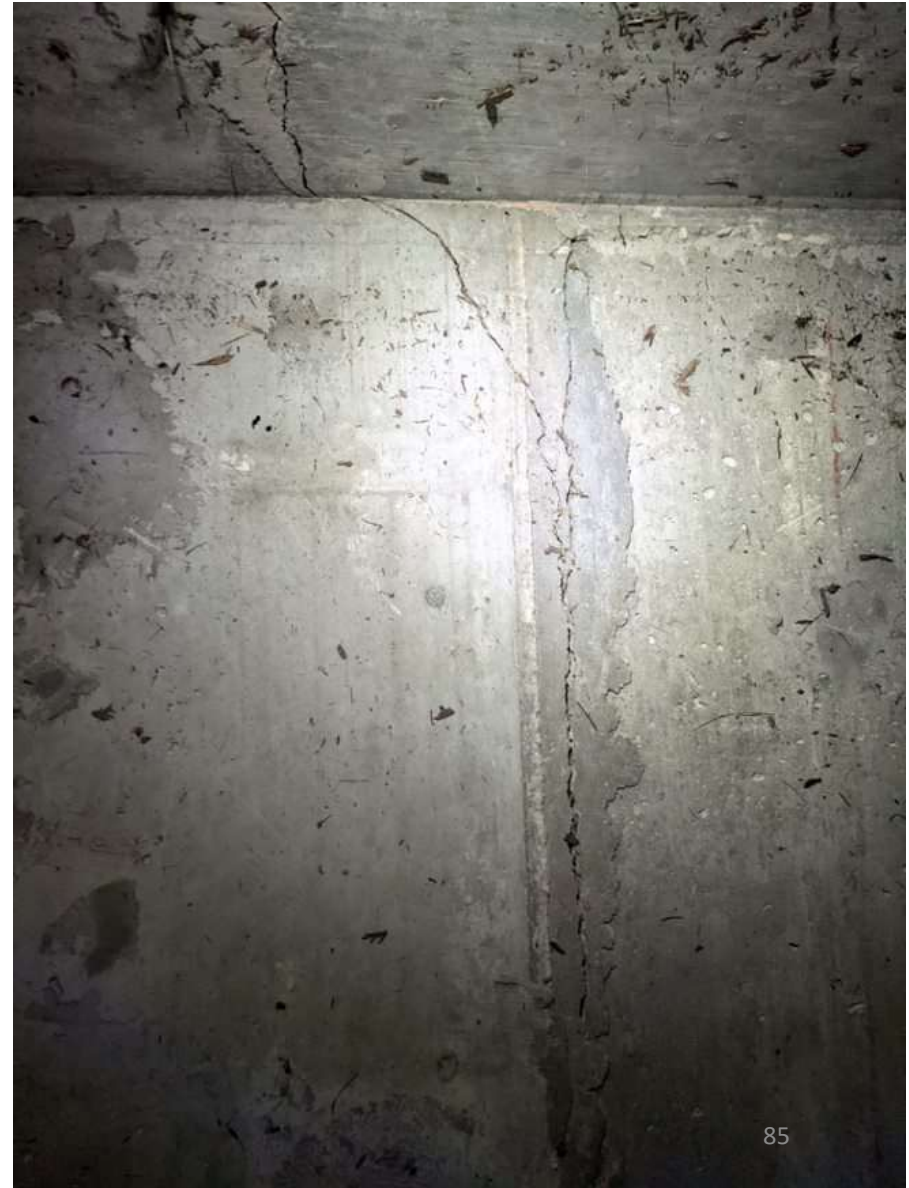
Joint 7 to Joint 8

- Ceiling joint and wall joint are offset about 6" (joint 7)

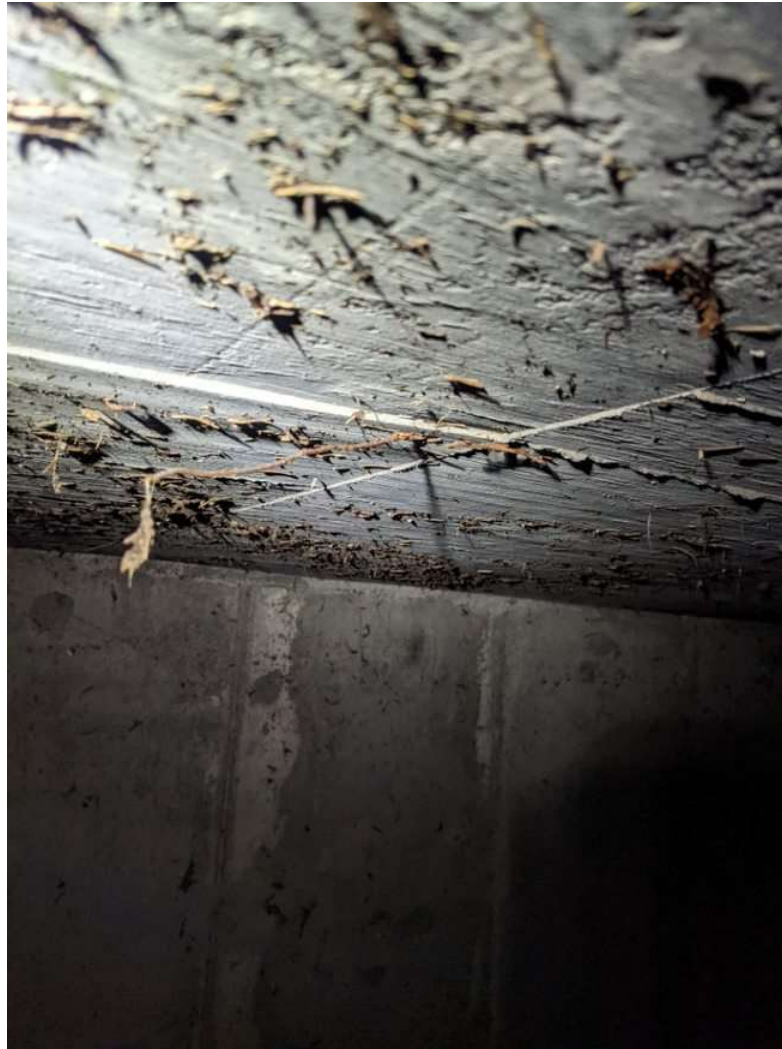
Joint 7 to Joint 8

- Thin metal wires/cables hanging from ceiling
