Agreement for the Menomonee River Levee System Accreditation

Design Report – Replacement of the Storm Sewer/Outfall on Honey Creek Parkway between 70th and 72nd Streets and Rehabilitation of the Schoonmaker Creek Culvert

- Inspected from North to South, heading downstream
- Objective: to capture defects, describe their location and size

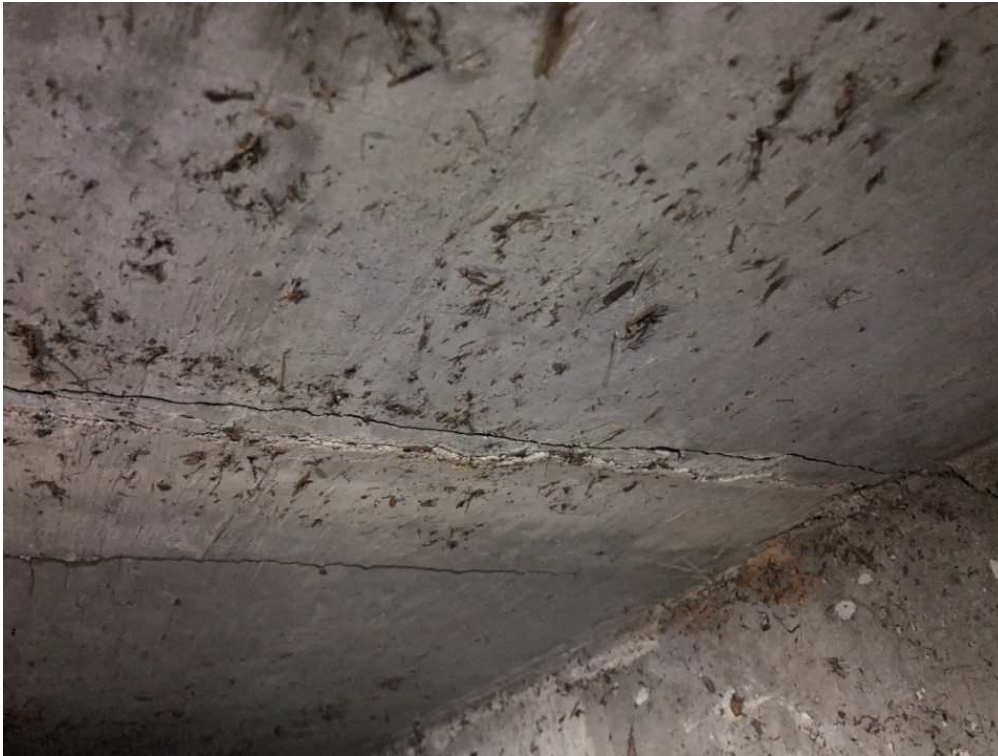
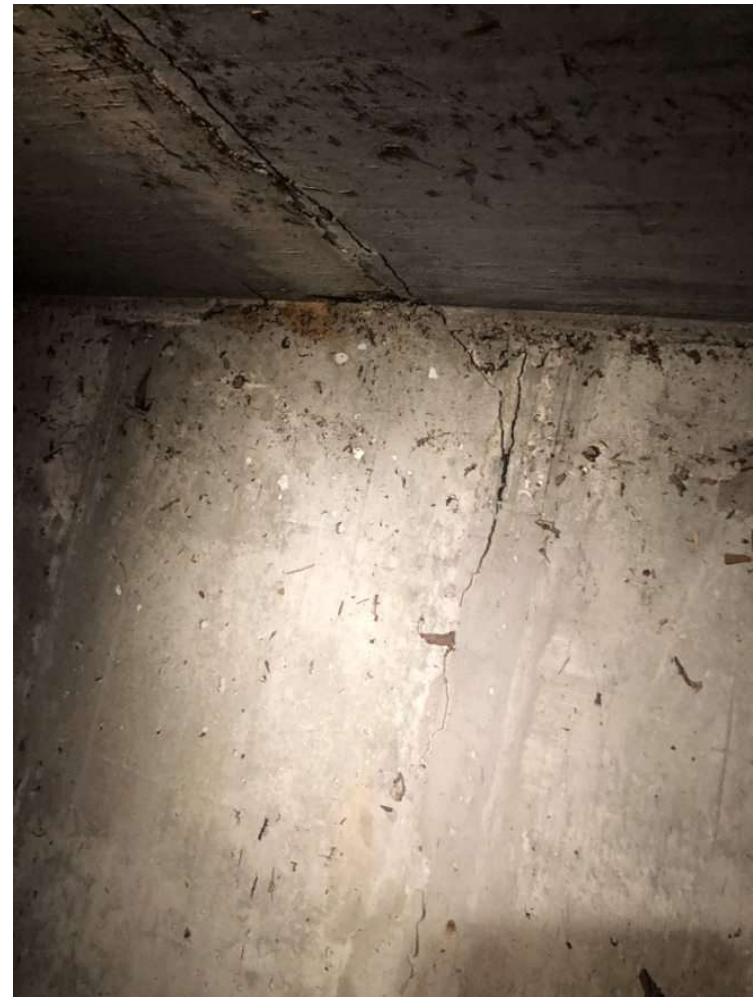
Joint 8 to Floodgate

- Circumferential crack at Joint 8
